**Routine Condition Bridge Inspection Form**  
(except for log stringer or timber stringer bridges)**GENERAL INFORMATION**

| *Site #: <u>CK 2178</u> | *Crossing Name: <u>Salsbury Crk</u> | *Type/Class: <input checked="" type="checkbox"/> Temporary bridge<br><input type="checkbox"/> Permanent bridge | *Project File ID# <u>B466</u> |
| *FSR Name: <u>Terepoki</u> | *Forest District: <u>Chilliwack</u> | *Kilometres: <u>2.4km</u> | User km: |

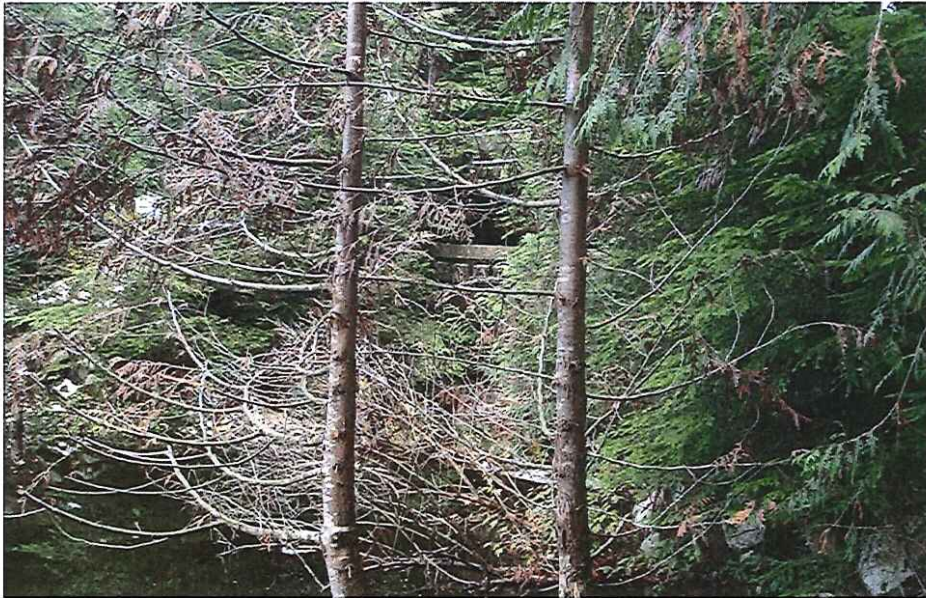
CK2178 Crossing upstream

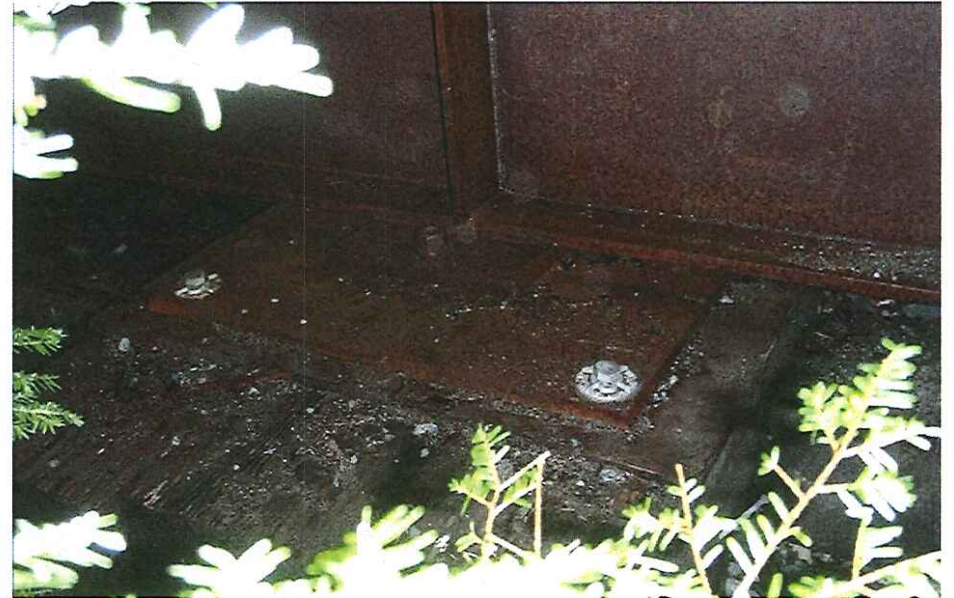
CK2178 Abutment left bank to portable bridge

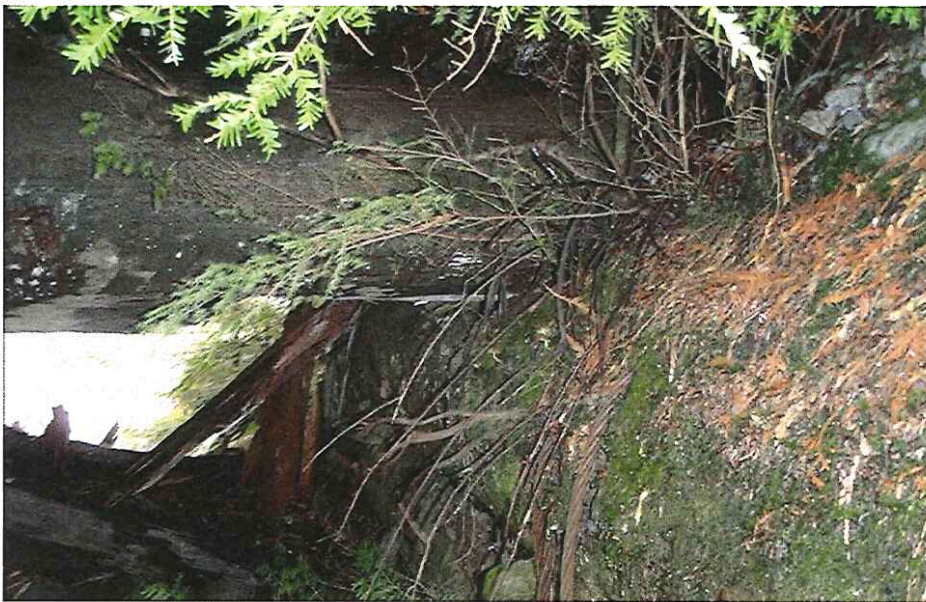
| Item | Present Condition<br>(circle) | Comments<br>(a comment is mandatory if condition "Poor" is selected) |
|---|---|---|
| Log/Timber Crib | E G F (P) N/A UR | Lots of rot old still functioning |

CK2178 Abutment Left Bank

| GENERAL INFORMATION | | | |
|---|---|---|---|
| 2 | continue to check cribbing as it is old / rotten but still functional for 5T. | | |

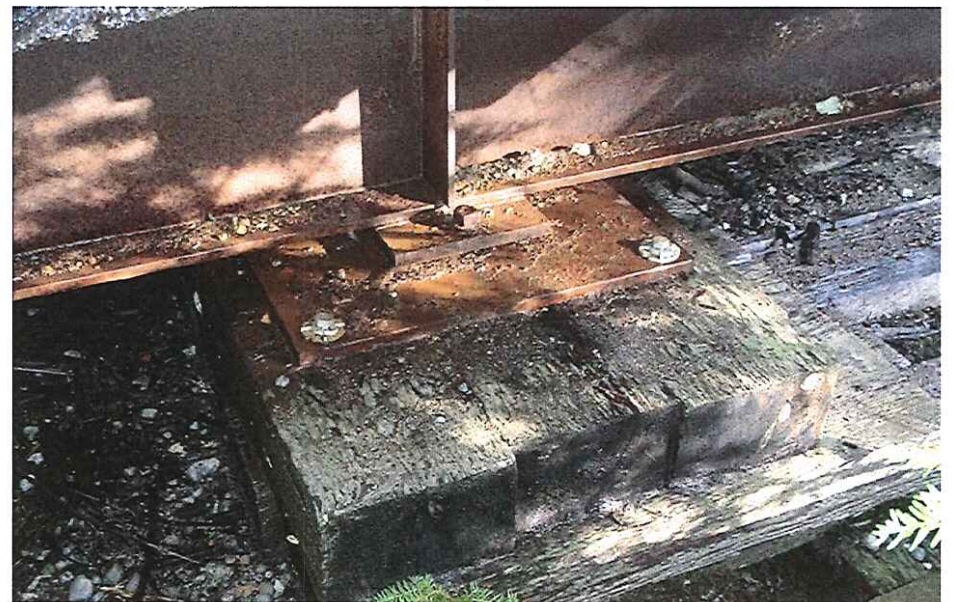
CK2178 Bearing right bank to portable bridge

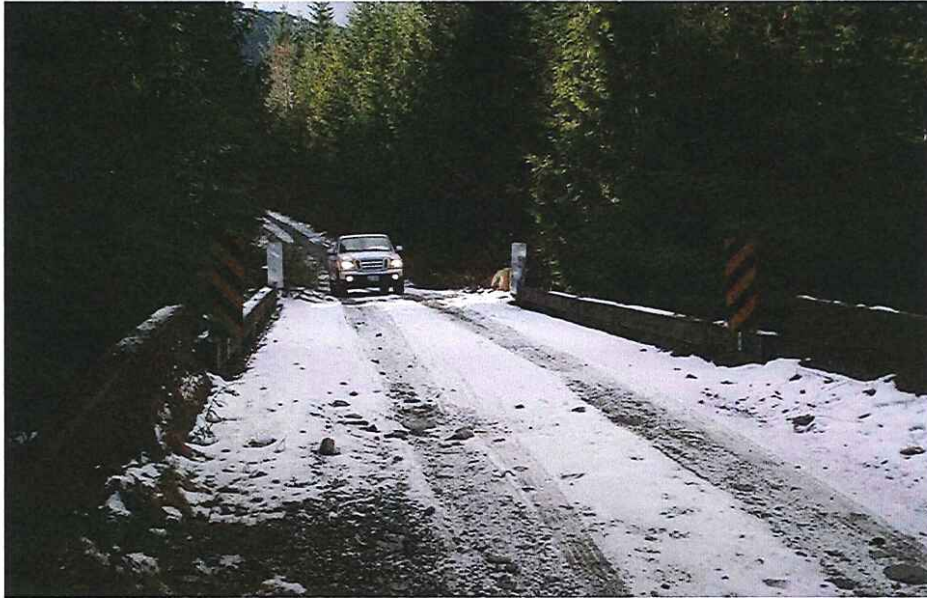
CK2178 Approach Left Bank

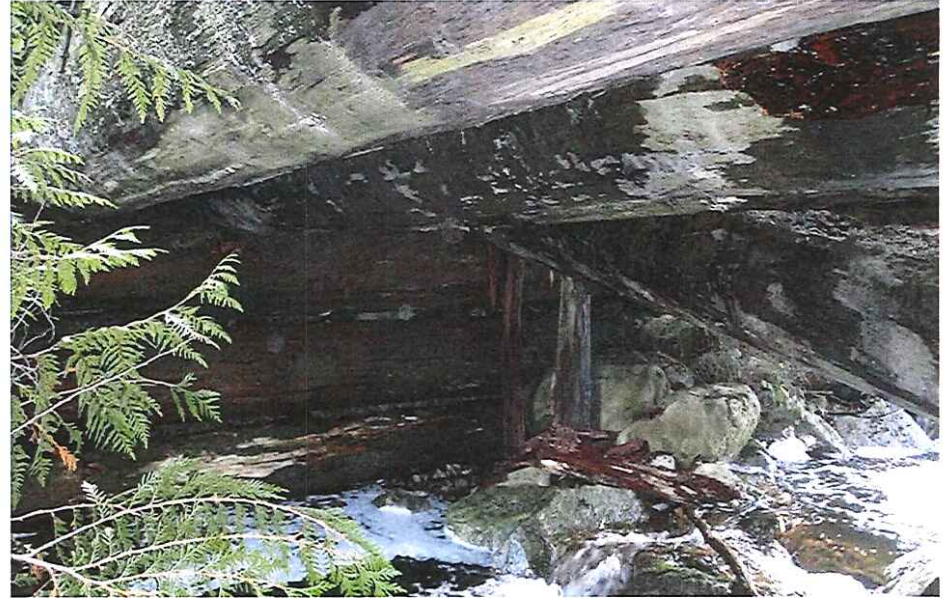
| GENERAL INFORMATION | | | |
|---|---|---|---|
| 1 | One stringer has fallen into the creek | | |

CK2178 Failed Stringer

| GENERAL INFORMATION | | | |
|---|---|---|---|
| P Eng Reviewer's Comments<br>5 tonnes load rating. Consider complete replacement. | | | |

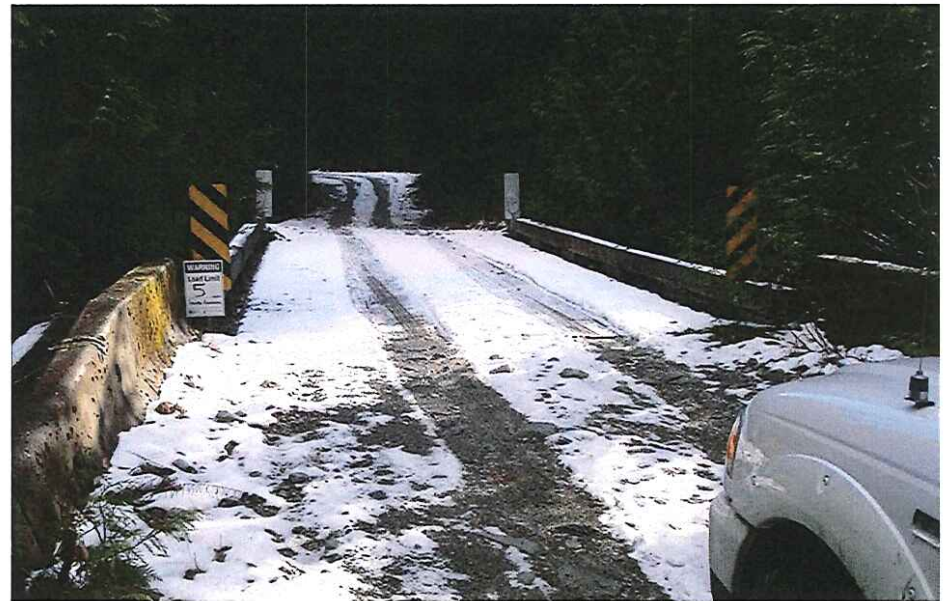
CK2178 Approach Right Bank
