**Routine Condition Bridge Inspection Form**  
(for log stringer or timber stringer bridges)**GENERAL INFORMATION**

| *Site #: <u>CK-2199</u> | *Crossing Name: <u>NEEDLE</u> | *Type/Class: <input type="checkbox"/> Major Culvert<br><input type="checkbox"/> Woodbox/Log Culvert | *Project File ID# |
| *FSR Name: <u>Nahatlatch</u> | *Forest District: | *Kilometres: <u>35 km</u> | User km: |

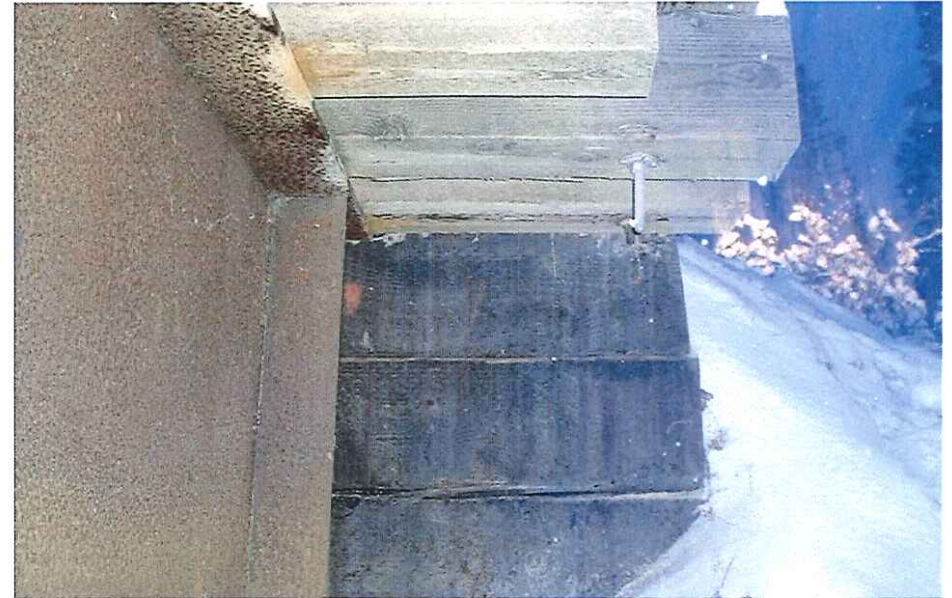
CK2199 Ballast Wall and Sub-Deck

| Item | Present Condition<br>(circle) | Comments<br>(a comment is mandatory if condition "Poor" is selected) |
|---|---|---|
| Sub-deck | E (G) F P N/A UR | From under-side observation |

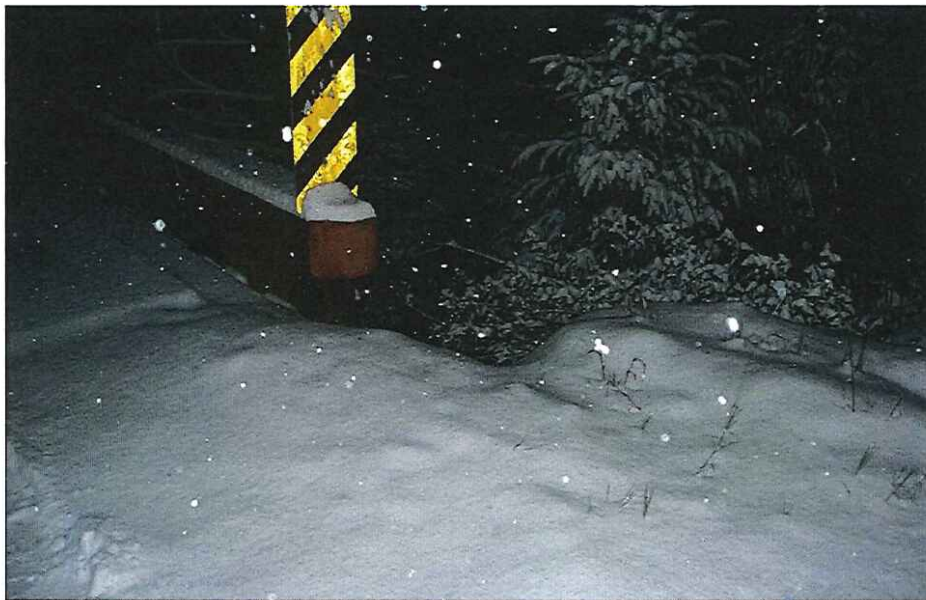
CK2199 RH Bank

| Item | Present Condition<br>(circle) | Comments<br>(a comment is mandatory if condition "Poor" is selected) |
|---|---|---|
| Fill | E G (F) P N/A UR | - Right & Bush side banks have minor erosion. |

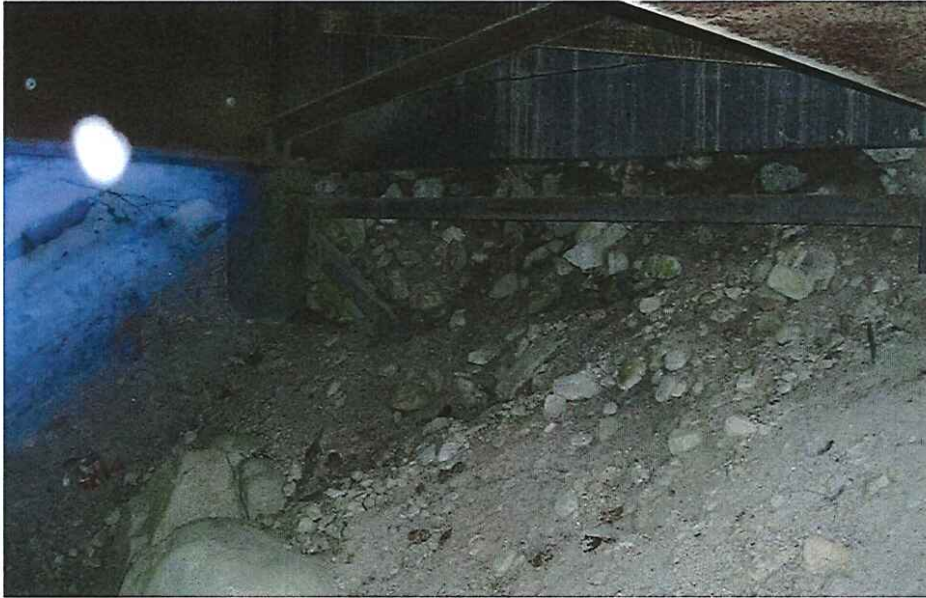
CK2199 Woods Abutment

| Item | Present Condition<br>(circle) | Comments<br>(a comment is mandatory if condition "Poor" is selected) |
|---|---|---|
| Piles or Posts | E (G) F P N/A UR | - Minor rust |

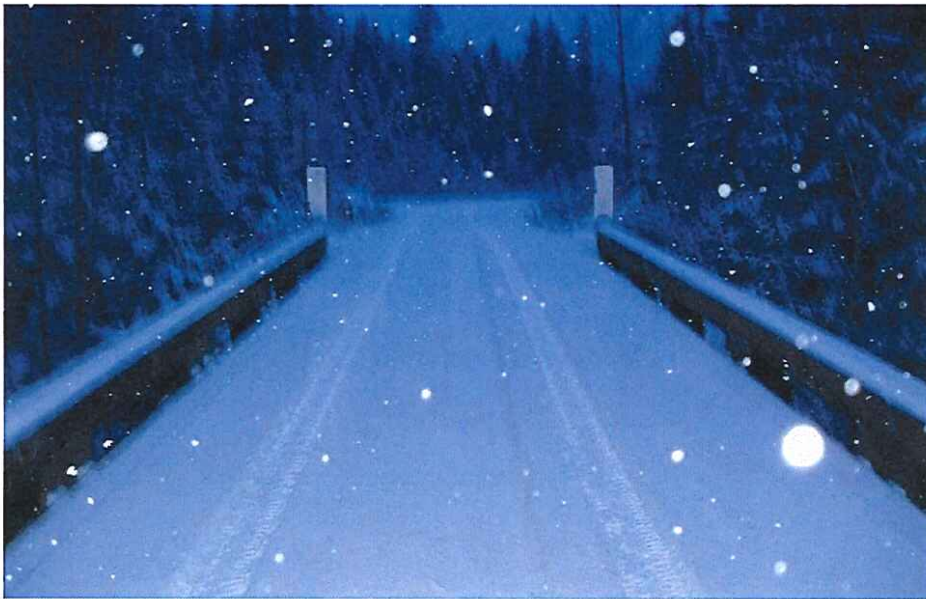
CK2199 Camp Approach (2)

| Item | Present Condition<br>(circle or fill-in) | Comments<br>(a comment is mandatory if condition "Poor" is selected) |
|---|---|---|
| Road Surface | E G (F) P UR | - Some approach settlement, snow cover. |

| GENERAL INFORMATION | | | | | | | |
|---|---|---|---|---|---|---|---|
| 1 | H <u>M</u> L | | Approach materials. | | | | |

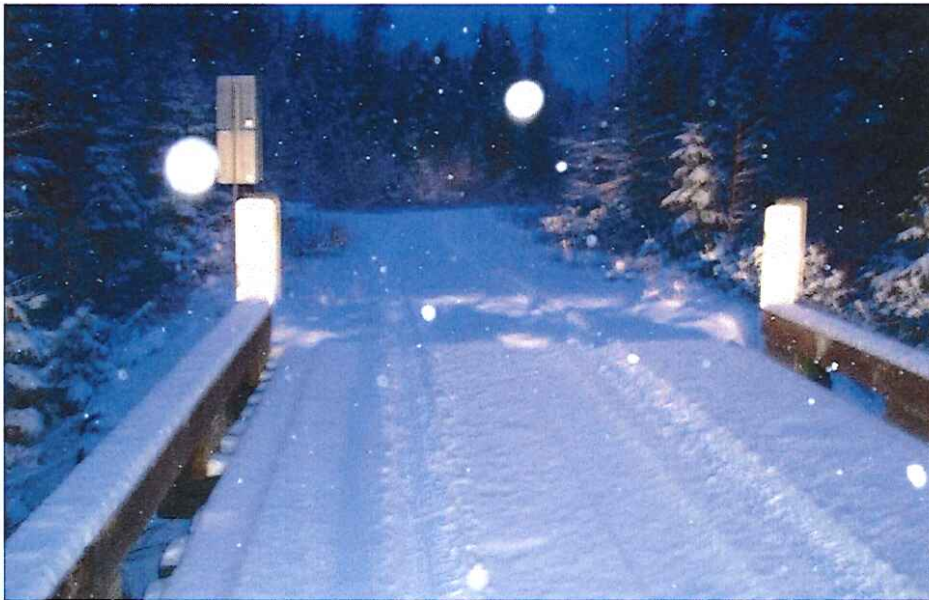
CK2199 Camp Approach

Inspection indicates "Good" fenders but pictures do not show any present.
