## Routine Condition Culvert Inspection Form

| *Site #: <u>CK 2205</u> | *Crossing Name: <u>Side Crk</u> | *Type/Class: <input checked="" type="checkbox"/> Major Culvert<br><input type="checkbox"/> Woodbox/Log Culvert | *Project File ID# <u>8019</u> |
| *FSR Name: <u>NORTH AINSLIE CRK</u> | *Forest District: <u>CK</u> | *Kilometres: _____ | User km: <u>17.4</u> |

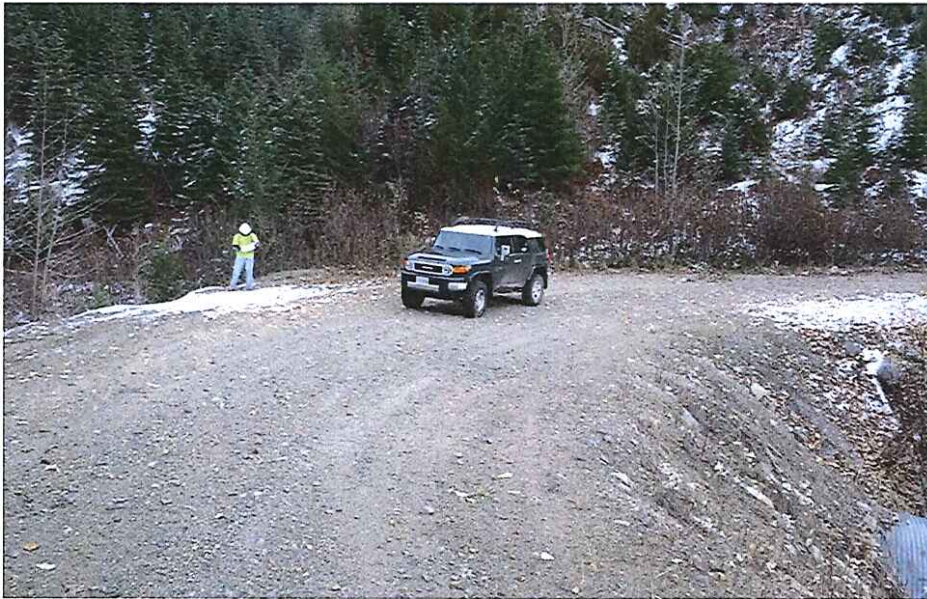
| Item | Present Condition<br>(circle or fill-in) | Comments<br>(a comment is mandatory if condition "Poor" is selected) |
|---|---|---|
| Alignment | E G <u>(F)</u> P UR | Right curve, downhill gradient |

CK2205 Right to Left Approach

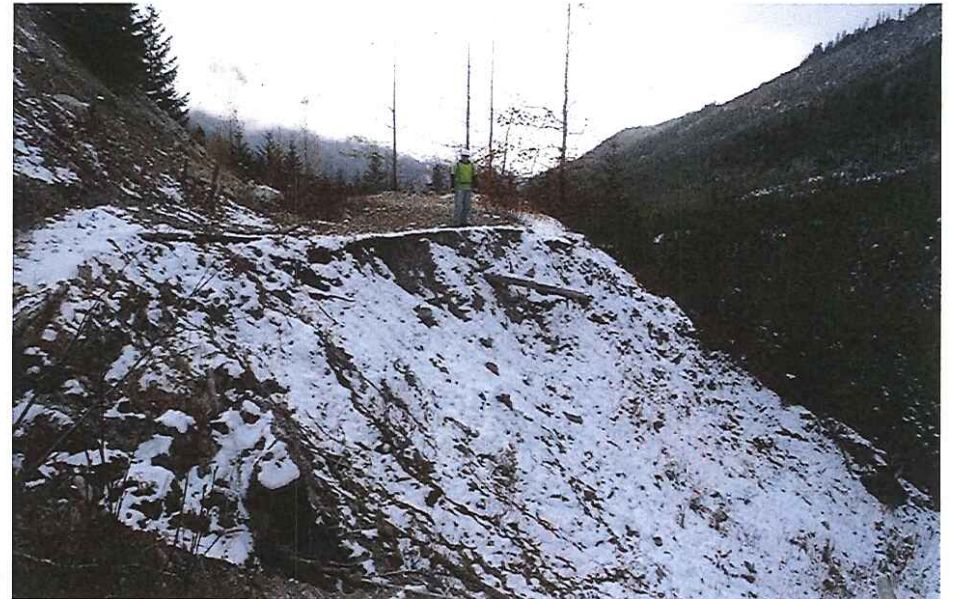
CK2205 Impassable road failure

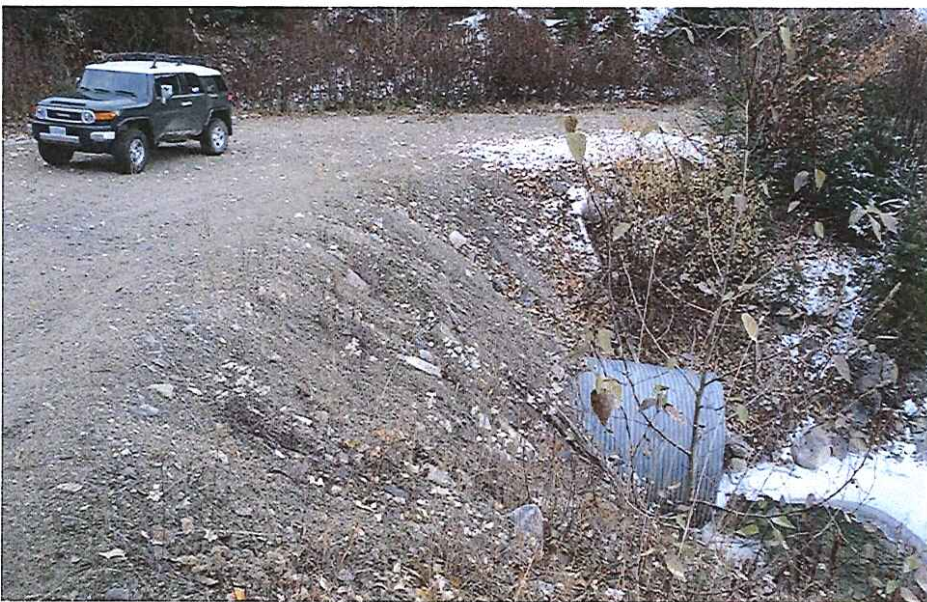
| Item | Present Condition<br>(circle) | Comments<br>(a comment is mandatory if condition "Poor" is selected) |
|---|---|---|
| Fill | E G <u>(F)</u> P UR | Eroding on outlet side |
| Outlet | E G <u>(F)</u> P UR | 1m TOLLINGE POOL Eroding fill, 2.0m fill |

CK2205 Outlet fill erosion

| Monitor Item # | *Monitor Description |
|---|---|
| 1 | monitor eroding outlet |

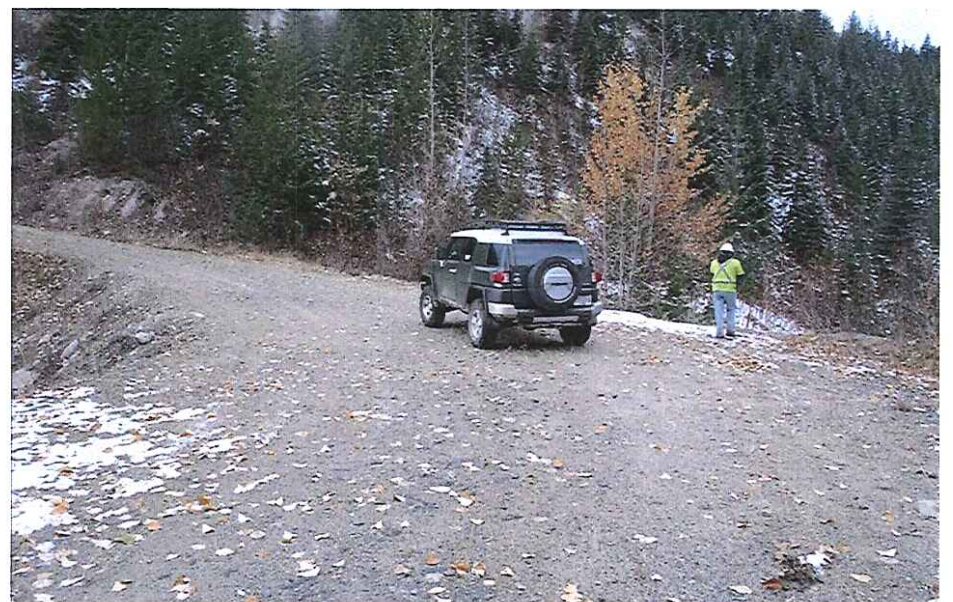
CK2205 Left to Right Approach

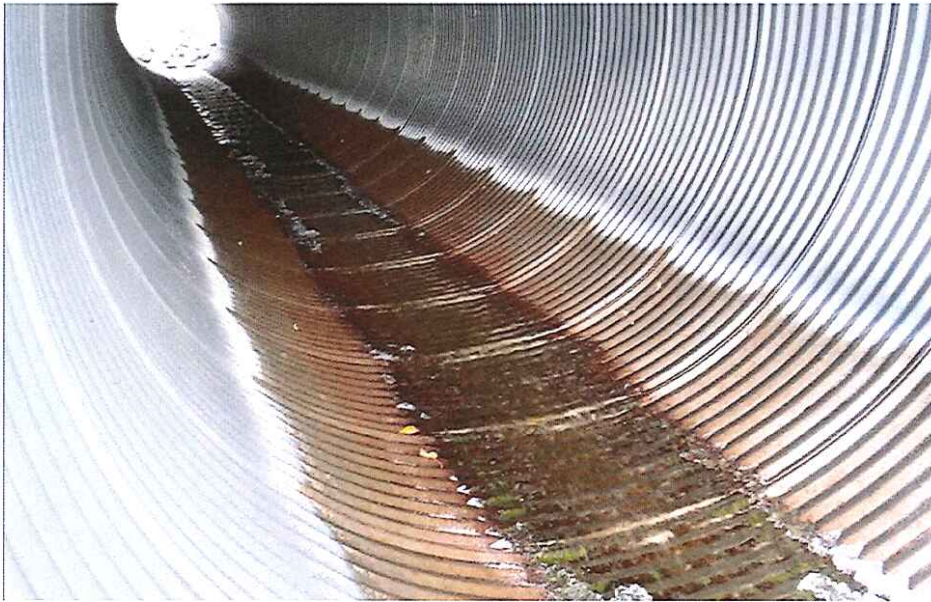
| Item | Present Condition<br>(circle) | Comments<br>(a comment is mandatory if condition "Poor" is selected) |
|---|---|---|
| Coating (N/A to woodbox/log culvert) | E <u>(G)</u> F P N/A UR | rust on floor |
| Floor | E G <u>(F)</u> P N/A UR | rust |

CK2205 Floor

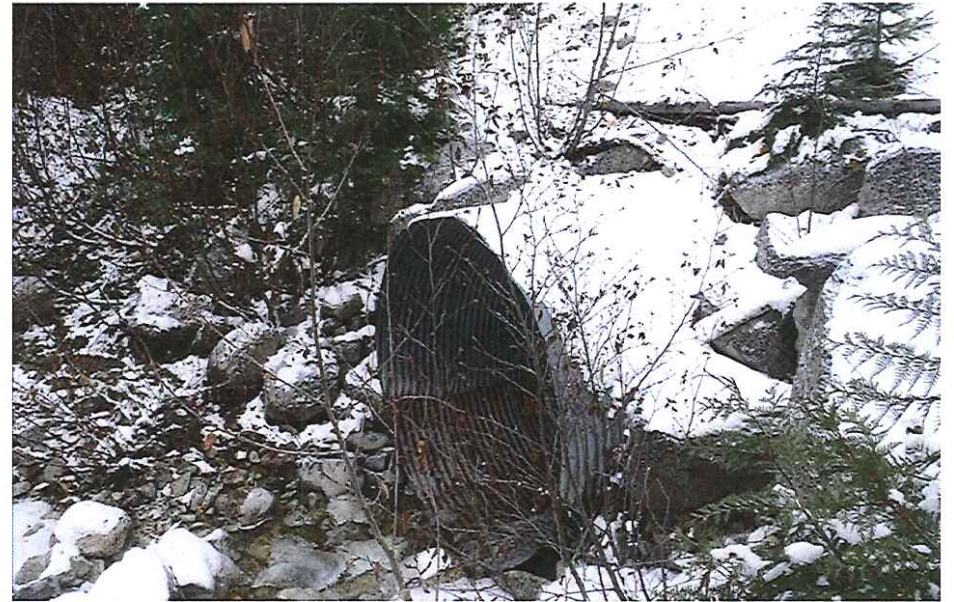
| Item | Present Condition<br>(circle) | Comments<br>(a comment is mandatory if condition "Poor" is selected) |
|---|---|---|
| Inlet | E <u>(G)</u> F P UR | 1.7m fill |
| Riprap | E <u>(G)</u> F P N/A UR | Good on inlet |

CK2205 Inlet

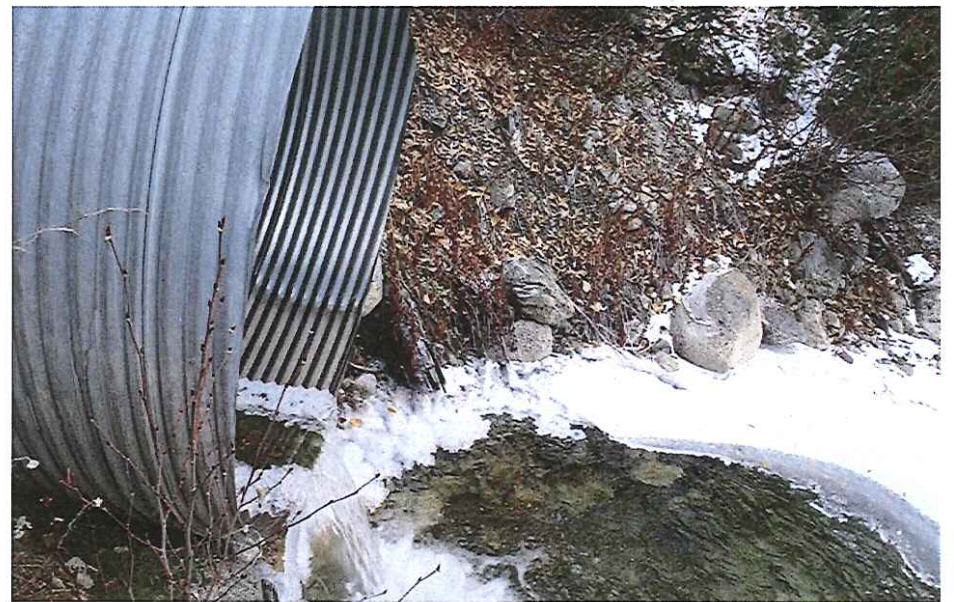
CK2205 Outlet
