## Routine Condition Culvert Inspection Form

| GENERAL INFORMATION | | | | (enter either long/lat or UTM below-- not both) | | | |
|---|---|---|---|---|--|--|--|
| *Site #: <u>CK 2208</u> | *Crossing Name: <u>Side Crk</u> | *Type/Class: <input checked="" type="checkbox"/> Major Culvert<br><input type="checkbox"/> Woodbox/Log Culvert | *Project File ID# <u>8019</u> | | | | |
| *FSR Name: <u>NORTH ALASKA</u><br><u>MOUNTAIN</u> | *Forest District: <u>CK</u> | *Kilometres: _____ | User km: <u>403 22.5</u> | | | | |

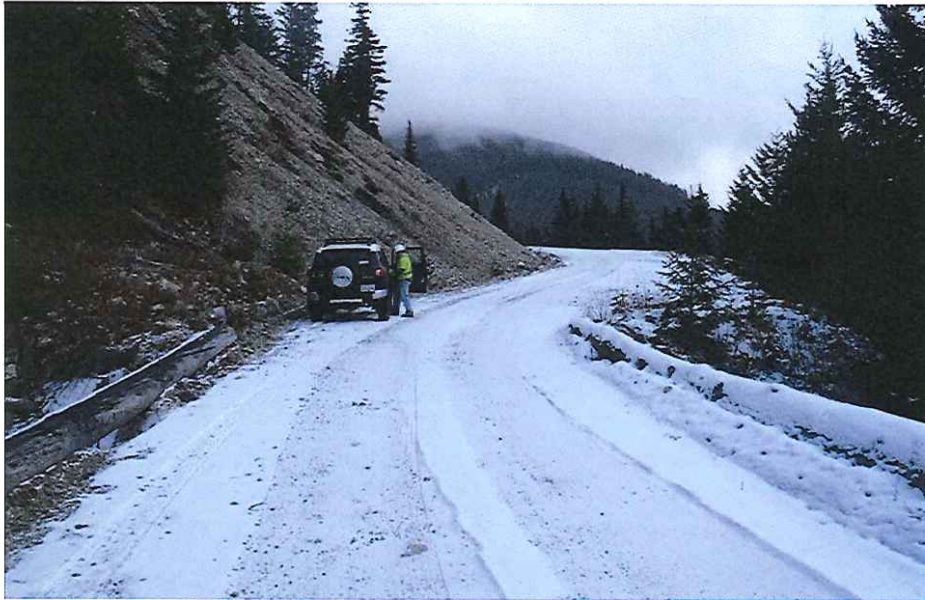
| GENERAL INFORMATION | | | | (enter either long/lat or UTM below-- not both) | | | |
|---|---|---|---|---|--|--|--|
| Alignment | E G <u>(F)</u> P UR | <u>Moderate curve &amp; incline</u> | | | | | |

CK2208 Right to Left Approach

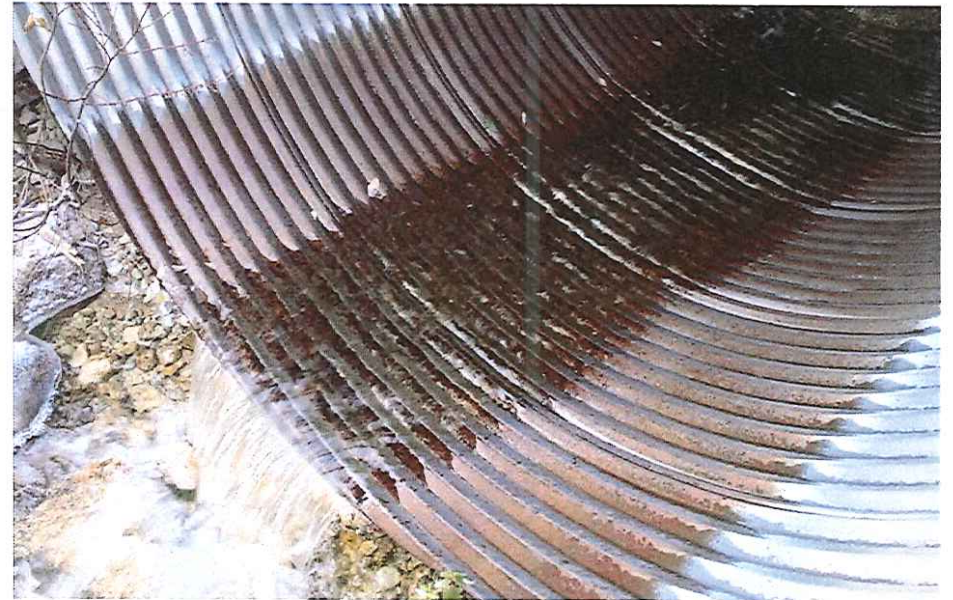
| GENERAL INFORMATION | | | | (enter either long/lat or UTM below-- not both) | | | |
|---|---|---|---|---|--|--|--|
| Coating (N/A to woodbox/log culvert) | E G <u>(F)</u> P N/A UR | <u>FLOOR HAS RUST</u> | | | | | |
| Floor | E G <u>(F)</u> P N/A UR | <u>RUST</u> | | | | | |

CK2208 Floor Rust

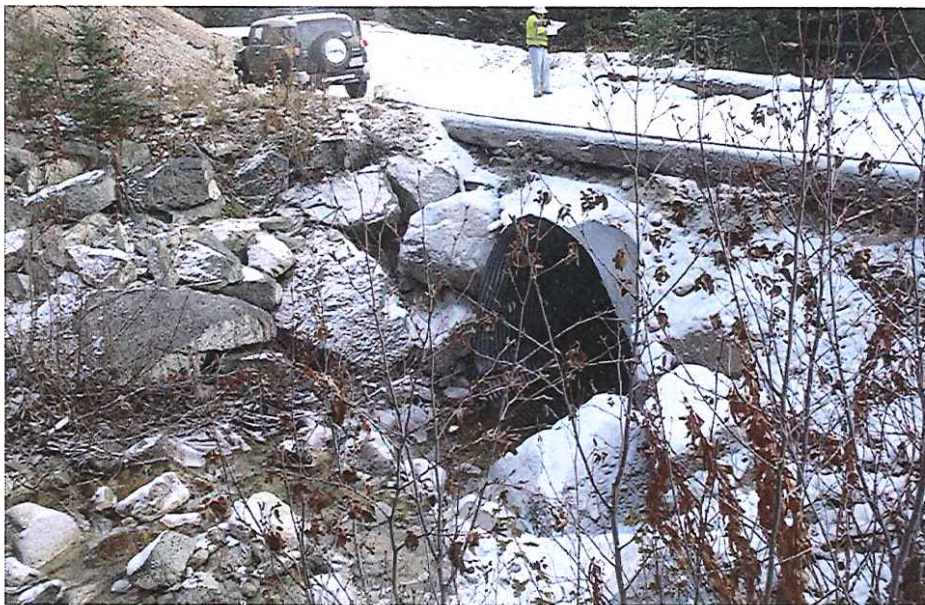
| GENERAL INFORMATION | | | | (enter either long/lat or UTM below-- not both) | | | |
|---|---|---|---|---|--|--|--|
| Inlet | E G <u>(F)</u> P UR | <u>0.9m cover</u> | | | | | |

CK2208 Inlet

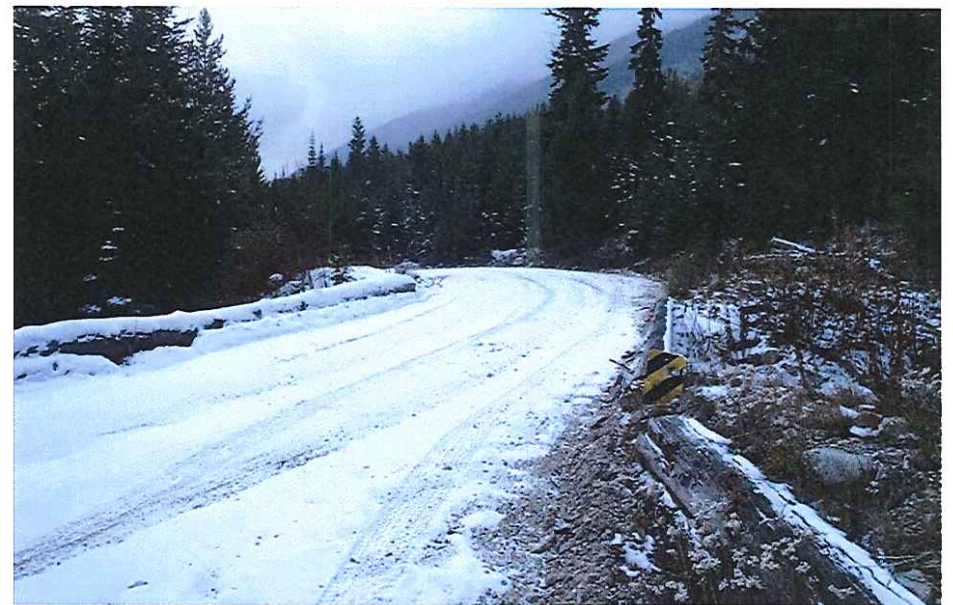
CK2208 Left to Right Approach

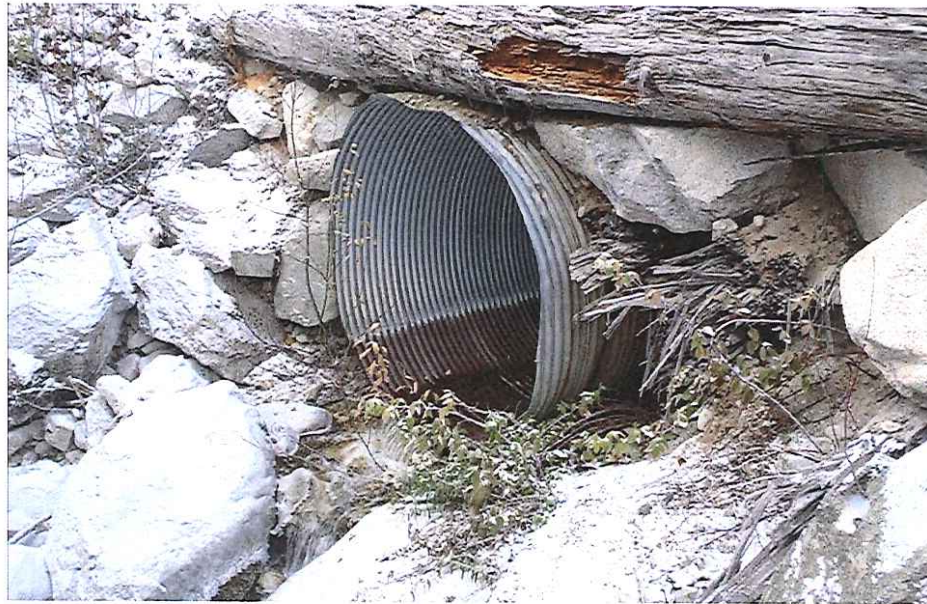
| GENERAL INFORMATION | | | | (enter either long/lat or UTM below-- not both) | | | |
|---|---|---|---|---|--|--|--|
| Head Walls | E G F <u>(P)</u> N/A UR | <u>ROTTEN LOGS</u> | | | | | |
| Outlet | E G F <u>(P)</u> UR | <u>0.9m COVER &amp; CURB</u> | | | | | |

CK2208 Outlet

| Repair Item # | *Priority (circle) | *Estimate (\$) | *Repair Description |
|---|---|---|---|
| 1 | H M <u>L</u> | | REPAIR HEADWALLS |

Inspector's Comments  
IF YOU ARE GOING TO FIX THE HEADWALLS I SUGGEST FULL REPAIR

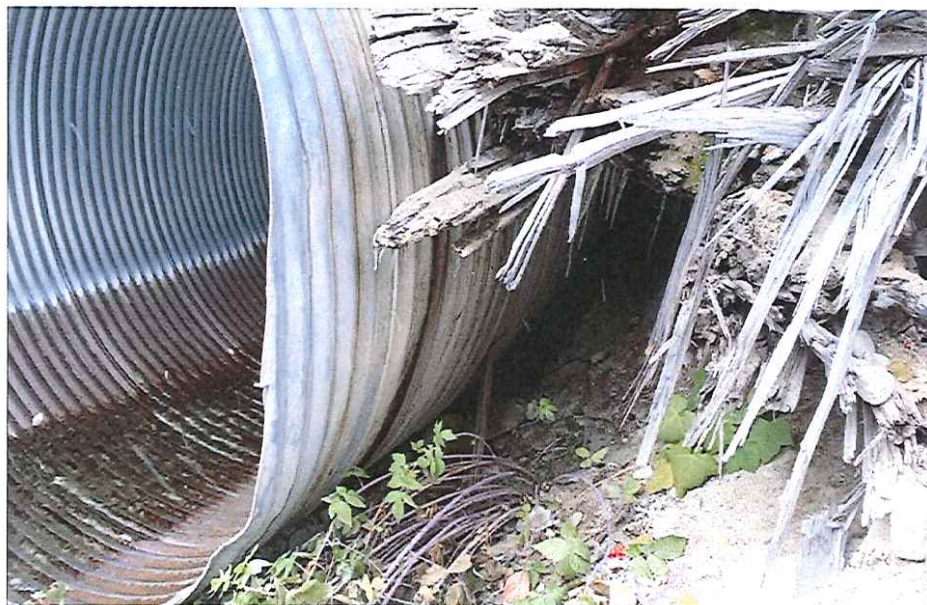
| GENERAL INFORMATION | | | | (enter either long/lat or UTM below-- not both) | | | |
|---|---|---|---|---|--|--|--|
| Fill | E G F <u>(P)</u> UR | <u>OUTLET FILL BRACING LOGS INSTALLED PARALLEL TO CULVERT</u> | | | | | |

CK2208 Outlet Fill hole and logs
