**Routine Condition Bridge Inspection Form**  
(for log stringer or timber stringer bridges)**GENERAL INFORMATION**

| *Site #: CK 2210 | *Crossing Name: Mowhokum Crk | *Type/Class: <input type="checkbox"/> Major Culvert<br><input type="checkbox"/> Woodbox/Log Culvert | *Project File ID# 8019 |
| *FSR Name: Mowhokum Crk | *Forest District: CK | *Kilometres: | User km: 6.5 |

\*Date of Inspection (yyyy/mm/dd)  
2011/11/07\*Inspection Company Name  
CNSITE ENGINEERING LTD\*Inspector's Name (print)  
JEREMY ARAKI

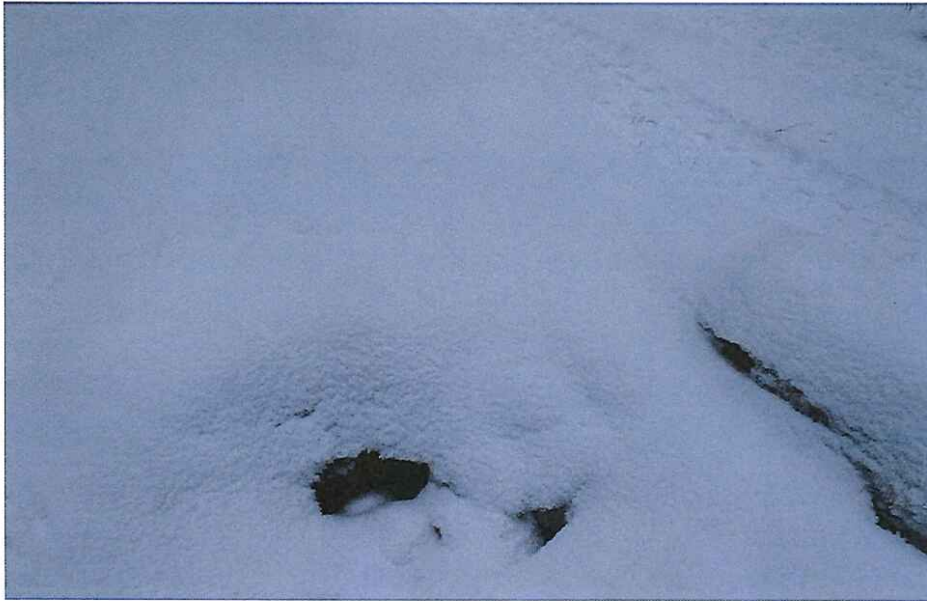
| Item | Present Condition<br>(circle) | Comments<br>(a comment is mandatory if condition "Poor" is selected) |
|---|---|---|
| Running Surface (N/A if running surface is gravel or timber planks) | E G F <b>(P)</b> N/A UR | WASHED OUT |
| Gravel Surface | E G F <b>(P)</b> N/A UR | Washed through on 1/4 side |

CK2210 Deck Scour

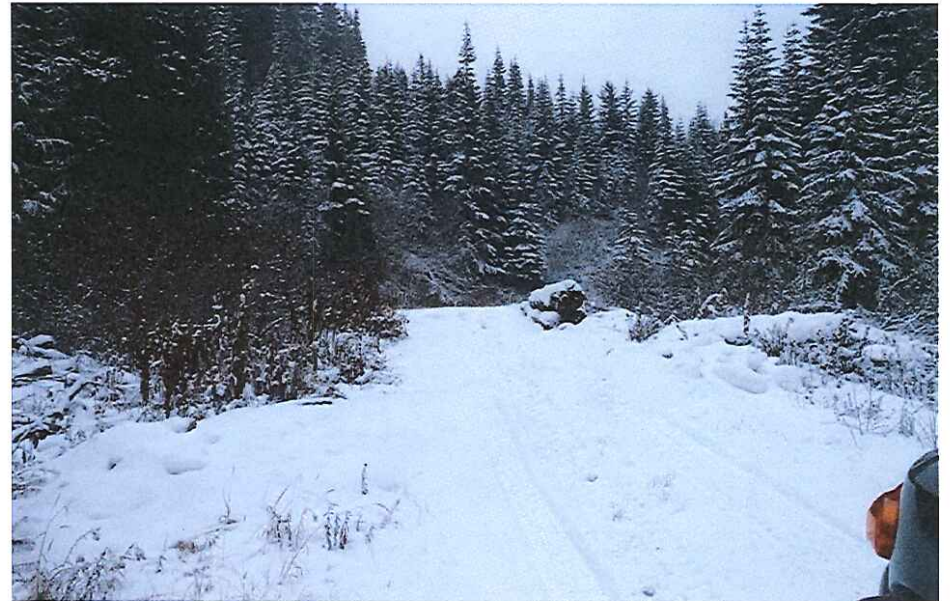
CK2210 Left to Right Approach

| Item | Present Condition<br>(circle or fill-in) | Comments<br>(a comment is mandatory if condition "Poor" is selected) |
|---|---|---|
| Road Surface | E G F <b>(P)</b> UR | FILL WASHED OF BRIDGE |

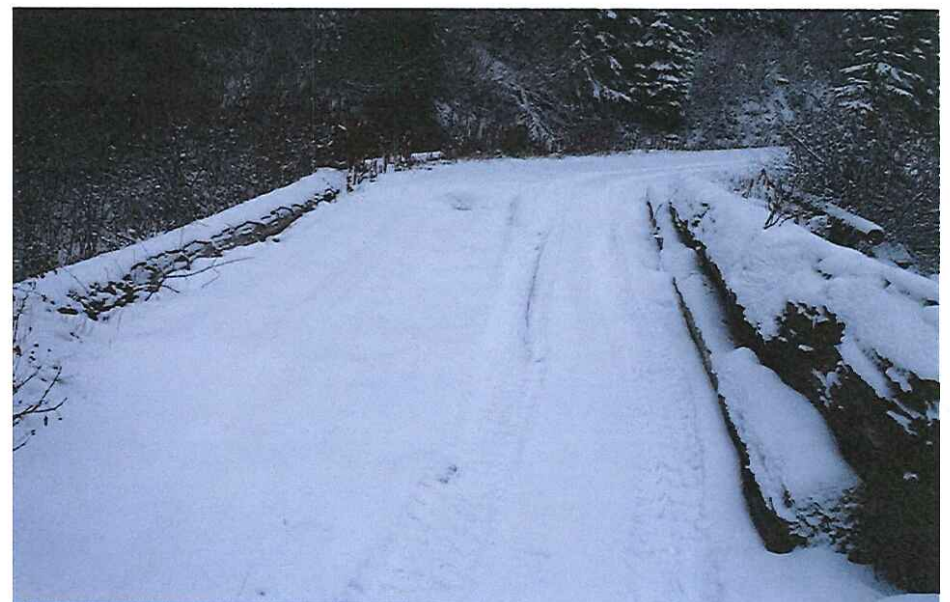
CK2210 Deck

| Item | Present Condition<br>(circle) | Comments<br>(a comment is mandatory if condition "Poor" is selected) |
|---|---|---|
| Curb Rail/Blocks/Posts | E G F <b>(P)</b> UR | ROTEN LOGS |
| Hardware | E G F <b>(P)</b> N/A UR | Looking loose |

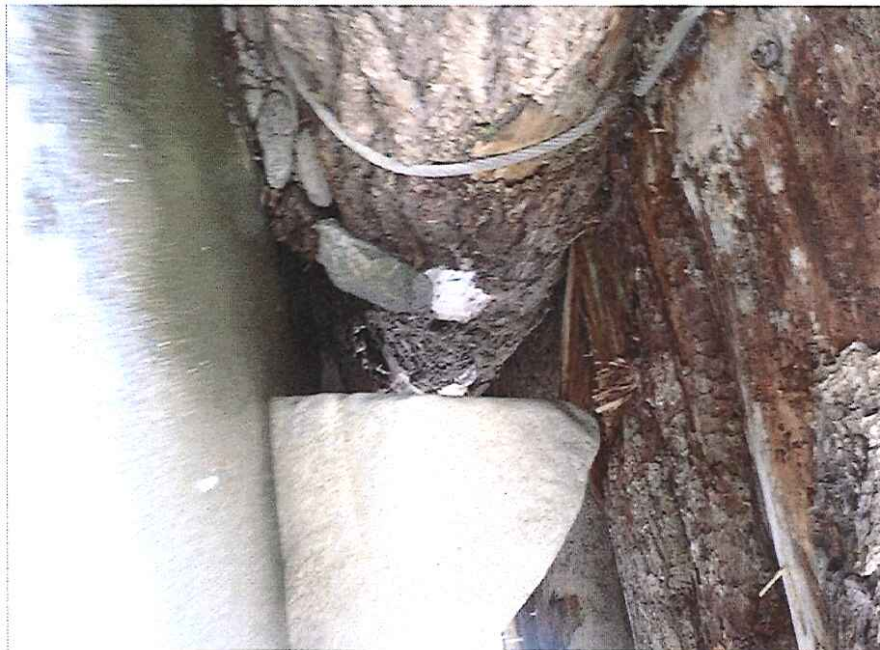
CK2210 Right Abutment

| Item | Present Condition<br>(circle) | Comments<br>(a comment is mandatory if condition "Poor" is selected) |
|---|---|---|
| Caps or Sills | E G F <b>(P)</b> N/A UR | Both sills undermined |
| Bearings | E G F <b>(P)</b> N/A UR | SAILS CRACKING & UNDERMINED |

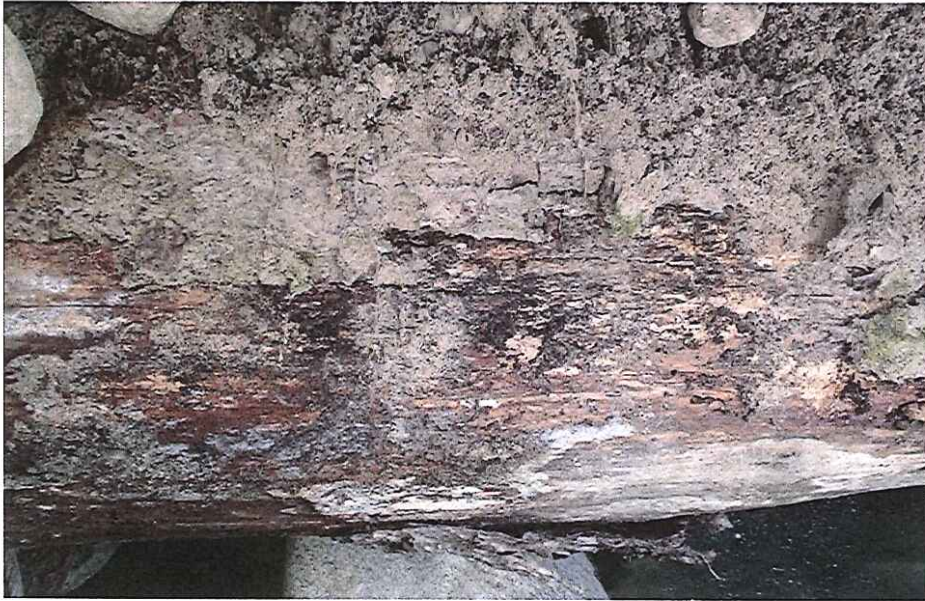
| Item | | Present Condition (circle) | | Comments (a comment is mandatory if condition "Poor" is selected) | | | |
|---|---|---|---|---|---|---|---|
| 3 | | Y N | | (2 cases extensive rot at 2nd from end) | | | - D.S STRINGER BROKEN AND WAS RECD |
| 6 | | Y N | | | | | - 2 OTHERS FAILED IN SHEAR AT ENDS |

CK2210 Stringer crushing failure

| Repair Item # | Priority (circle) | Estimate (\$) | Repair Description |
|---|---|---|---|
| 1 | <u>H</u> M L | | REPLACE OR TAKE OUT ASAP |

Condemned. Block access and remove or replace.

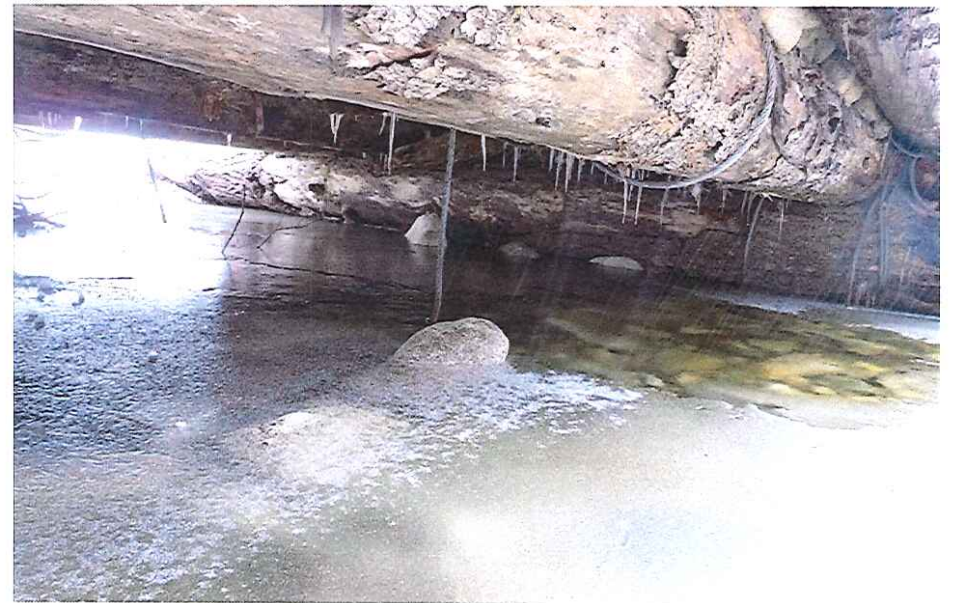
CK2210 Left Abutment

| Item | Present Condition<br>(circle) | Comments<br>(a comment is mandatory if condition "Poor" is selected) |
|---|---|---|
| Log/Timber Cribs | E G F <b>(P)</b> N/A UR | SINGLE Fd SAILS TOTALLY UNDERMINED |
