## Routine Condition Culvert Inspection Form

| GENERAL INFORMATION | | | | (enter either long/lat or UTM below - not both) | | | |
|---|---|---|---|---|---|--|--|
| *Site #: <u>CK-2211</u> | *Crossing Name: <u>Side Creek</u> | *Type/Class: <input checked="" type="checkbox"/> Major Culvert<br><input type="checkbox"/> Woodbox/Log Culvert | *Project File ID# <u>8117</u> | | *Br. <u>01</u> | | |
| *FSR Name: <u>North Emory Creek</u> | | | | | | | |

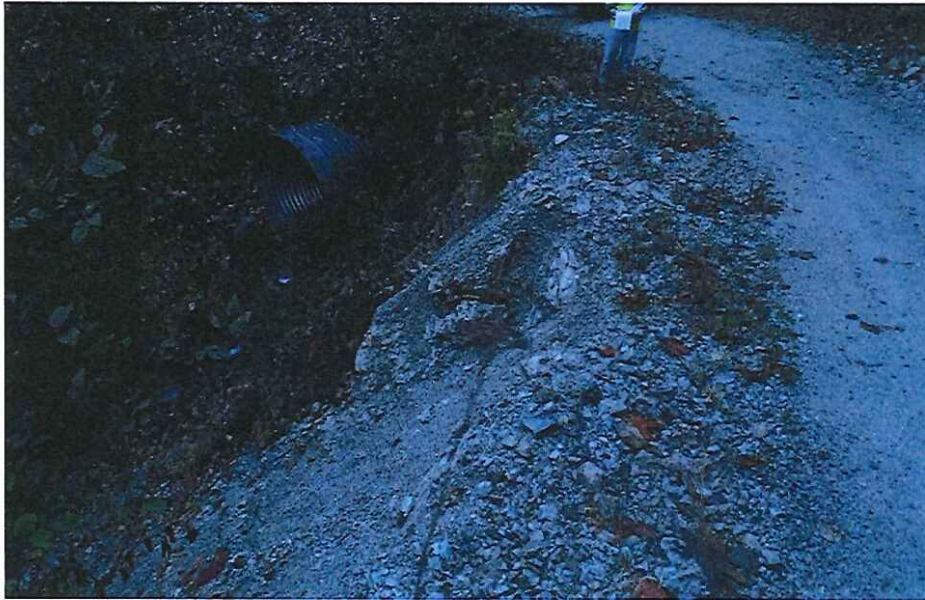
| GENERAL INFORMATION | | | | (enter either long/lat or UTM below - not both) | | | |
|---|---|---|---|---|---|--|--|
| Fill | E G F <u>(P)</u> UR | | <u>Falling fill slope on outlet left side</u> | | | | |

CK2211 Right Approach Fill erosion

Stabilize left approach prior to industrial activity. Present load rating of L100 or 91 tonnes to continue.

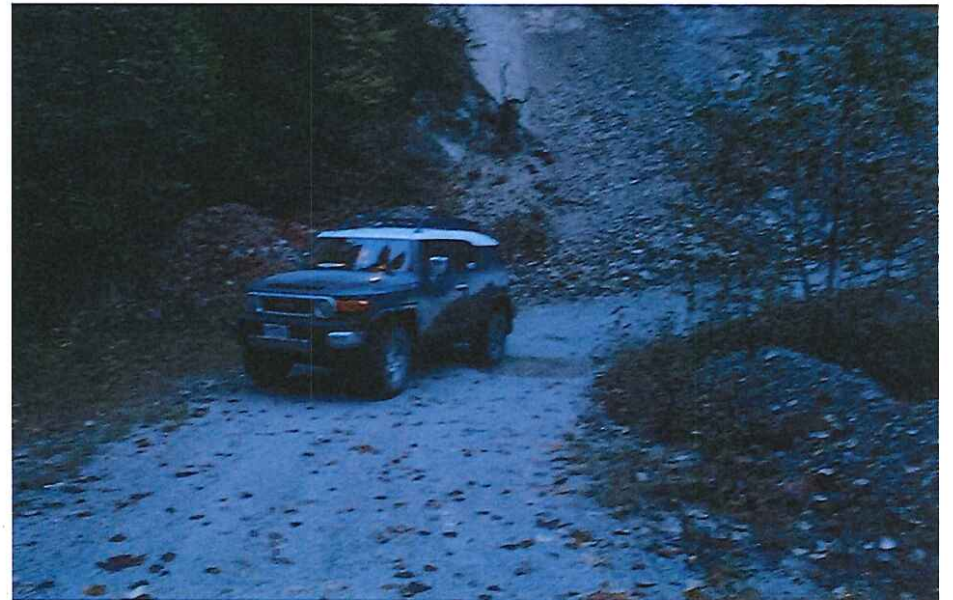
CK2211 Right to Left Approach

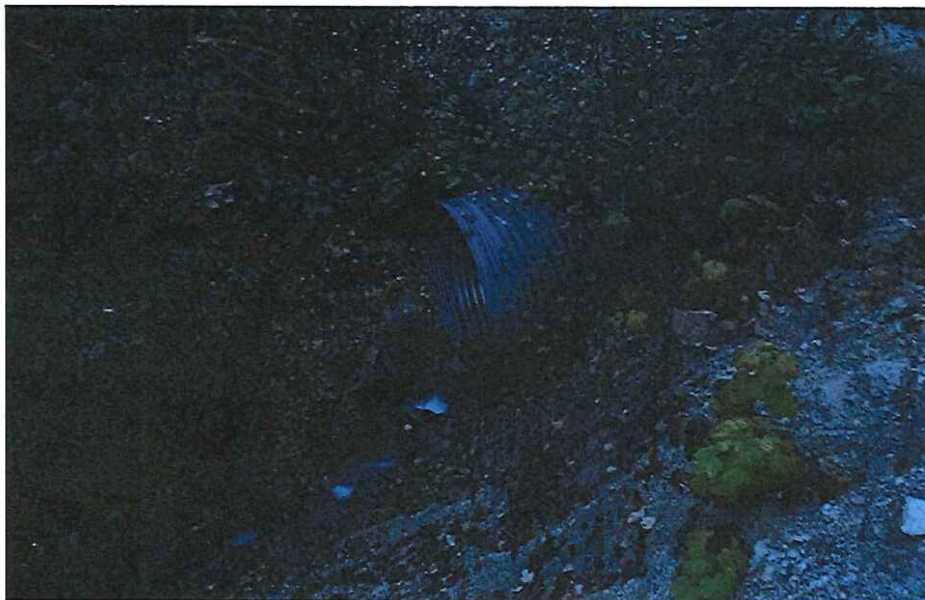
| GENERAL INFORMATION | | | | (enter either long/lat or UTM below - not both) | | | |
|---|---|---|---|---|---|--|--|
| Outlet | E G <u>(P)</u> P UR | | <u>Erosion on left approach &amp; left side outlet</u> | | | | |
| Riprap | E <u>(G)</u> F P <u>(N/A)</u> UR | | <u>BT FAIR OUTLET</u> | | | | |

CK2211 Outlet

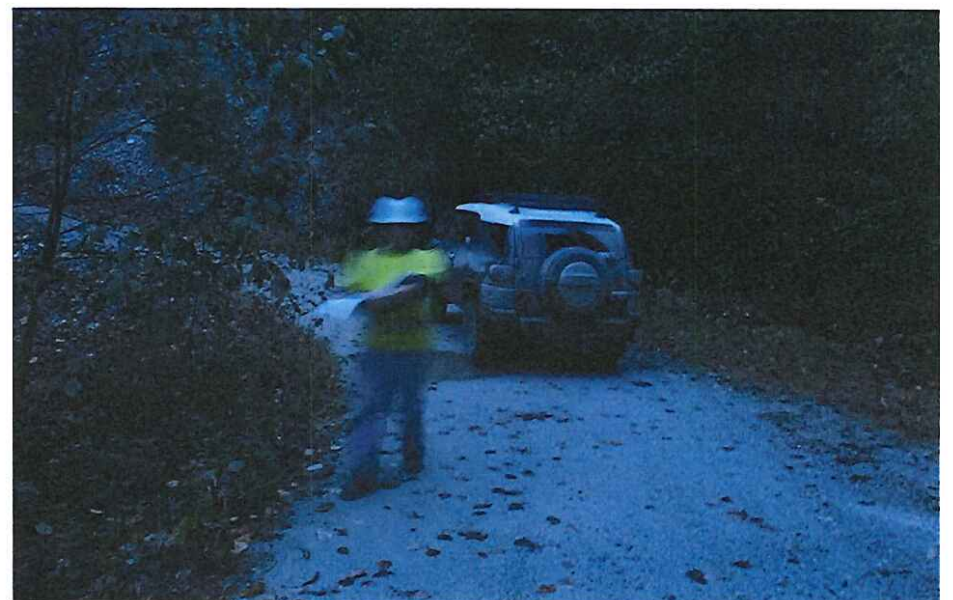
CK2211 Left to Right Approach

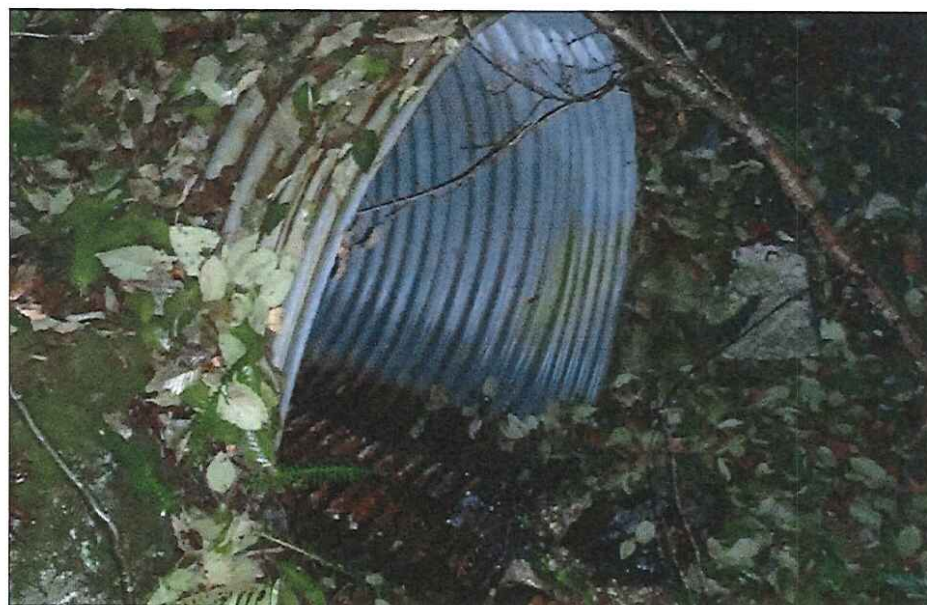
CK2211 Inlet
