**Routine Condition Bridge Inspection Form**  
(for log stringer or timber stringer bridges)

| GENERAL INFORMATION | | | | (enter either long/lat or UTM below - not both) | | |
|---|---|---|---|---|--|--|
| *Site #: <u>CK-2232</u> | *Crossing Name: <u>Bucklin Creek</u> | *Type/Class: <input type="checkbox"/> Major Culvert<br><input checked="" type="checkbox"/> Woodbox/Log Culvert | *Project File ID# <u>8394</u> | | | |
| *FSR Name: <u>Pitt-Bucklin Creek</u> | *Forest District: <u>CK</u> | *Kilometres: | User km: | | | |

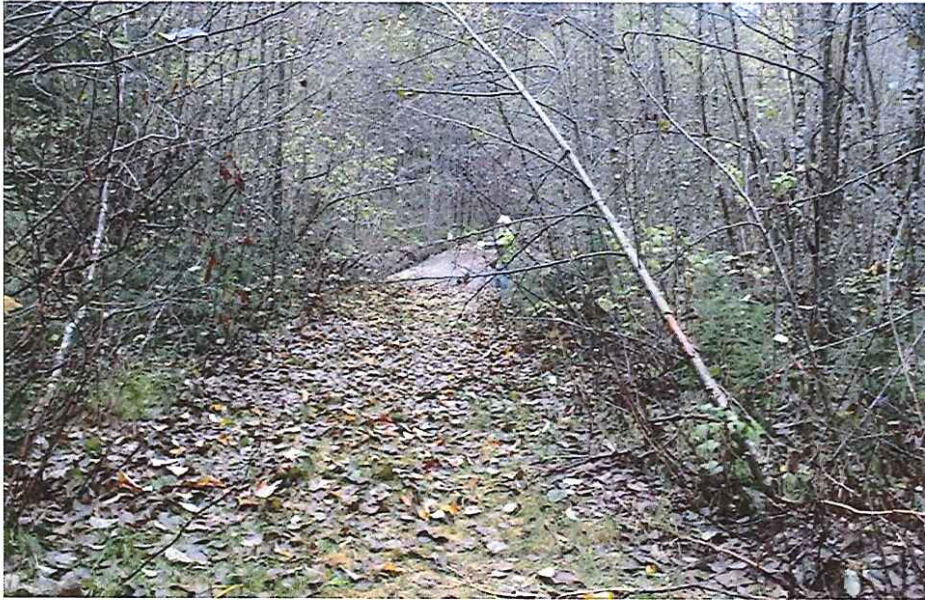
CK2232 Right to Left Approach

| GENERAL INFORMATION | | | | (enter either long/lat or UTM below - not both) | | |
|---|---|---|---|---|--|--|
| Alignment | E G F <b>(P)</b> UR | <u>right horizontal curves</u> | | | | |

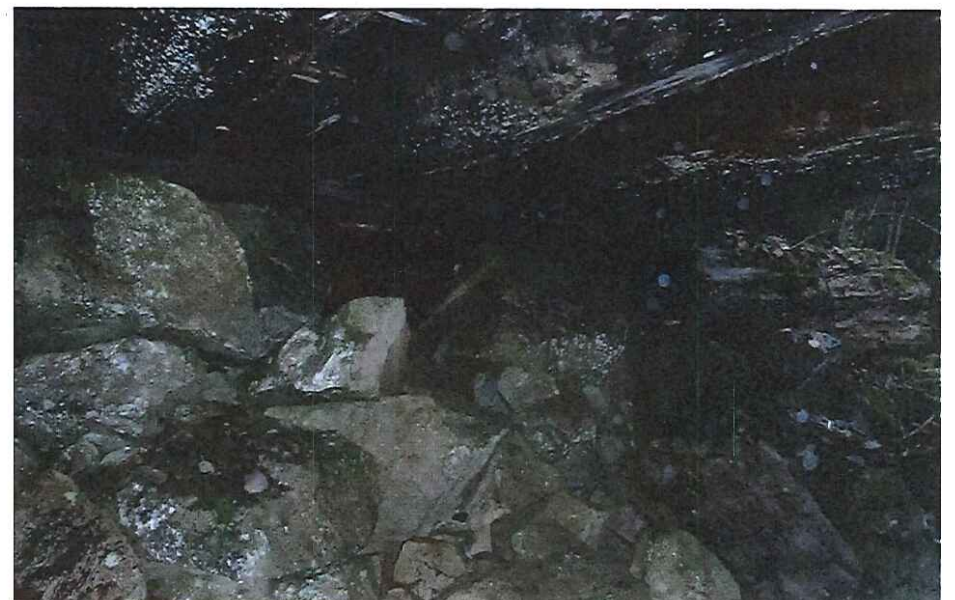
CK2232 Left Abutment

| GENERAL INFORMATION | | | | (enter either long/lat or UTM below - not both) | | |
|---|---|---|---|---|--|--|
| Log/Timber Cribbs | E G <b>(F)</b> P N/A UR | <u>CRIBS R. PITT SAUGLE SKL LEFT</u> | | | | |
| Ballast Wall | E G F <b>(P)</b> N/A UR | <u>Rotting</u> | | | | |

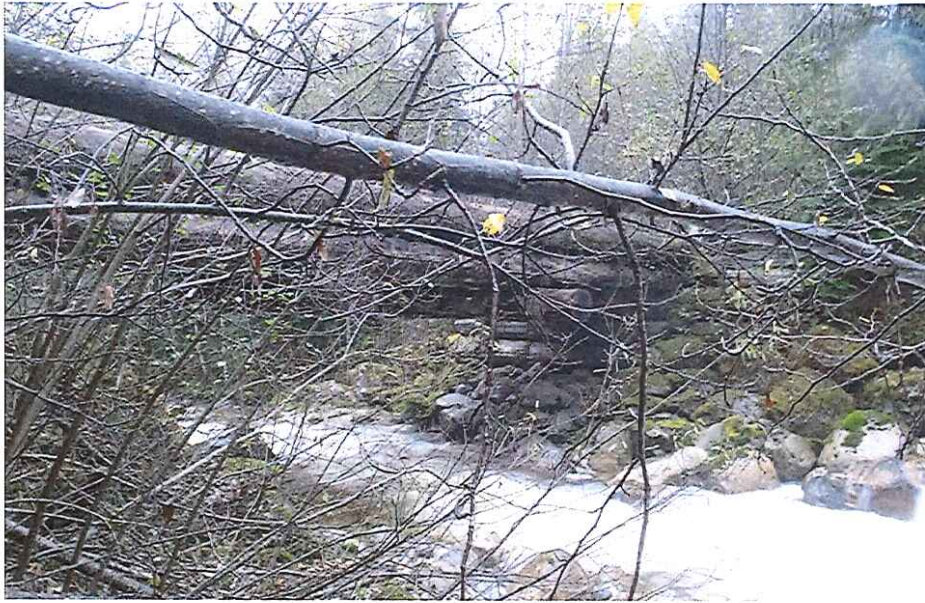
CK2232 Span 1 From Upstream

| GENERAL INFORMATION | | | | (enter either long/lat or UTM below - not both) | | |
|---|---|---|---|---|--|--|
| Running Planks | E G F <b>(P)</b> N/A UR | <u>Rotting</u> | | | | |
| Ties | E G F <b>(P)</b> N/A UR | <u>Rotting &amp; splitting</u> | | | | |
| Overall Deck Condition | E G F <b>(P)</b> UR | <u>ROTEN</u> | | | | |

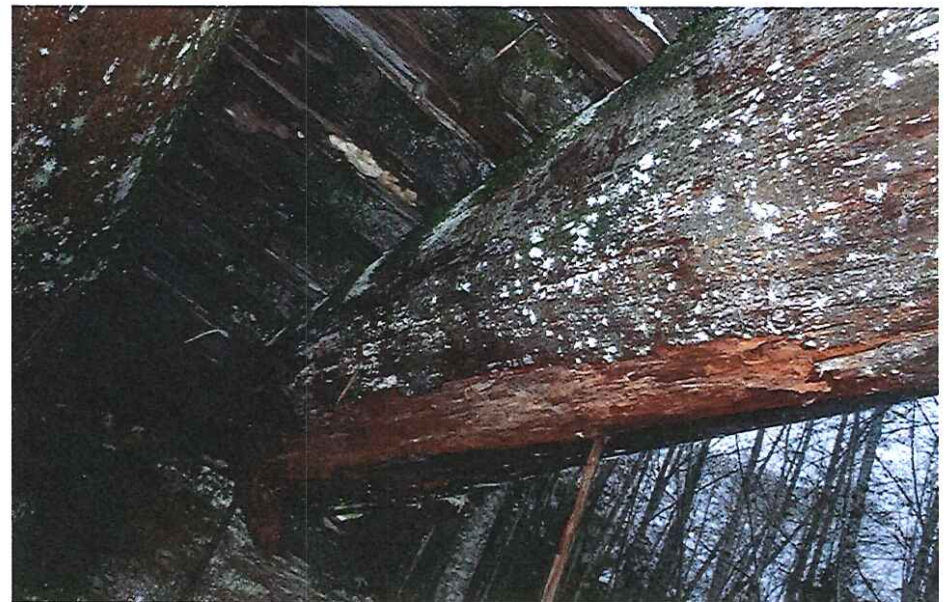
| GENERAL INFORMATION | | | | | | | |
|---|---|---|---|---|---|---|---|
| 1 | | Y N | 5 STRINGERS | | | | TOTALLY ROTEN & FAILS |
| Inspector's Comments: CLOSE MAY FAIL AT ANY TIME | | | | | | | |

CK2232 Span 2 failed stringer

| GENERAL INFORMATION | | | | | | | |
|---|---|---|---|---|---|---|---|
| 1 | H M L | | CLOSE OFF ASAP! | | | | |
| P Eng Reviewer's Comments: Condemned. Remove/replace ASAP. | | | | | | | |
| Block access. | | | | | | | |
