**Routine Condition Bridge Inspection Form**  
(for log stringer or timber stringer bridges)**GENERAL INFORMATION**

| *Site #: <u>CR 2236</u> | *Crossing Name:<br>Unknown | *Type/Class: <input type="checkbox"/> Major Culvert<br><input checked="" type="checkbox"/> Woodbox/Log Culvert | *Project File ID# <u>7004</u> |
| *FSR Name:<br><u>Sawtooth</u> | *Forest District:<br><u>CK</u> | *Kilometres:<br><u>9.2</u> | User km:<br><u>9.6</u> |

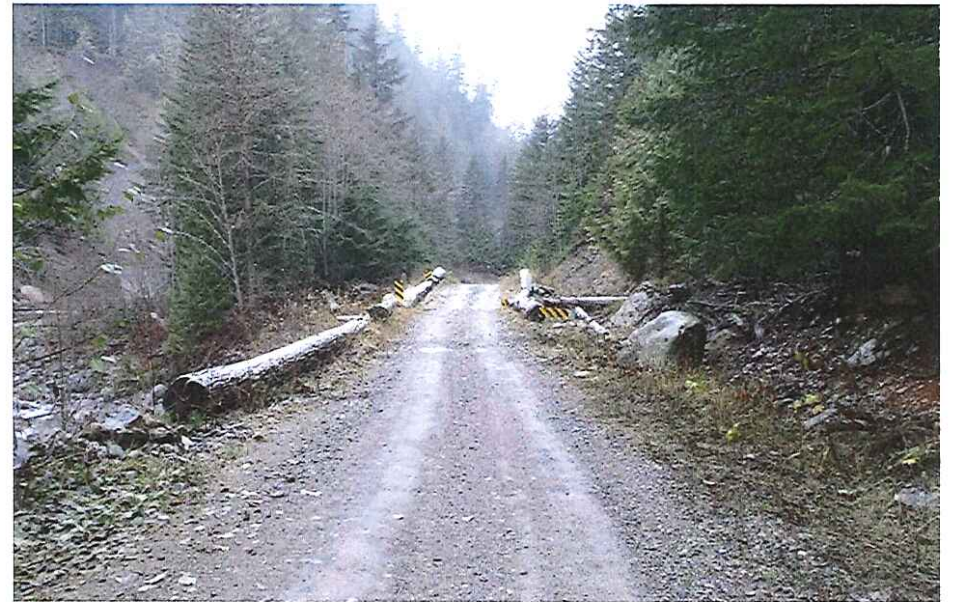
CK2236 Left to Right Approach

| Item | Present Condition<br>(circle or fill-in) | Comments<br>(a comment is mandatory if condition "Poor" is selected) |
|---|---|---|
| Alignment | E G <u>(F)</u> P UR | BAD CREST |
| Road Surface | E G F <u>(P)</u> UR | ROUGH, WASHED, DEEPS DITCHED |

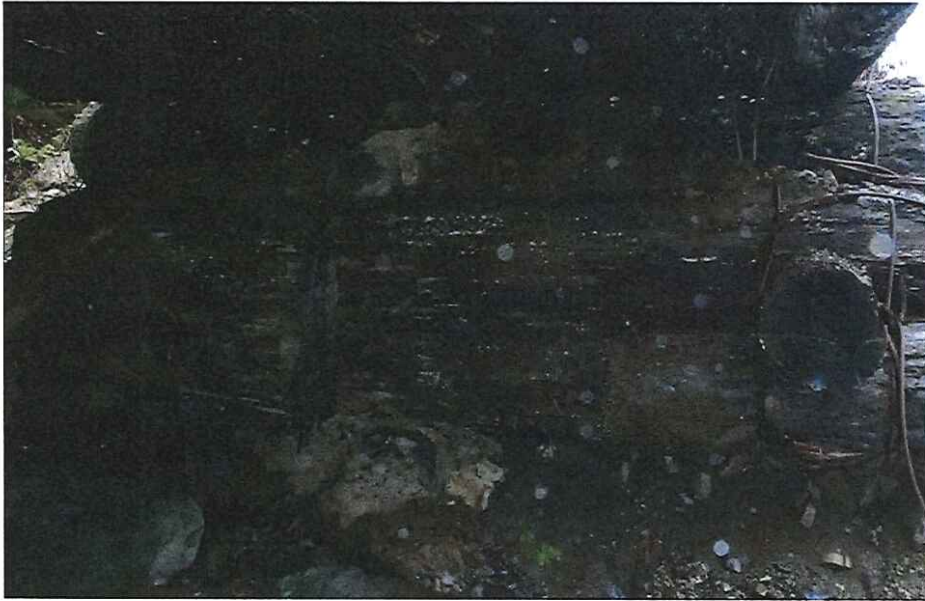
CK2236 Left Abutment

| Item | Present Condition<br>(circle) | Comments<br>(a comment is mandatory if condition "Poor" is selected) |
|---|---|---|
| Log/Timber Cribbs | E G F <u>(P)</u> N/A UR | LEFT IS HANGING, RIGHT IS SKYLINE SILL |
| Tie-backs | E G <u>(F)</u> P N/A UR | 2 ON LEFT ON ROCK FILL |
| Fill | E G F <u>(P)</u> N/A UR | LEFT IS SCOURED, RIGHT OK |

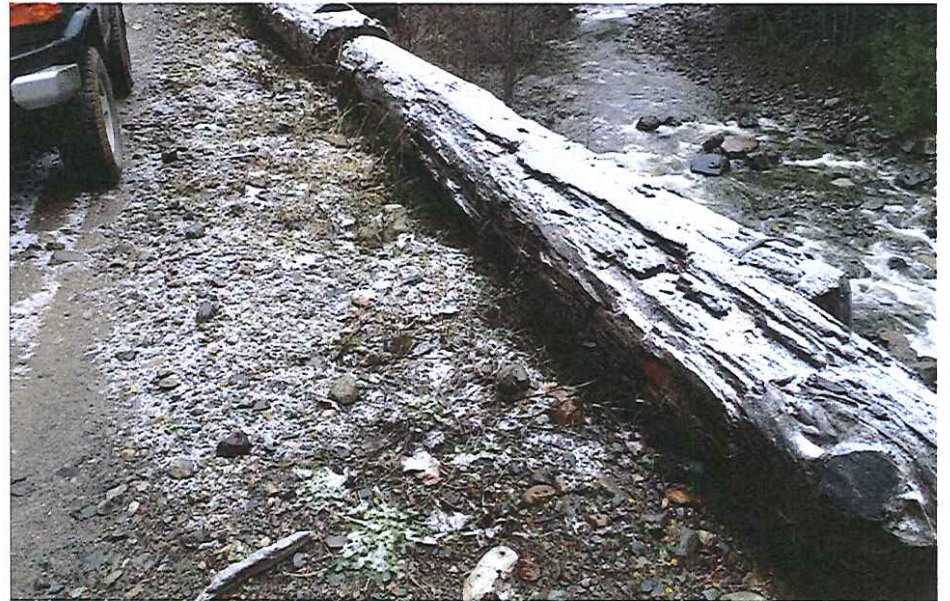
| Item | Present Condition<br>(circle) | Comments<br>(a comment is mandatory if condition "Poor" is selected) |
|---|---|---|
| Running Surface (N/A if running surface is gravel or timber planks) | E G F <u>(P)</u> N/A UR | DITCHED / MUCKY |

CK2236 Deck fill eroding

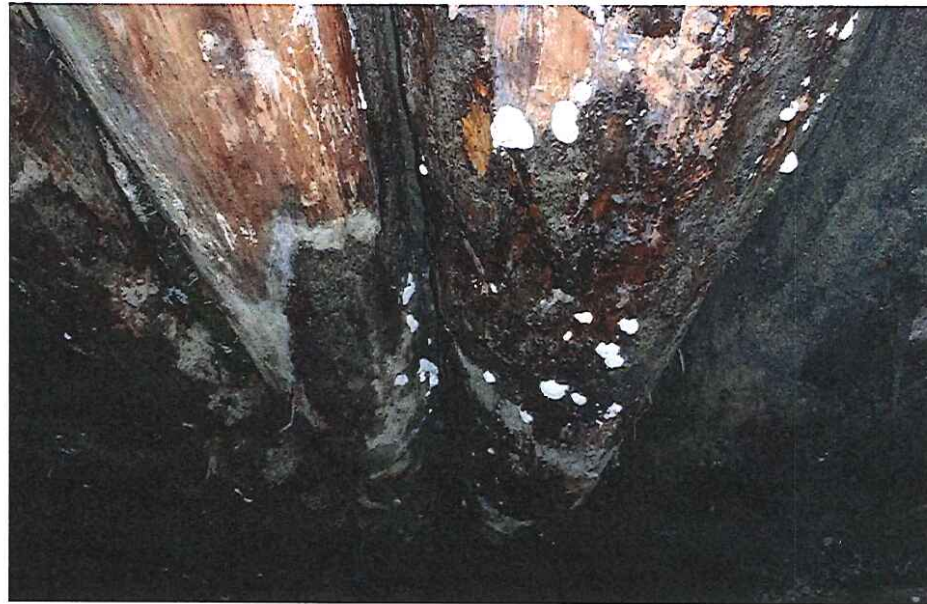
CK2236 Stringers

| GENERAL INFORMATION | | | | | | | |
|---|---|---|---|---|---|---|---|
| 1 | FD | Y N | 48 | | | | COSES WERE OK, BUT |
| 2 | | Y N | 58 | | | | COURSED IN RESULTING BODIES GOT |
| 3 | | Y N | 55 | | | | ROT AROUND BODIES BUT JUST SHALLOW (1-2cm) |
| 4 | | Y N | 43 | | | | DUE TO NATURE OF FD SUGGEST ALL NO GOOD. |

| GENERAL INFORMATION | | | | | | | |
|---|---|---|---|---|---|---|---|
| 1 | H M L | | REPLACE | | | | |
| P Eng Reviewer's Comments 2 tonnes load rating. Please post. Remove or replace soon. | | | | | | | |
