**Routine Condition Bridge Inspection Form**  
(except for log stringer or timber stringer bridges)**GENERAL INFORMATION**

| *Site #: <u>CK 2248</u> | *Crossing Name:<br><u>Spuzzum Crk</u> | *Type/Class: <input type="checkbox"/> Temporary bridge<br><input checked="" type="checkbox"/> Permanent bridge | *Project File ID# <u>0128</u> |

\*Date of Inspection  
(yyyy/mm/dd)  
2011/11/11\*Inspection Company  
Name  
CUMBERLAND\*Inspector's Name (print)  
J. C. P. ARAKI

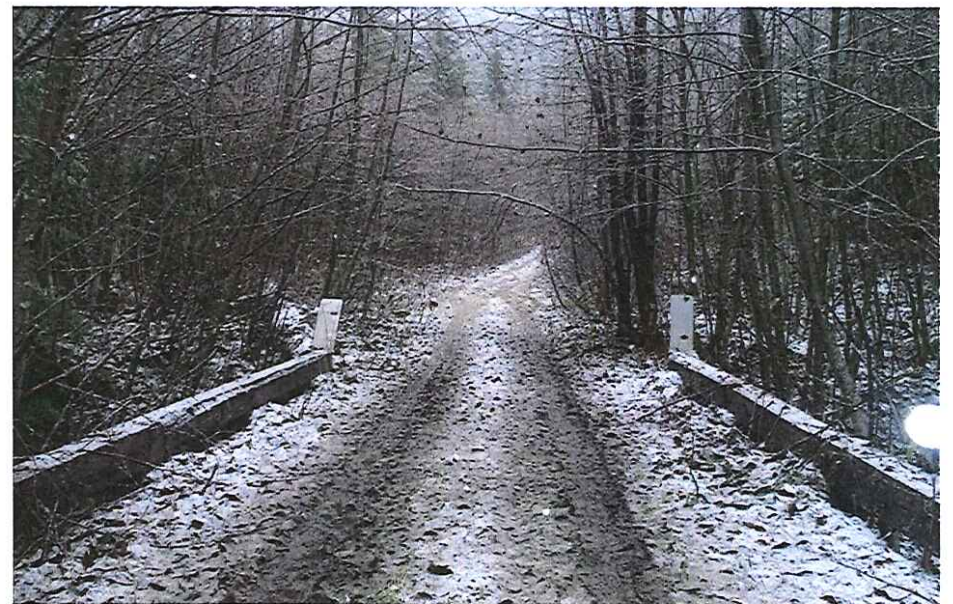
CK2248 Right Approach

| Item | Present Condition<br>(circle or fill-in) | Comments<br>(a comment is mandatory if condition "Poor" is selected) |
|---|---|---|
| Brushing Required | <u>Yes</u> No | WHOLE ROAD ALMOST IMPASSABLE |
| Road Surface | E G <u>F</u> P UR | MUCKY & OVERGROWN |

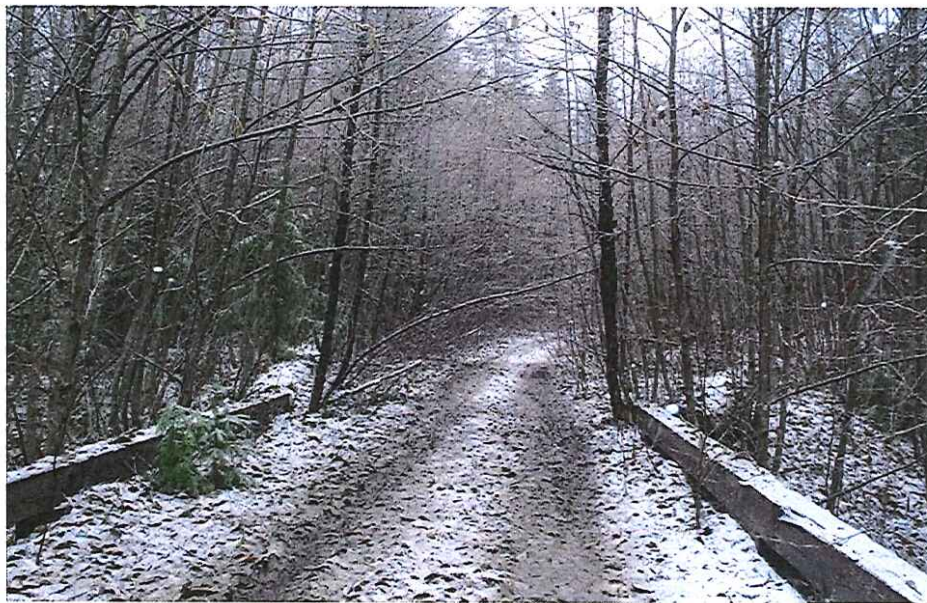
CK2248 Left Approach

| Item | Present Condition<br>(circle or fill-in) | Comments<br>(a comment is mandatory if condition "Poor" is selected) |
|---|---|---|
| Delineator Missing Left | 0 <u>1</u> 2 | LEFT AISLE MISSING |
| Fender Condition | E G F <u>P</u> None UR | OLD LOGS, NOT HIGH |

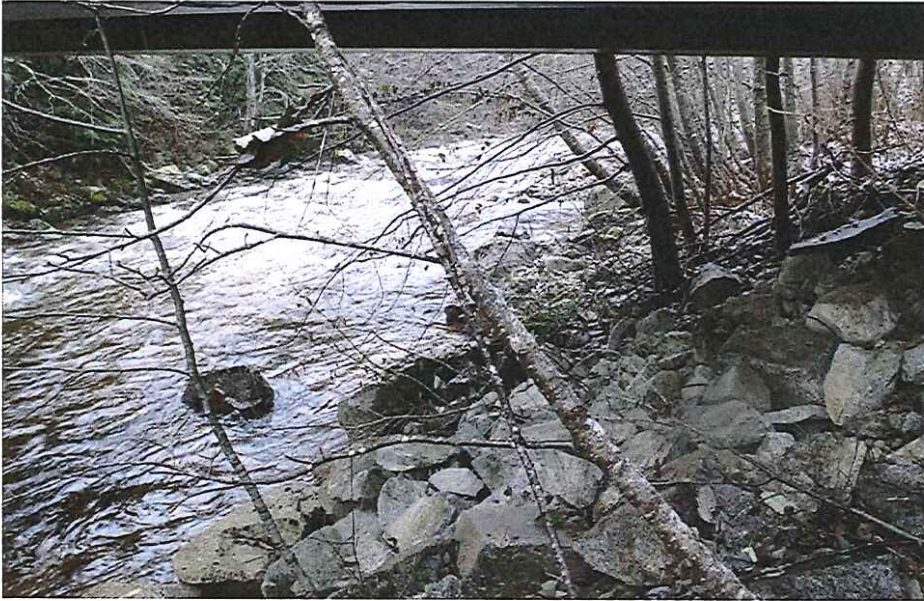
CK2248 Left Abutment Rip Rap

| Item | Present Condition<br>(circle) | Comments<br>(a comment is mandatory if condition "Poor" is selected) |
|---|---|---|
| Riprap | E <u>G</u> F P N/A UR | |

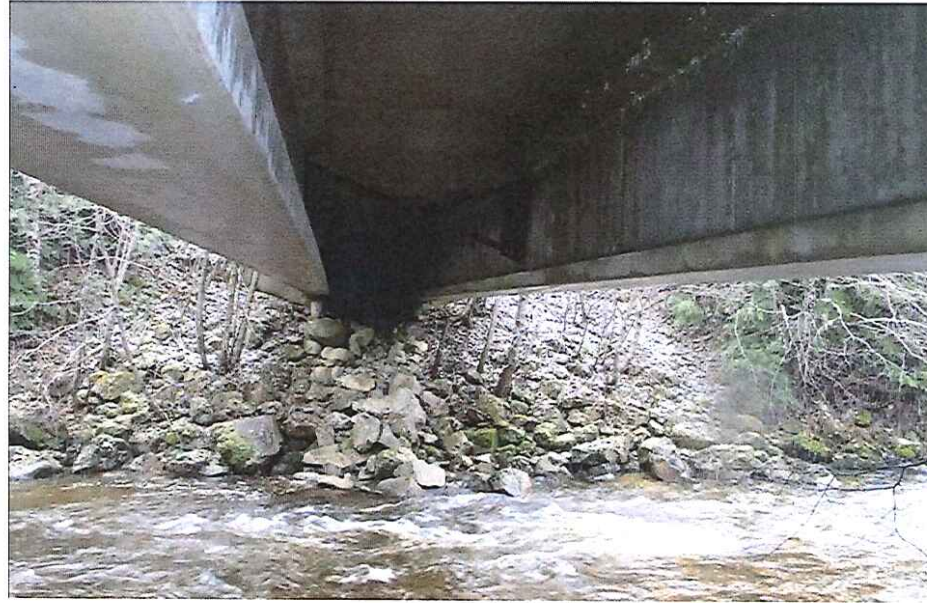
CK2248 Girders

| Item | Present Condition<br>(circle) | Comments<br>(a comment is mandatory if condition "Poor" is selected) |
|---|---|---|
| Girders | E (G) F P UR | CONCR CAMP |

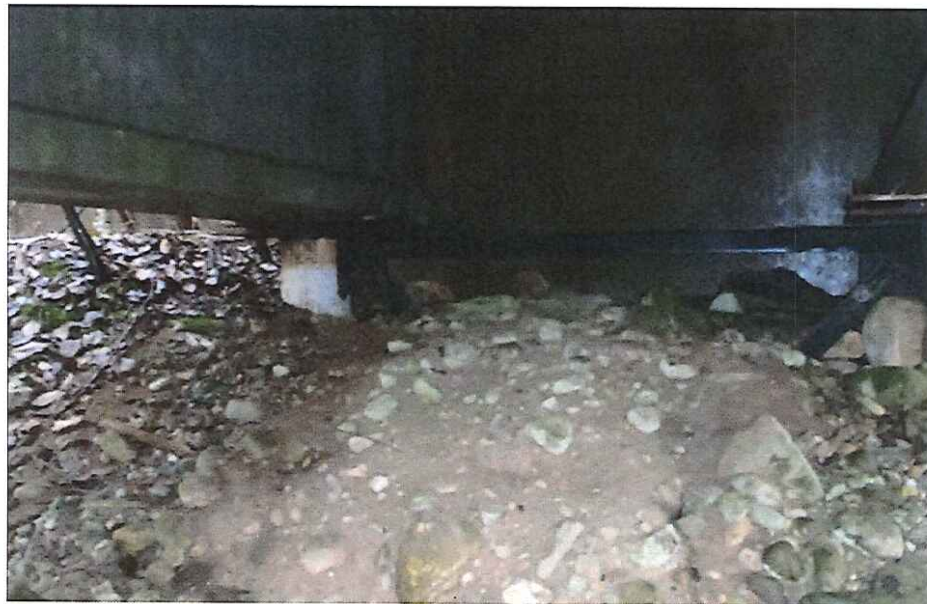
CK2248 Left Abutment Bearing

| Item | Present Condition<br>(circle) | Comments<br>(a comment is mandatory if condition "Poor" is selected) |
|---|---|---|
| Bearings | E <u>G</u> F P N/A UR | |
