**Routine Condition Bridge Inspection Form**  
(except for log stringer or timber stringer bridges)

| GENERAL INFORMATION | | | | (enter either long/lat or UTM below - not both) | | | |
|---|---|---|---|---|--|--|--|
| *Site #: <u>CK 2253</u> | *Crossing Name: | *Type/Class: <input type="checkbox"/> Temporary bridge<br><input type="checkbox"/> Permanent bridge | *Project File ID# <u>6092</u> | | | | |
| *FSR Name: <u>SQUAINT</u> | *Forest District: <u>CK</u> | *Kilometres: <u>2.7</u> | User km: <u>312</u> | | | | |

| GENERAL INFORMATION | | | |
|---|---|---|---|
| *Date of Inspection (yyyy/mm/dd)<br><u>2011/11/07</u> | *Inspection Company Name<br><u>ONSITE ENG LTD</u> | *Inspector's Name (print)<br><u>KEVIN ARAKI</u> | Inspector's Signature<br><u>J. C. P. ARAKI</u><br># 29356<br>PROFESSIONAL ENGINEER<br>OF<br>BRITISH COLUMBIA |

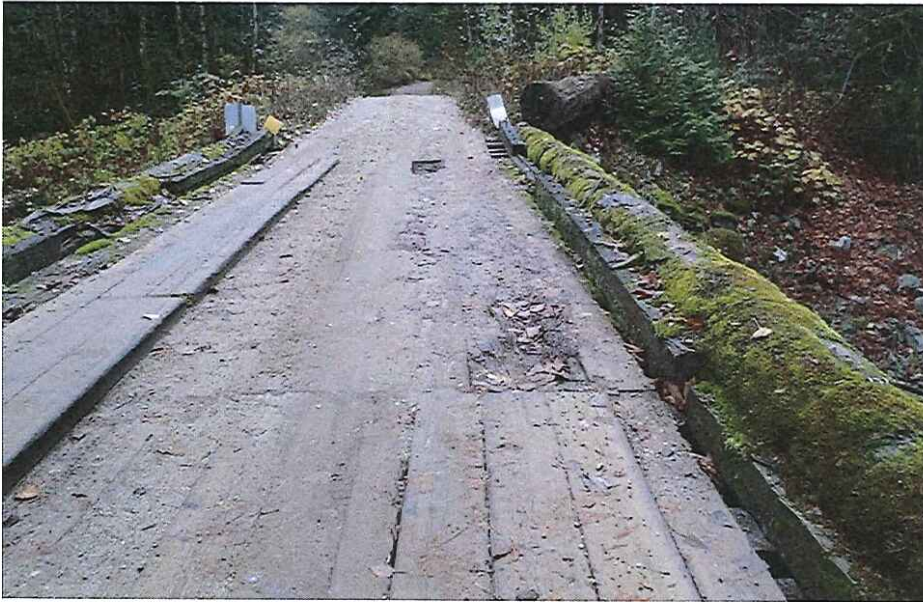
CK2253 Deck

| GENERAL INFORMATION | | | | (enter either long/lat or UTM below - not both) | | | |
|---|---|---|---|---|--|--|--|
| Running Surface (N/A if running surface is gravel or timber planks) | E | G F <u>P</u> N/A UR | <u>ROTTEN</u> | | | | |
| Sub-deck | E | G F <u>P</u> N/A UR | <u>ROTTEN</u> | | | | |
| Overall Deck Condition | E | G F <u>P</u> UR | | | | | |

| GENERAL INFORMATION | | | |
|---|---|---|---|
| P Eng Reviewer's Comments<br><u>Replace entire structure. Present load rating of 5 tonnes to continue.</u> | | | |

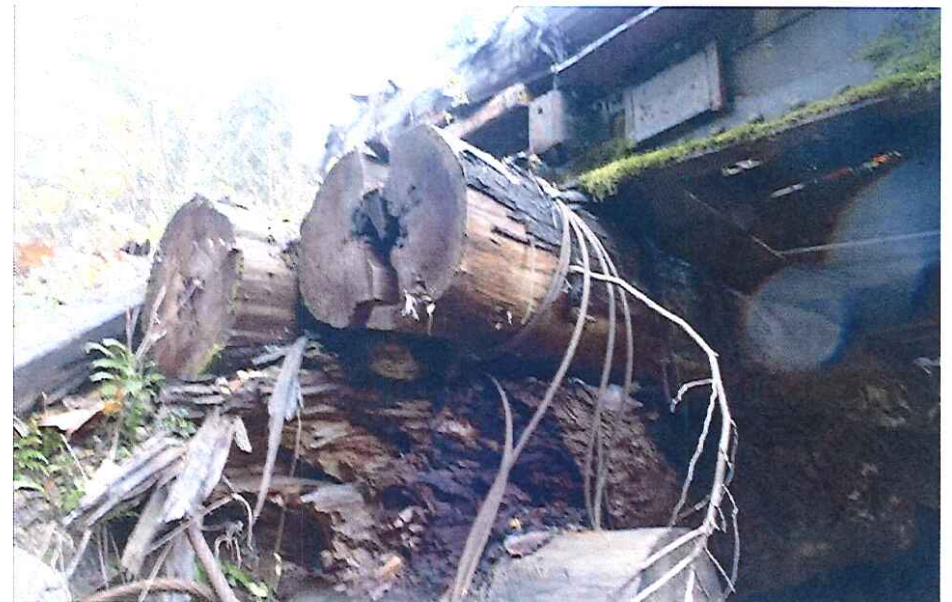
CK2253 Crushing Right Sill

| GENERAL INFORMATION | | | | (enter either long/lat or UTM below - not both) | | | |
|---|---|---|---|---|--|--|--|
| Caps or Sills | E | G F <u>P</u> N/A UR | <u>BITING ON CRIEB, NOT TIED BACK, RIGHT ONE CRUS. END</u> | | | | |
| Bearings | E | G F <u>P</u> N/A UR | <u>CRUSHED SILL LOG</u> | | | | |

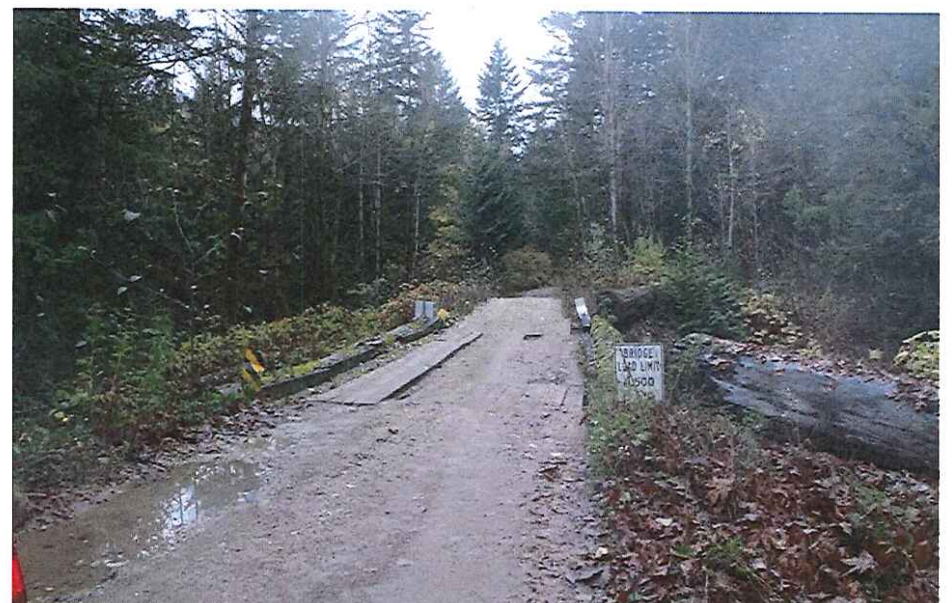
CK2253 Left to Right Approach

| GENERAL INFORMATION | | | | (enter either long/lat or UTM below - not both) | | | |
|---|---|---|---|---|--|--|--|
| Alignment | E | G F <u>P</u> UR | <u>BLIND HILL</u> | | | | |
| Fender Condition | E | G F <u>P</u> None UR | <u>2 MISSING</u> | | | | |

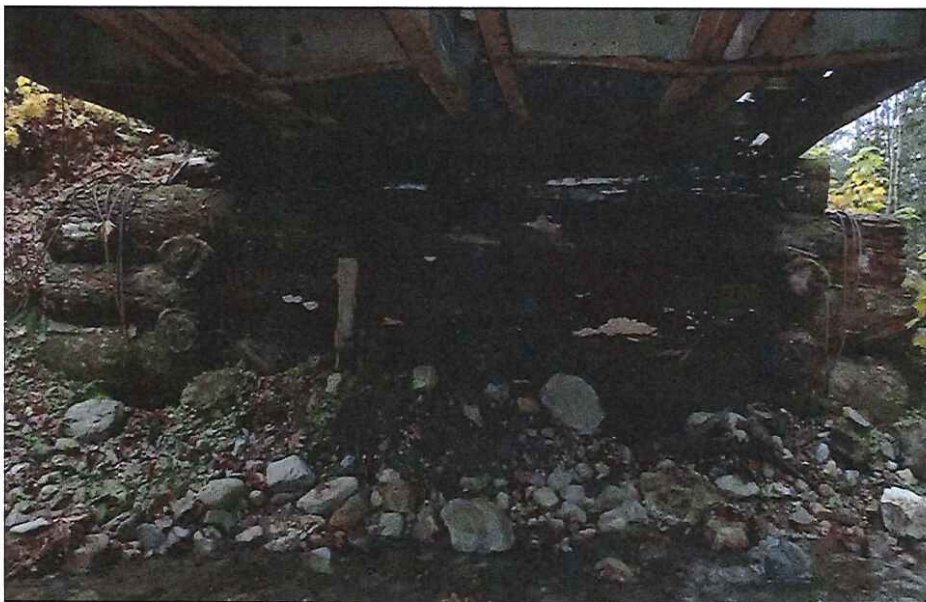
CK2253 Left Abutment

| GENERAL INFORMATION | | | | (enter either long/lat or UTM below - not both) | | | |
|---|---|---|---|---|--|--|--|
| Log/Timber Cribs | E | G F <u>P</u> N/A UR | <u>ROTTEN 3x LEFT 4x RIGHT WITH EXTRA SILL</u> | | | | |
| Tie-backs | E | G F <u>P</u> N/A UR | <u>ROTTEN LOG ON TOP</u> | | | | |
