**Routine Condition Bridge Inspection Form**  
(except for log stringer or timber stringer bridges)**GENERAL INFORMATION**

| *Site #: <u>CK 2254</u> | *Crossing Name: | *Type/Class: <input checked="" type="checkbox"/> Temporary bridge<br><input type="checkbox"/> Permanent bridge | *Project File ID# <u>6092</u> |
| *FSR Name: <u>SQUEAH</u> | *Forest District: <u>CK</u> | *Kilometres: <u>6.1</u> | User km: <u>6.6</u> |

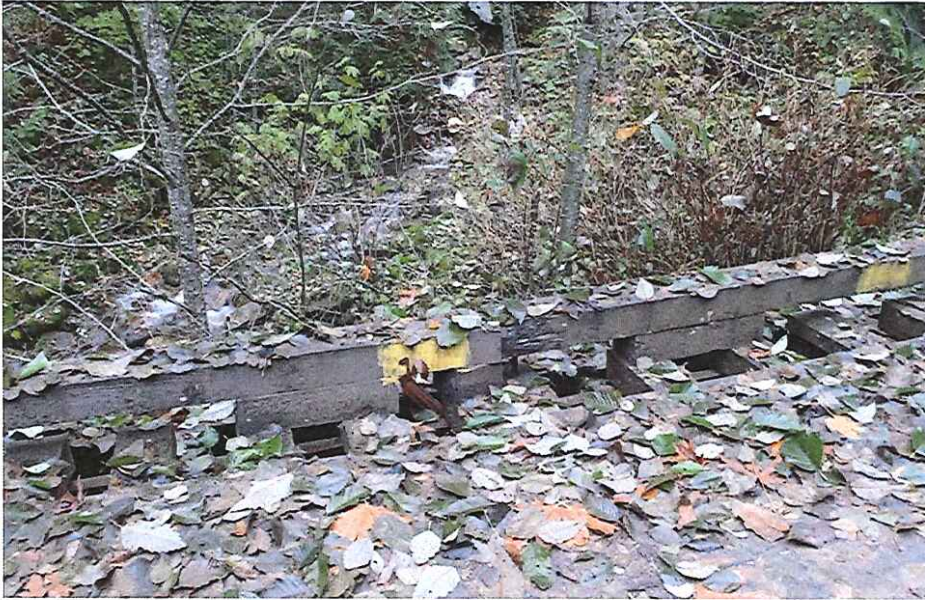
| Item | Present Condition (circle) | Comments (a comment is mandatory if condition "Poor" is selected) |
|---|---|---|
| Curb Rail/Blocks/Posts | E G F <u>(P)</u> UR | <u>DAMAGED &amp; SMALL</u> |

CK2254 Guard Rails

| GENERAL INFORMATION | | | |
|---|---|---|---|
| 1 | H <b>(M)</b> L | | RUNNING RAILS |

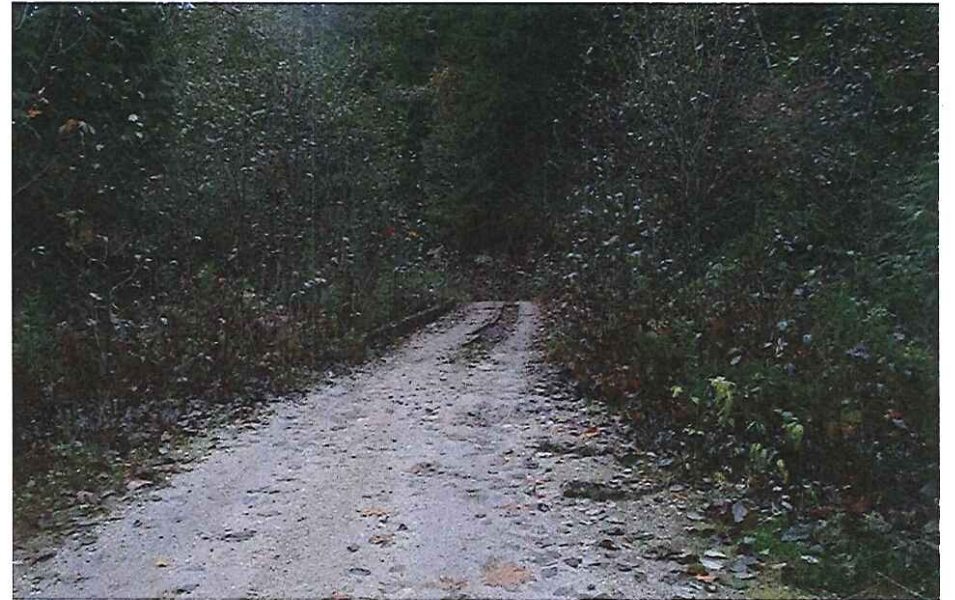
| Item | Present Condition (circle or fill-in) | Comments (a comment is mandatory if condition "Poor" is selected) |
|---|---|---|
| Alignment | E G <u>(F)</u> P UR | <u>TIGHT RIGHT APPROACH</u> |

CK2254 Left to Right Approach

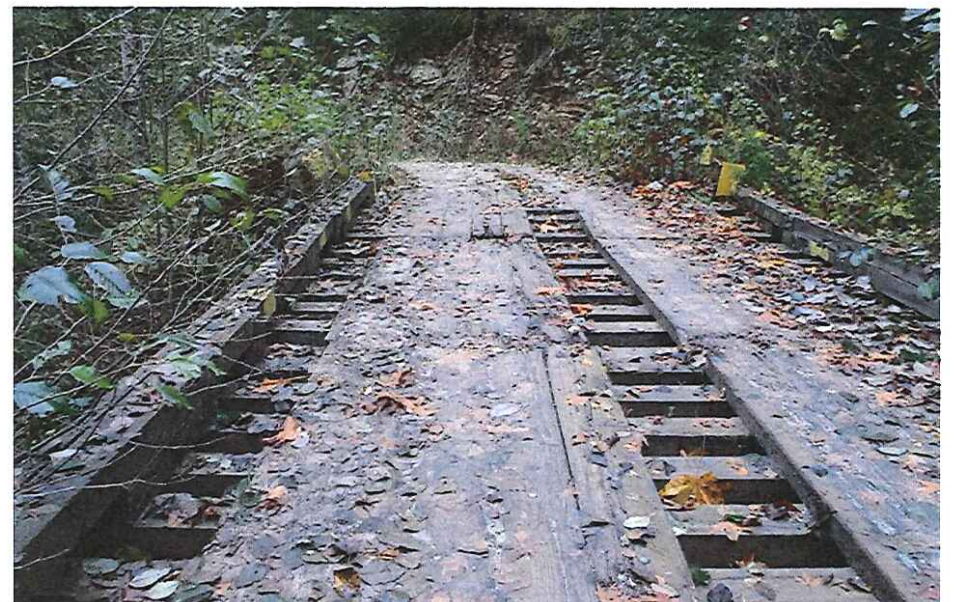
| Item | Present Condition (circle) | Comments (a comment is mandatory if condition "Poor" is selected) |
|---|---|---|
| Running Surface (N/A if running surface is gravel or timber planks) | E G F <u>(P)</u> N/A UR | <u>ROTTING DECK PLANKS</u> |

CK2254 Deck

| GENERAL INFORMATION | | | |
|---|---|---|---|
| P Eng Reviewer's Comments<br><u>Patch holes in deck and plan to replace entire structure soon.</u> | | | |

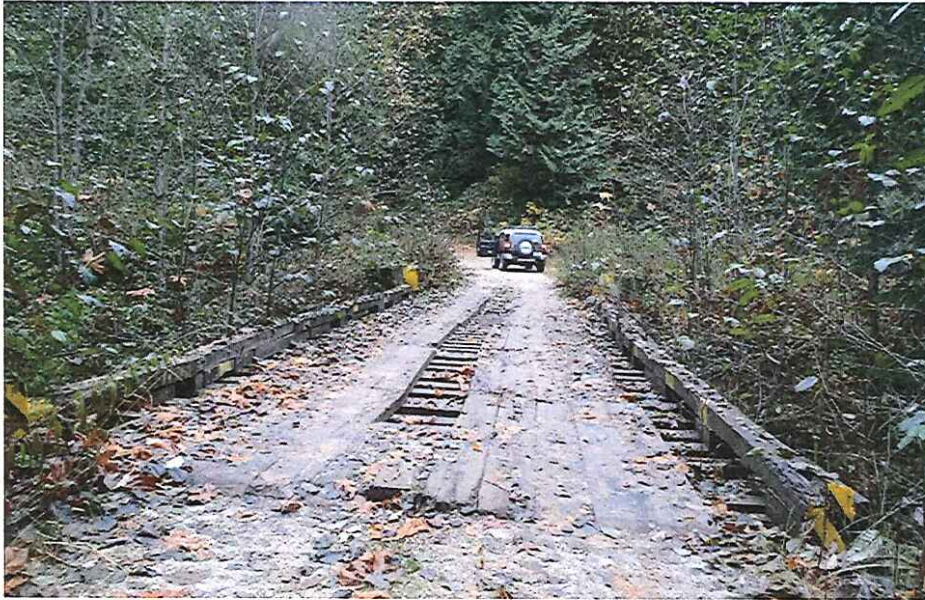
CK2254 Right to Left Approach

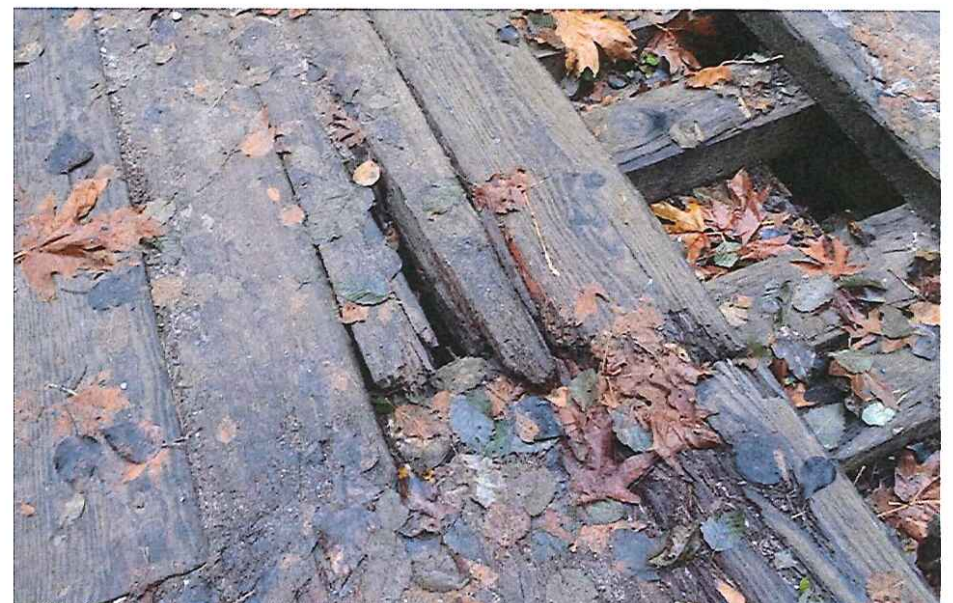
CK2254 Deck Damage

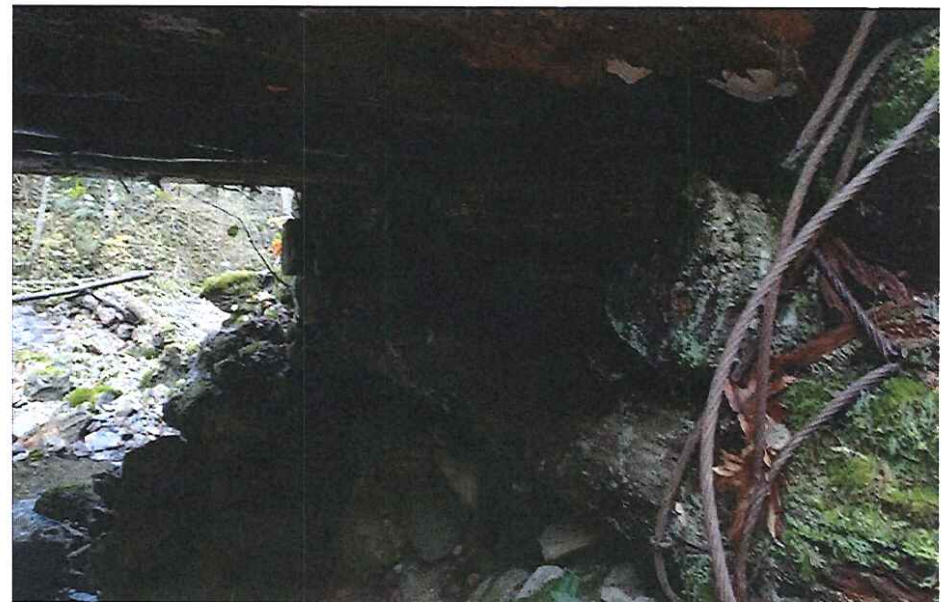
CK2254 Right Abutment

| Item | Present Condition (circle) | Comments (a comment is mandatory if condition "Poor" is selected) |
|---|---|---|
| Log/Timber Cribs | E G F <u>(P)</u> N/A UR | <u>ROTTEN CRIBS</u> |
