**Routine Condition Bridge Inspection Form**  
(for log stringer or timber stringer bridges)

| GENERAL INFORMATION | | | | (enter either long/lat or UTM below – not both) | |
|---|---|---|---|---|--|
| *Site #: <u>CK 2255</u> | *Crossing Name: | *Type/Class: <input type="checkbox"/> Major Culvert<br><input checked="" type="checkbox"/> Woodbox/Log Culvert | *Project File ID# <u>6091</u> | | |
| *FSR Name: <u>SQUEAK</u> | *Forest District: <u>CK</u> | *Kilometres: <u>7.9</u> | User km: <u>8.6</u> | | |

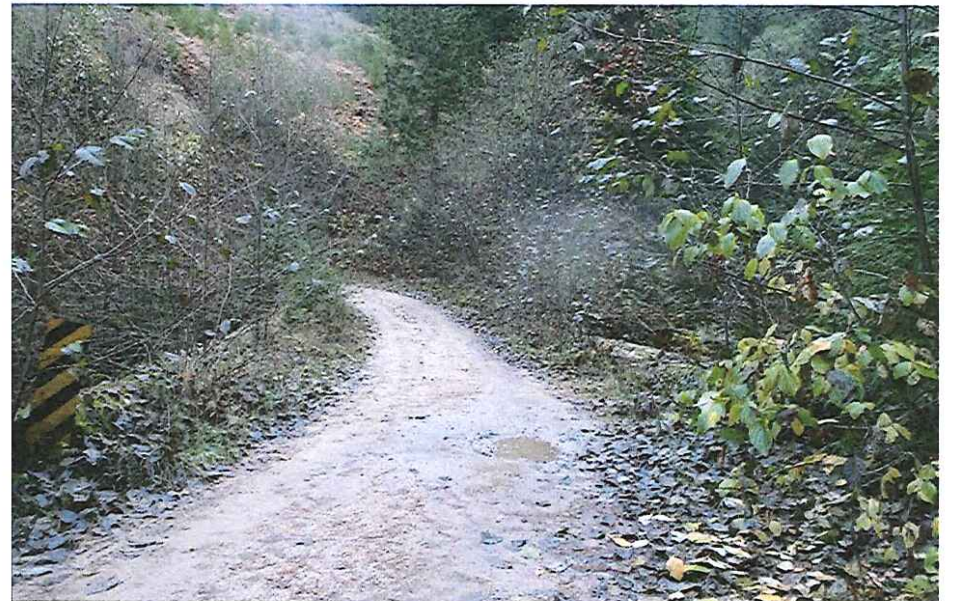
CK2255 Left to Right Approach

| GENERAL INFORMATION | | | | (enter either long/lat or UTM below – not both) | |
|---|---|---|---|---|--|
| Alignment | E G <u>(F)</u> P UR | <u>RIGHT CORNER</u> | | | |

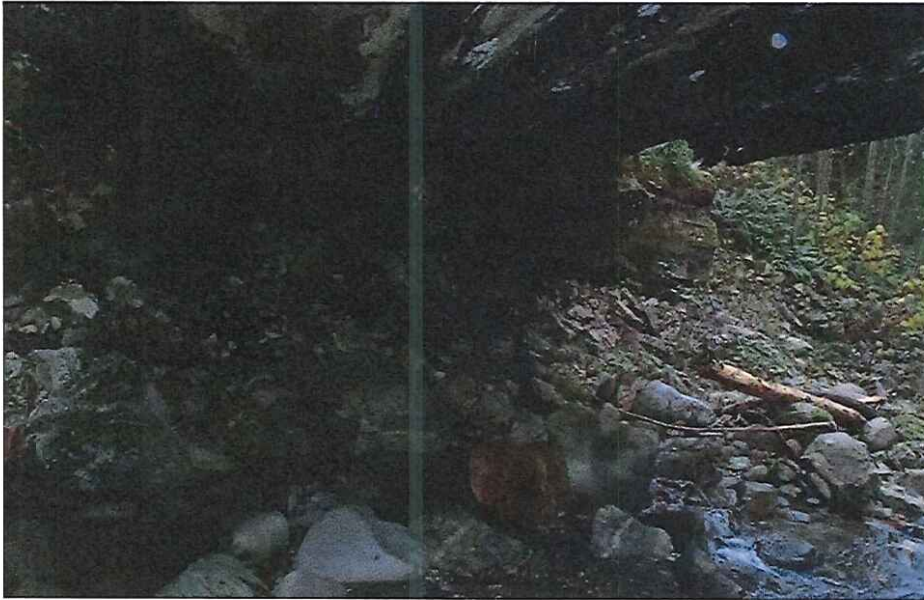
CK2255 Left Abutment

| GENERAL INFORMATION | | | | (enter either long/lat or UTM below – not both) | |
|---|---|---|---|---|--|
| Riprap | E G F <u>(P)</u> N/A UR | <u>SCOUR ON LEFT D.S.</u> | | | |

| Monitor Item # | *Monitor Description |
|---|---|
| 2 | SCOUR, LEFT DS ABUT |

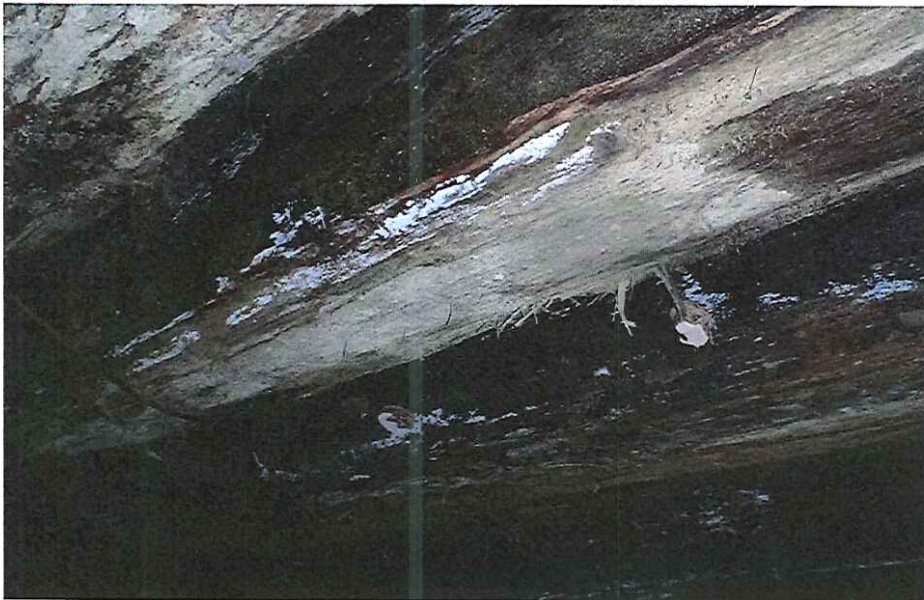
CK2255 Conc on Stringers

| Item | | Present Condition (circle) | | Comments<br>(a comment is mandatory if condition "Poor" is selected) | | | |
|---|---|---|---|---|---|---|---|
| 6 | | Y N | 85 | | | | CONC. EVERYWHERE! |

BIG Fd ROTTEN BRIDGE - REPLACE**PROFESSIONAL ENGINEER TO COMPLETE THIS SECTION**

5 tonnes load rating. Post load rating and replace entire structure soon.
