**Routine Condition Bridge Inspection Form**  
(for log stringer or timber stringer bridges)**GENERAL INFORMATION**

| *Site #: <u>CK 2256</u> | *Crossing Name: | *Type/Class: <input type="checkbox"/> Major Culvert<br><input checked="" type="checkbox"/> Woodbox/Log Culvert | *Project File ID# <u>6092</u> |
| *FSR Name: <u>SQUEAH</u> | *Forest District: <u>CK</u> | *Kilometres: | User km: <u>11.8</u> |

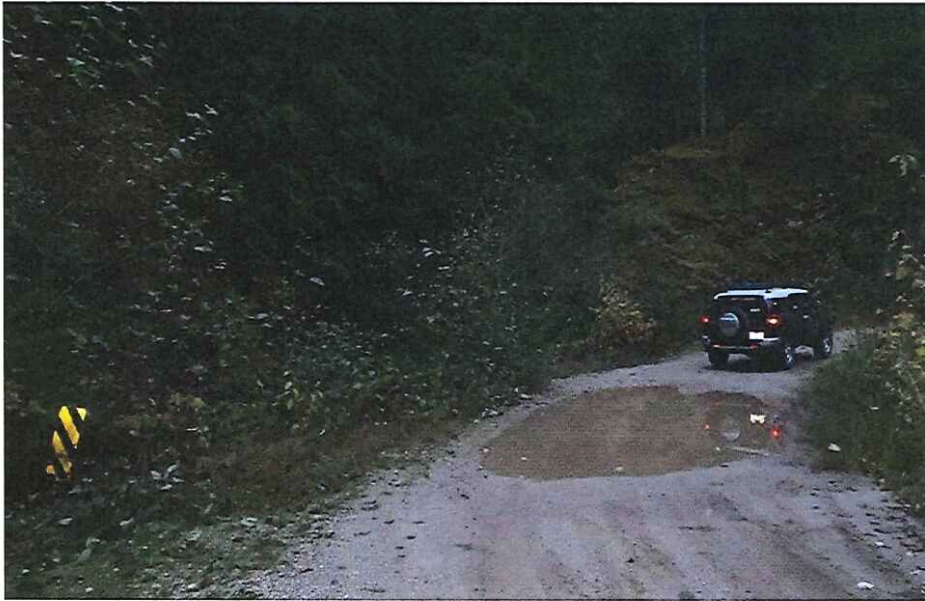
CK2256 Right to Left Approach

| Item | Present Condition<br>(circle or fill-in) | Comments<br>(a comment is mandatory if condition "Poor" is selected) |
|---|---|---|
| Road Surface | E G F <b>(P)</b> UR | LARGE PUDDLE ON BRIDGE |

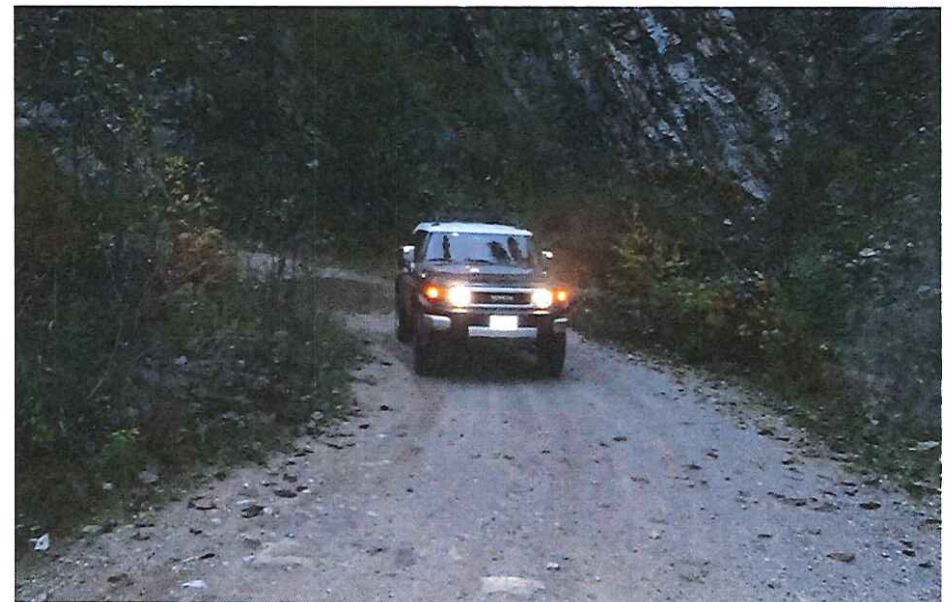
CK2256 Left to Right Approach

| Item | Present Condition<br>(circle or fill-in) | Comments<br>(a comment is mandatory if condition "Poor" is selected) |
|---|---|---|
| Alignment | E G <b>(F)</b> P UR | TIGHT CORNER |

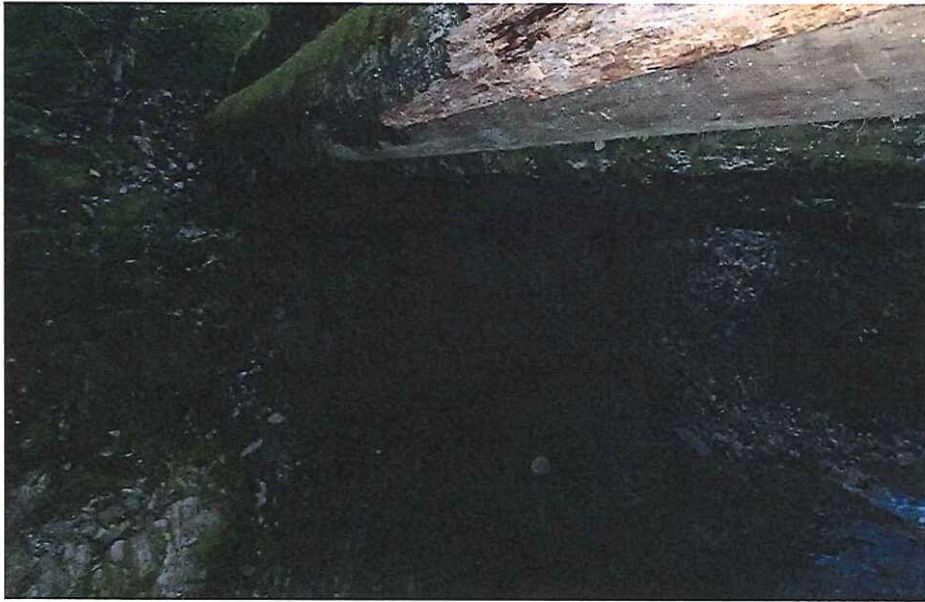
| Item | Present Condition<br>(circle) | Comments<br>(a comment is mandatory if condition "Poor" is selected) |
|---|---|---|
| Bearings | E G F <b>(P)</b> N/A UR | NOT FULLY SUPPORTED |

CK2256 Stringers. not fully supported

2 tonnes load rating. Post load rating and replace entire structure soon.

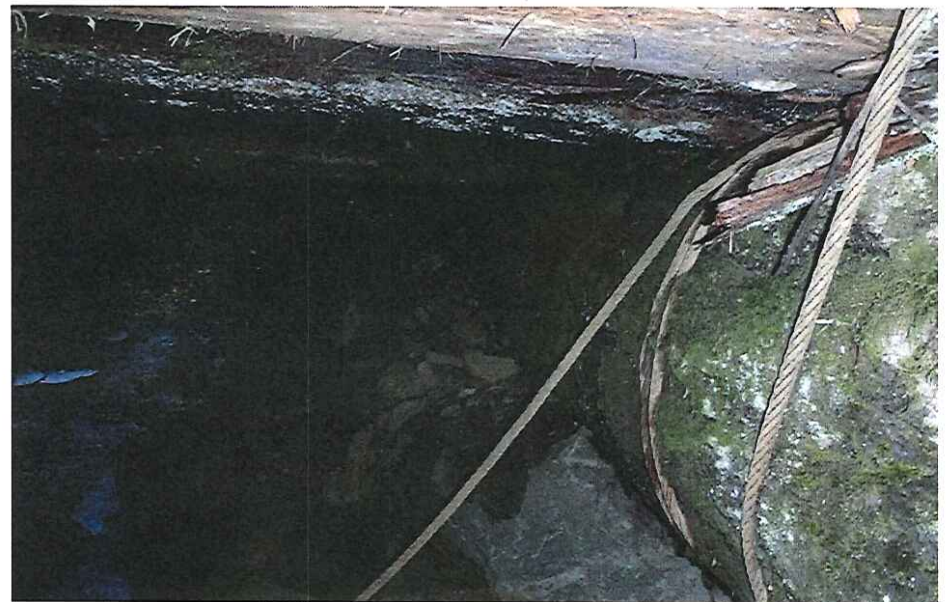
CK2256 Right Abutment

| Item | Present Condition<br>(circle) | Comments<br>(a comment is mandatory if condition "Poor" is selected) |
|---|---|---|
| Log/Timber Crib | E G F <b>(P)</b> N/A UR | LOGS ON RAIL - NOT FULLY SUPPORTED |
| Caps or Sills | E G F <b>(P)</b> N/A UR | ROTTEN LOGS |
