**Routine Condition Bridge Inspection Form**  
(for log stringer or timber stringer bridges)**GENERAL INFORMATION** (enter either long/lat or UTM below – not both)

| *Site #: <u>CL 2267</u> | *Crossing Name:<br><u>Unknown</u> | *Type/Class: <input type="checkbox"/> Major Culvert<br><input checked="" type="checkbox"/> Woodbox/Log Culvert | *Project File ID# <u>8013</u> |
| *FSR Name:<br><u>Stave River</u> | *Forest District:<br><u>CL</u> | *Kilometres: <u>10.5km</u> | User km: |

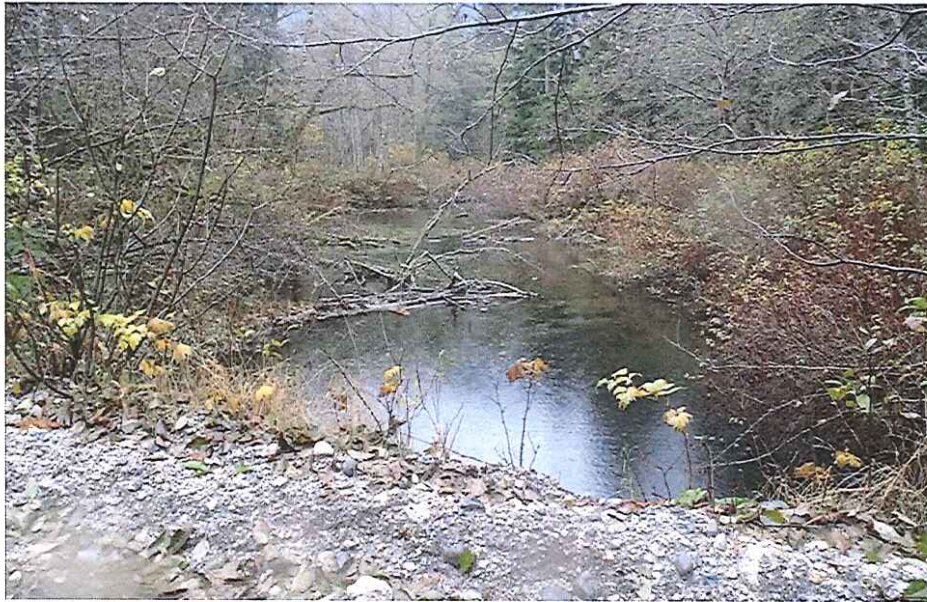
CK2262 Downstream

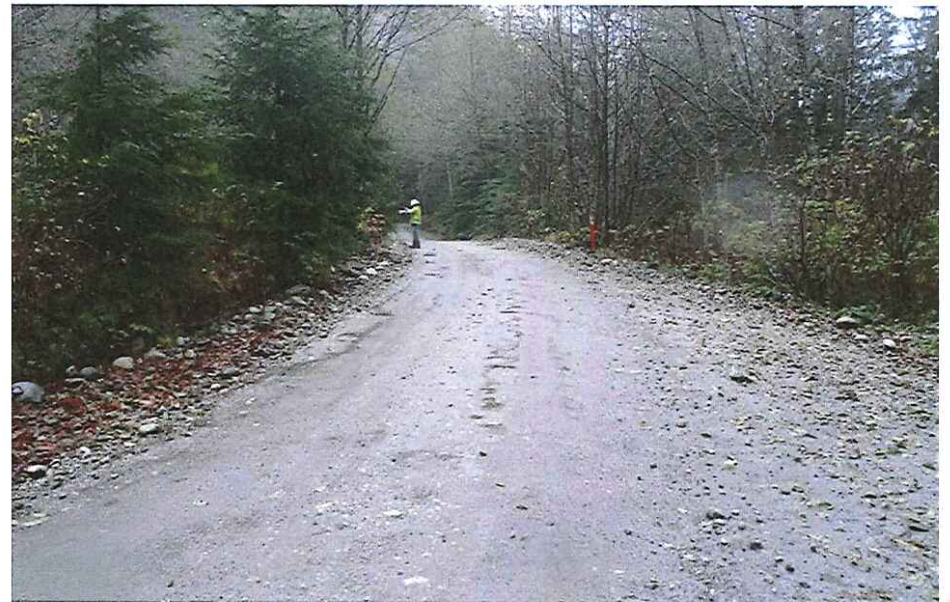
CK2262 Left to Right Approach

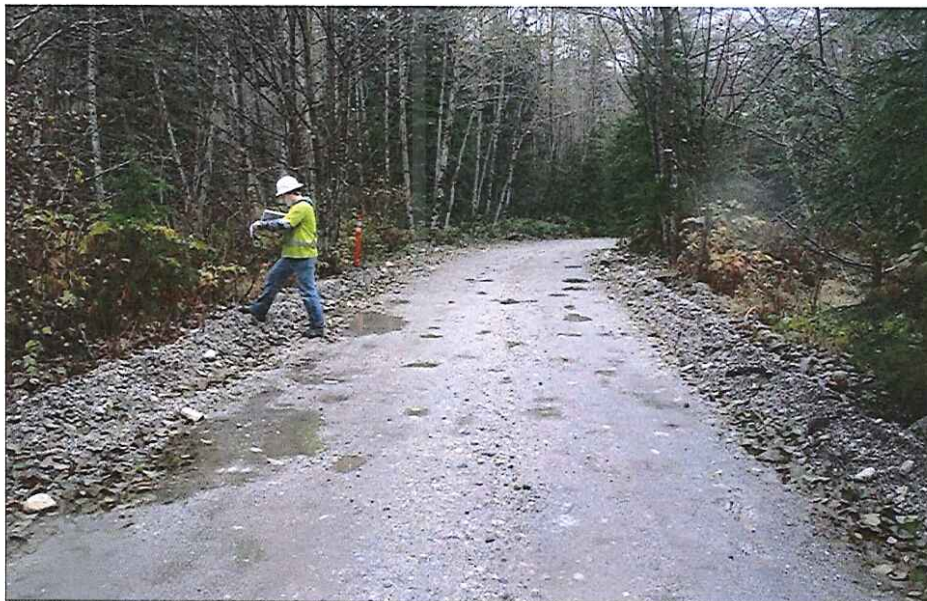
CK2262 Right to Left Approach

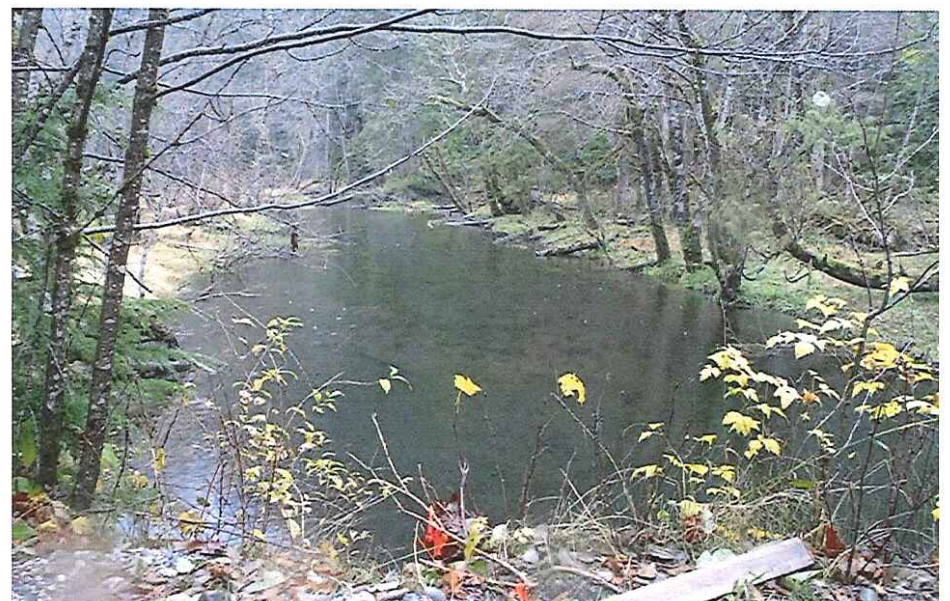
CK2262 Upstream

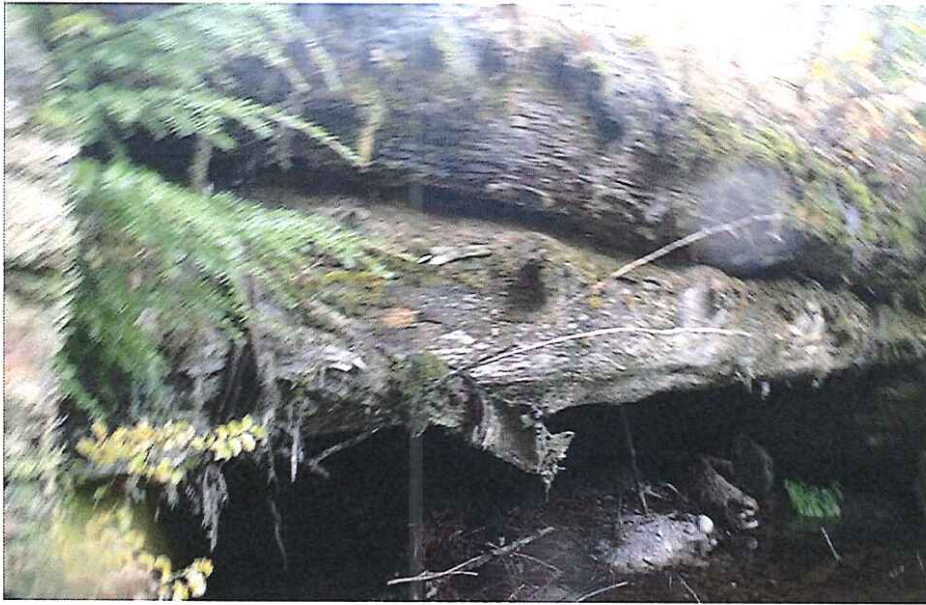
CK2262 From Downstream 2

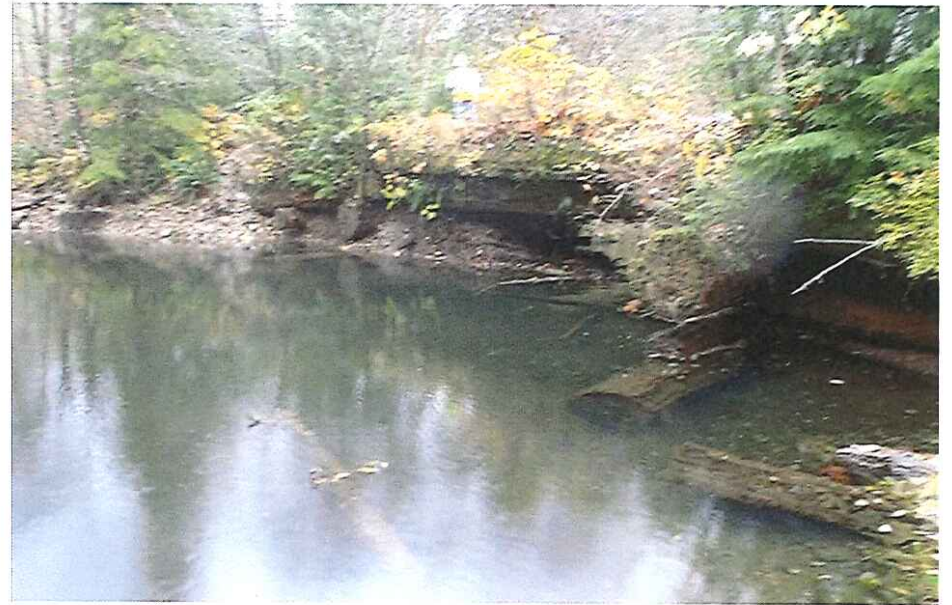
CK2262 From Upstream

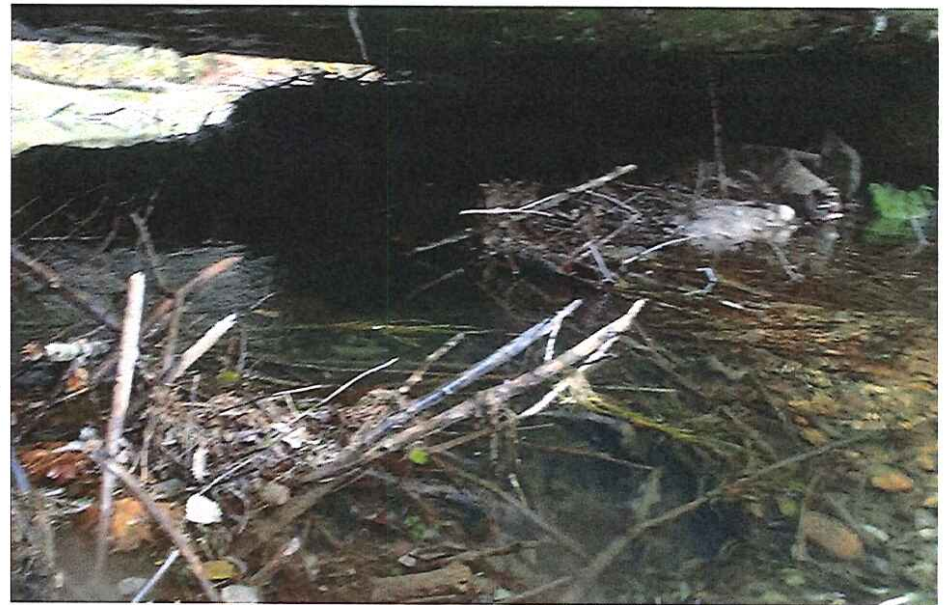
CK2262 From Downstream
