**Routine Condition Bridge Inspection Form**  
(for log stringer or timber stringer bridges)**GENERAL INFORMATION**

| *Site #: <u>CK-2263</u> | *Crossing Name:<br><u>Unknown</u> | *Type/Class: <input type="checkbox"/> Major Culvert<br><input checked="" type="checkbox"/> Woodbox/Log Culvert | *Project File ID# <u>8013</u> |
| *FSR Name:<br><u>Stave River</u> | *Forest District:<br><u>CK</u> | *Kilometres:<br><u>11.4km</u> | User km: |

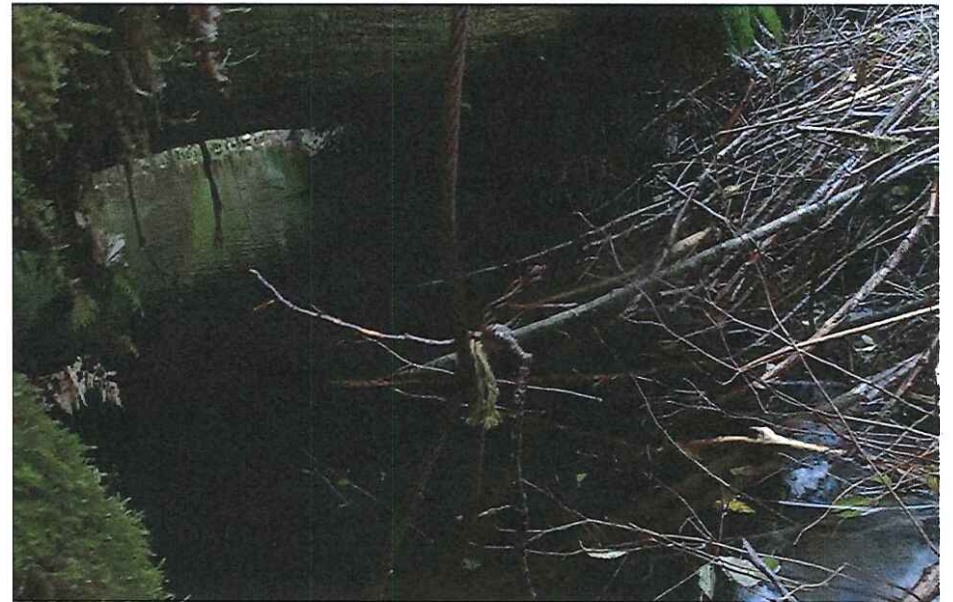
| Item | Present Condition<br>(circle) | Comments<br>(a comment is mandatory if condition "Poor" is selected) |
|---|---|---|
| Log/Timber Cribs | E G <u>(F)</u> P N/A UR | <u>CAUSED IN WATER DUE TO BEARD DAM</u> |

CK2263 Beaver dam at inlet

| Repair Item # | *Priority (circle) | *Estimate (\$) | *Repair Description |
|---|---|---|---|
| 2 | <u>H</u> M L | | REMOVE BEAVER DAMS |

Remove beaver dam and assess cribs and stringers in summer of 2012.

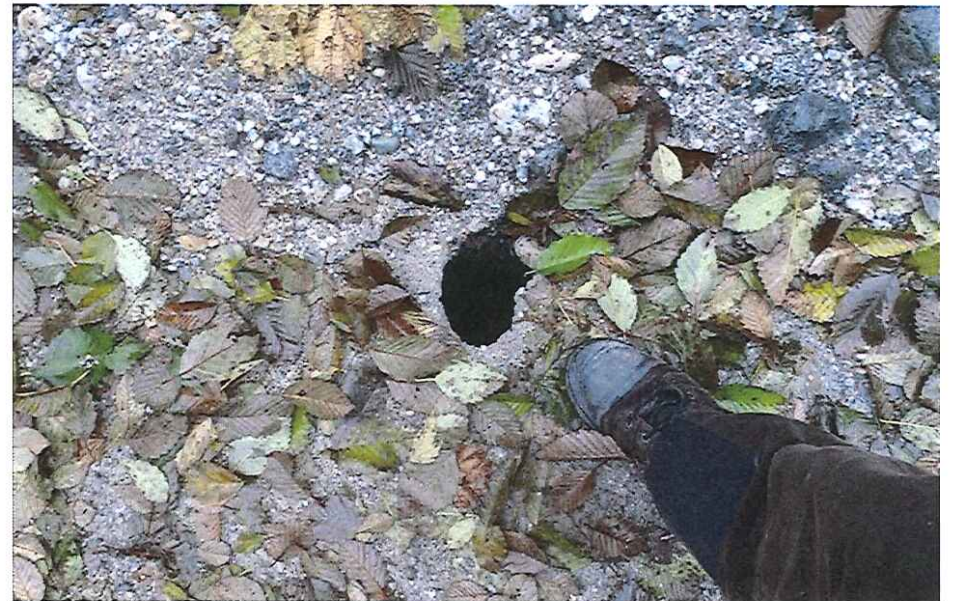
| Item | Present Condition<br>(circle or fill-in) | Comments<br>(a comment is mandatory if condition "Poor" is selected) |
|---|---|---|
| Road Surface | E G <u>(F)</u> P UR | <u>Hole in d/s fill</u> |

| Item | Present Condition<br>(circle) | Comments<br>(a comment is mandatory if condition "Poor" is selected) |
|---|---|---|
| Gravel Surface | E G F <u>(P)</u> N/A UR | <u>Hole in d/s and gravel fill</u> |
| Overall Deck Condition | E G F <u>(P)</u> | <u>HOLE IN FILL</u> |

CK2263 Hole in Fill

| Repair Item # | *Priority (circle) | *Estimate (\$) | *Repair Description |
|---|---|---|---|
| 3 | H M L | | REPLACE FILL & ADD GEOTEXTILE |

Post bridge ahead and load rating signs. Pull gravel surfacing, lay geotextile to prevent surfacing from eroding and replace to a minimum depth of 600mm. Place curbs and log fenders. Present load rating of L60 or 54 tonnes to continue.

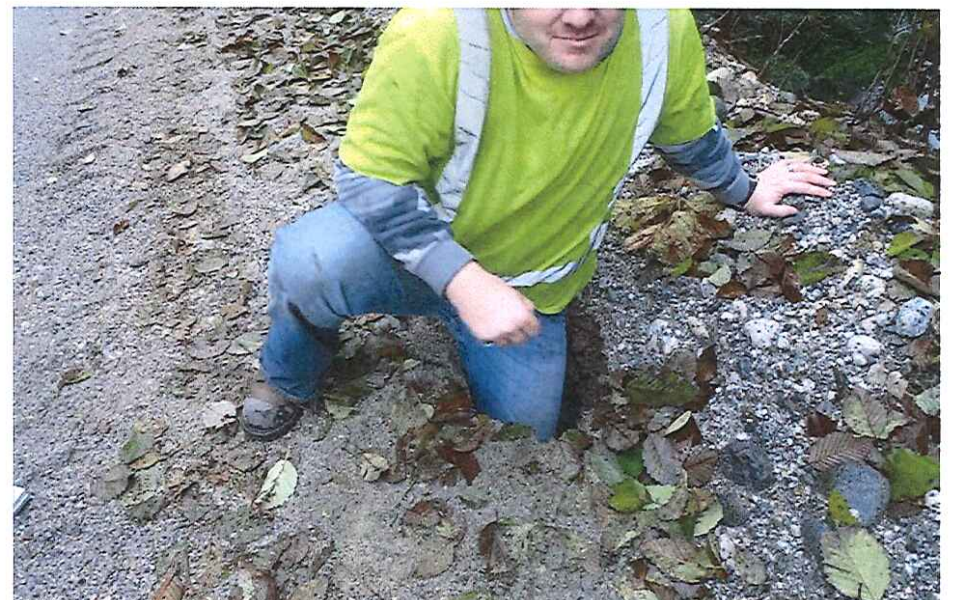
CK2263 Hole in Fill is bigger below

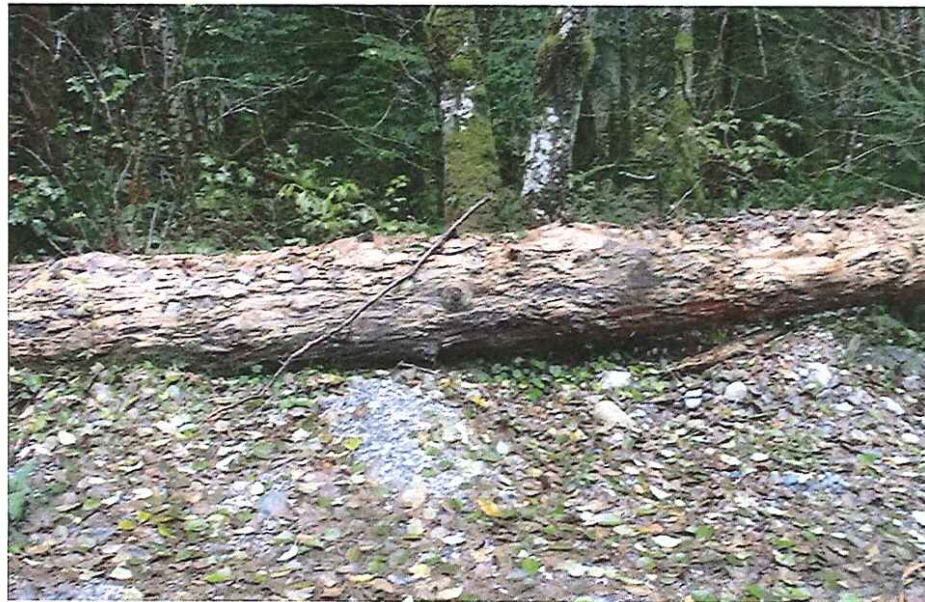
| Item | | Present Condition (circle) | | Comments (a comment is mandatory if condition "Poor" is selected) | | | |
|---|---|---|---|---|---|---|---|
| 3 | | Y N | SAME AS LAST | | | | Broken stringer replaced |

CK2263 Broken Stringer that was removed
