**Routine Condition Bridge Inspection Form**  
(for log stringer or timber stringer bridges)**GENERAL INFORMATION**

| *Site #: <u>CL 2269</u> | *Crossing Name:<br><u>Unknown</u> | *Type/Class: <input type="checkbox"/> Major Culvert<br><input checked="" type="checkbox"/> Woodbox/Log Culvert | *Project File ID# <u>8013</u> |
| *FSR Name:<br><u>Stave River</u> | *Forest District:<br><u>CK</u> | *Kilometres: <u>13.0km</u> | User km: <u>119</u> |

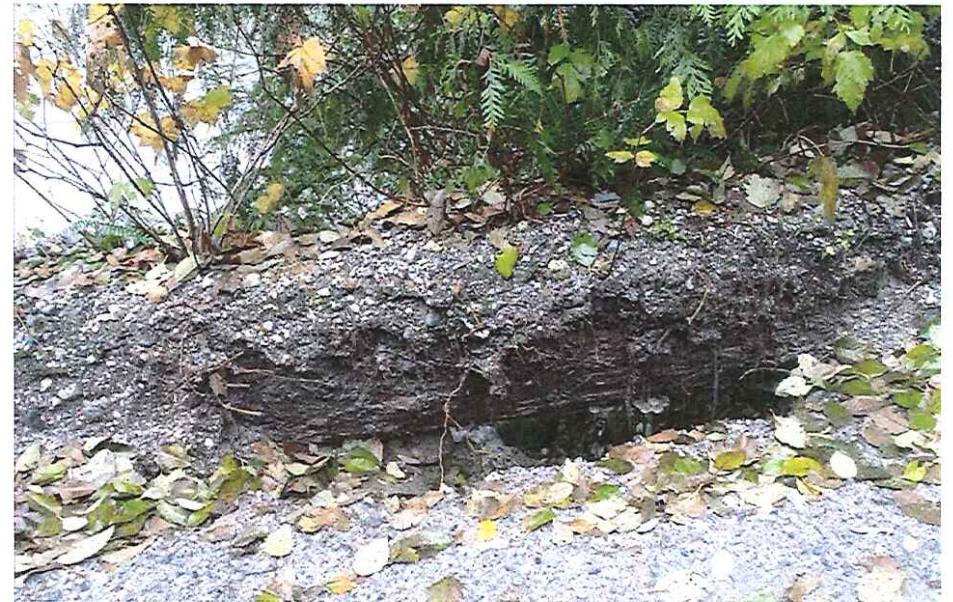
| Item | Present Condition<br>(circle) | Comments<br>(a comment is mandatory if condition "Poor" is selected) |
|---|---|---|
| Gravel Deck Depth | <u>0.7m</u> metres or N/A | <u>Failed on 4/s side</u> |

CK2264 Downstream side deck failure

| GENERAL INFORMATION | | | | | | | | | | | | | | |
|---|---|---|---|---|---|---|---|---|---|---|---|---|---|---|
| PEng Reviewer's Comments: 10 tonnes to continue. Post load rating. | | | | | Date Reviewed (yyyy/mm/dd) Jan 26, 2012 | | | | | Plan to replace entire structure. | | | | |

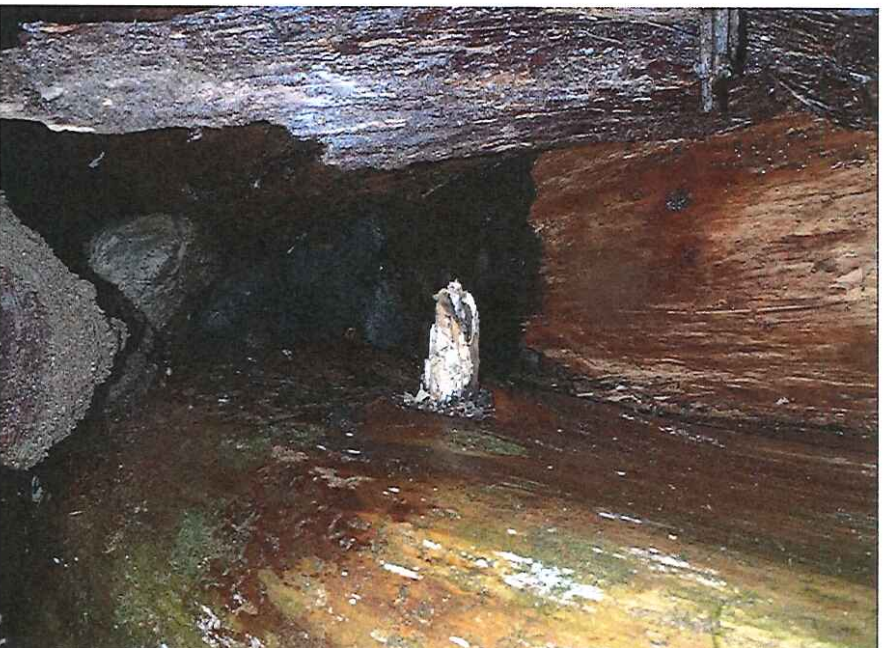
CK2264 wheel path fill failure

| GENERAL INFORMATION | | | | | | | | | | | | | | |
|---|---|---|---|---|---|---|---|---|---|---|---|---|---|---|
| 1 | (H) M L | | | | | Post load rating repair bridge | | | | | | | | |
