**Routine Condition Bridge Inspection Form**  
(for log stringer or timber stringer bridges)

| GENERAL INFORMATION | | | | (enter either long/lat or UTM below – not both) | | |
|---|---|---|---|---|--|--|
| *Site #: <u>CK-2265</u> | *Crossing Name: | *Type/Class: <input type="checkbox"/> Major Culvert<br><input checked="" type="checkbox"/> Woodbox/Log Culvert | *Project File ID# <u>8013</u> | | | |
| *FSR Name:<br><u>Stave River</u> | *Forest District:<br><u>CK</u> | *Kilometres:<br><u>12.05</u> | User km: | | | |

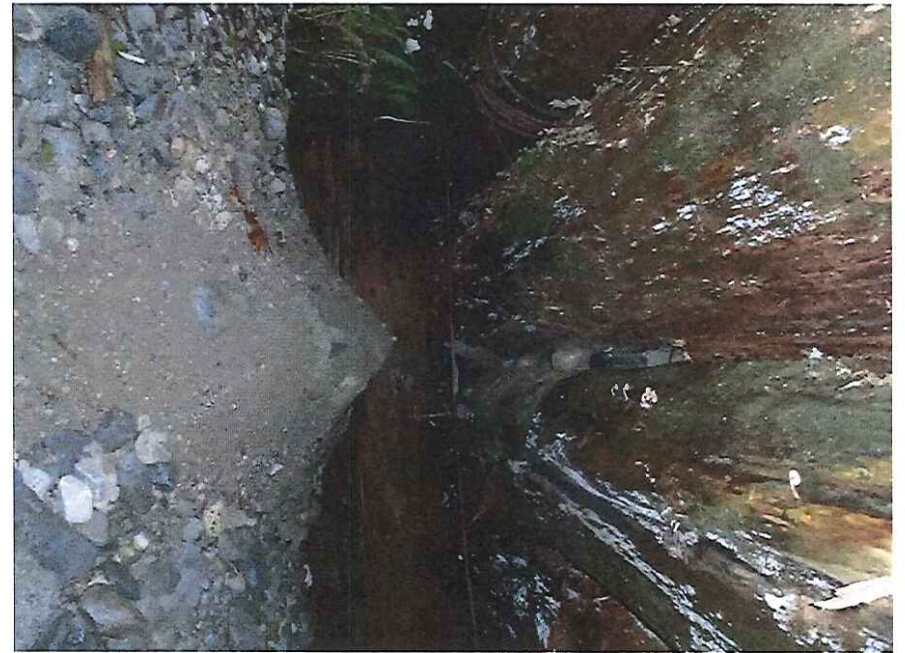
CK2265 Fill that has failed...

CK2265 stringers where the fill...

| Repair Item # | *Priority (circle) | *Estimate (\$) | *Repair Description |
|---|---|---|---|
| 2 | H M L | | remove gravel fill, lay geotextile and backfill to 600mm depth |

Remove gravel fill, lay geotextile and backfill to 600mm depth.

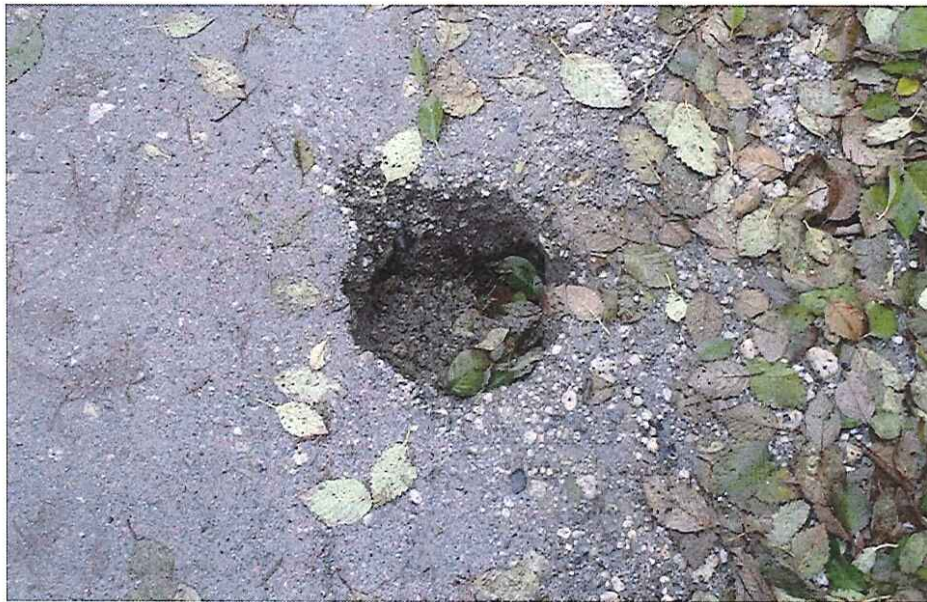
CK2265 hole in fill
