**Routine Condition Bridge Inspection Form**  
(for log stringer or timber stringer bridges)**GENERAL INFORMATION**

| *Site #: <u>CL-2267</u> | *Crossing Name:<br><u>Ole Crk</u> | *Type/Class: <input type="checkbox"/> Major Culvert<br><input checked="" type="checkbox"/> Woodbox/Log Culvert | *Project File ID# <u>8013</u> |
| *FSR Name:<br><u>Stave River</u> | *Forest District:<br><u>CK</u> | *Kilometres: | User km: <u>17.6</u> |

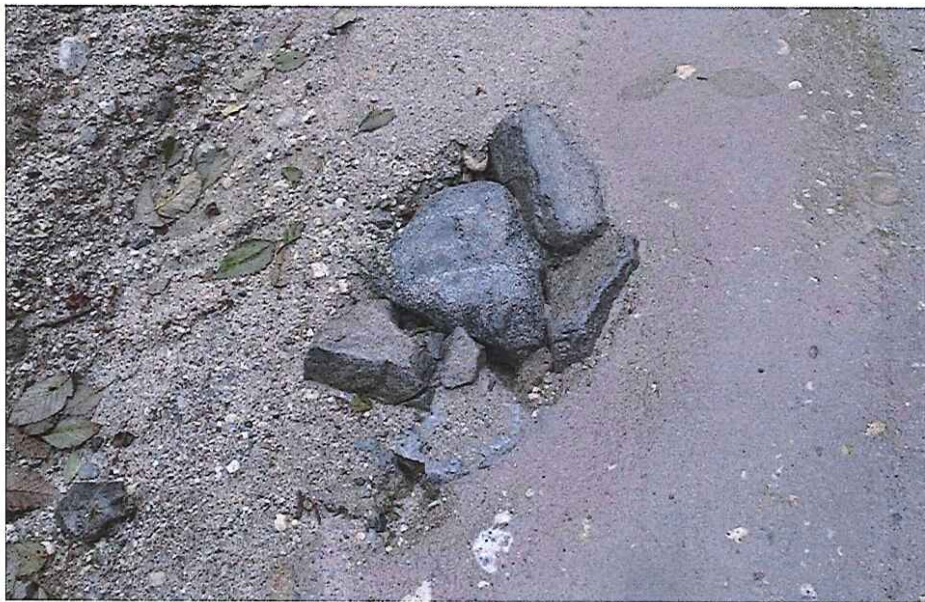
| Item | Present Condition<br>(circle) | Comments<br>(a comment is mandatory if condition "Poor" is selected) |
|---|---|---|
| Gravel Surface | E G F <u>(P)</u> N/A UR | <u>Filling through</u> |

CK2267 Deck Damage

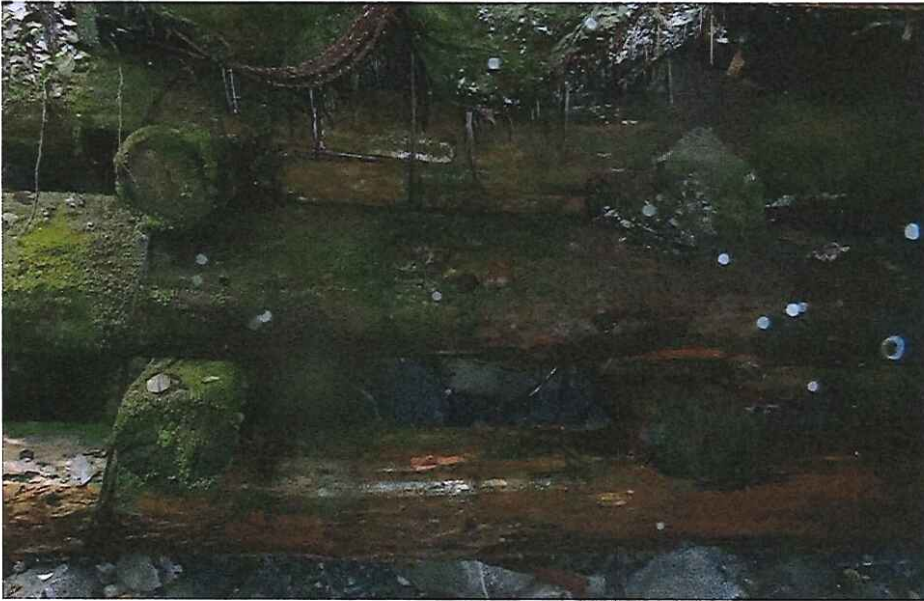
CK2267 Left Abutment

| Item | Present Condition<br>(circle) | Comments<br>(a comment is mandatory if condition "Poor" is selected) |
|---|---|---|
| Log/Timber Cribbs | E G <u>(F)</u> P N/A UR | <u>Left is poor, broken on w/s side Right is fair</u> |

| Monitor Item # | *Monitor Description |
|---|---|
| 2 | BROKEN CRIB |

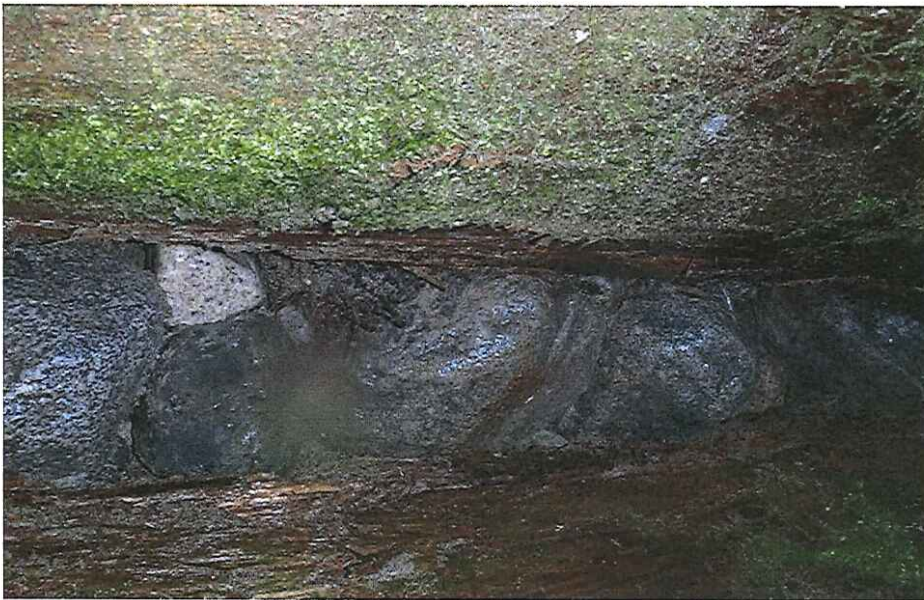
| Item | Present Condition<br>(circle) | Comments<br>(a comment is mandatory if condition "Poor" is selected) |
|---|---|---|
| Fill | E G F <u>(P)</u> N/A UR | <u>Filling</u> |

LOAD RATE - REMEMBER FILL IS FAILING ON DUCK**PROFESSIONAL ENGINEER TO COMPLETE THIS SECTION**

CK2267 fill failing

| Repair Item # | *Priority (circle) | *Estimate (\$) | *Repair Description |
|---|---|---|---|
| 1 | (H) M L | | DIG OUT BRIDGE |
