**Routine Condition Bridge Inspection Form**  
(except for log stringer or timber stringer bridges)

| GENERAL INFORMATION | | | | (enter either long/lat or UTM below - not both) | | | |
|---|---|---|---|---|--|--|--|
| *Site #: <u>CK-2269</u> | *Crossing Name: <u>Stave River</u> | *Type/Class: <input type="checkbox"/> Temporary bridge<br><input checked="" type="checkbox"/> Permanent bridge | *Project File ID# <u>8013</u> | | | | |
| *FSR Name: <u>Stave River</u> | | | User km: <u>70.8</u> | | | | |

| GENERAL INFORMATION | | | |
|---|---|---|---|
| *Date of Inspection (yyyy/mm/dd)<br><u>2011/11/09</u> | *Inspection Company Name<br><u>OnSite Engineering</u> | *Inspector's Name (print)<br><u>Jeremy Araki</u> | Inspector's Signature<br> |

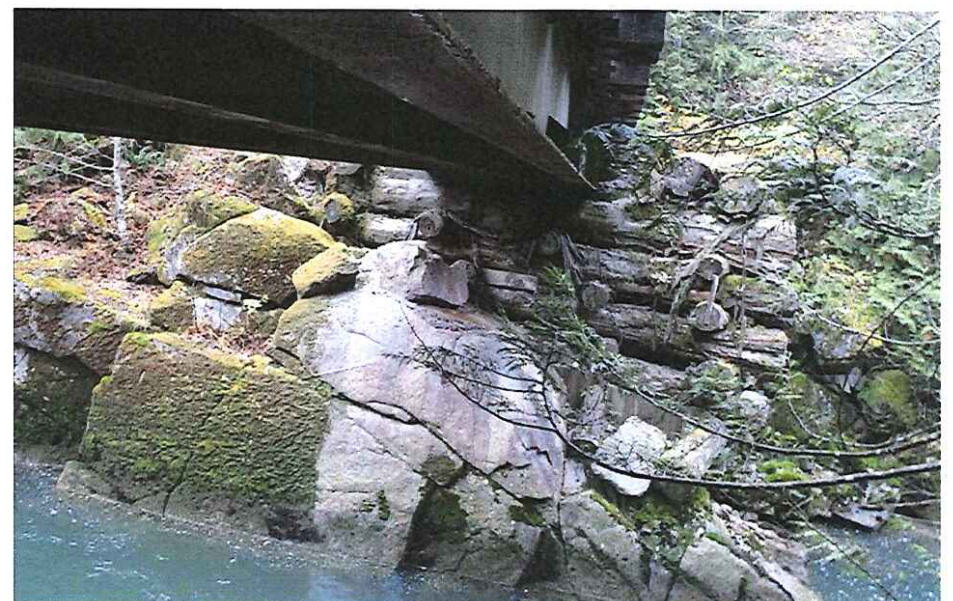
CK2269 Left Abutment

| GENERAL INFORMATION | | | | (enter either long/lat or UTM below - not both) | | | |
|---|---|---|---|---|--|--|--|
| Log/Timber Cribs | E G <u>(F)</u> P N/A UR | <u>CRIBS ON LEFT CW</u> | | | | | |
| Tie-backs | E G <u>(F)</u> P N/A UR | <u>CW</u> | | | | | |
| Hardware | E G <u>(F)</u> P N/A UR | <u>LAXING LOOSE</u> | | | | | |

| GENERAL INFORMATION | | | |
|---|---|---|---|
| 1 | LEFT CRIB, NO CHANGE SINCE 2009 | | |
| P Eng Reviewer's Comments<br><u>Monitor camp crib for settlement.</u> | | | |

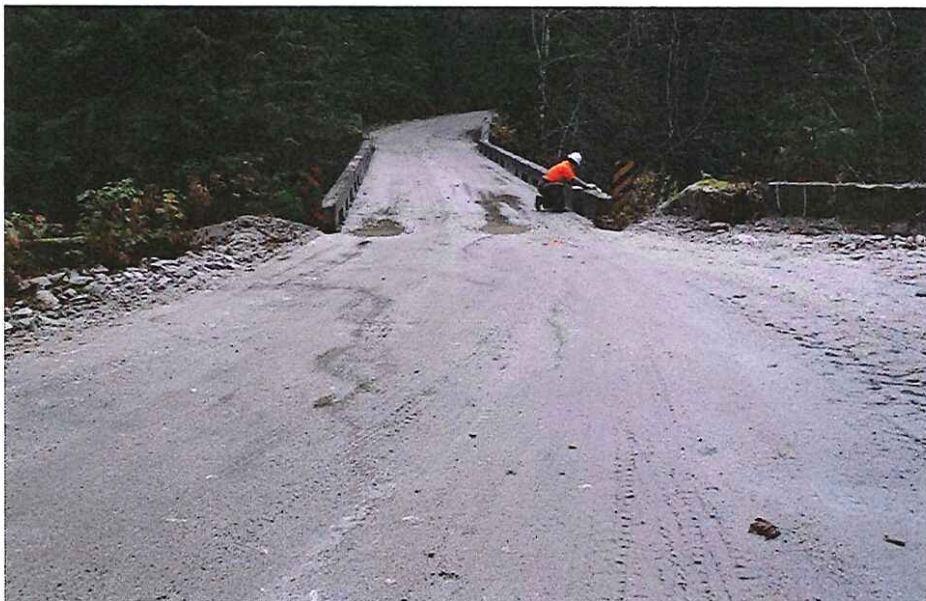
CK2269 Left to Right Approach

| GENERAL INFORMATION | | | | (enter either long/lat or UTM below - not both) | | | |
|---|---|---|---|---|--|--|--|
| Alignment | E G <u>(F)</u> P UR | <u>TIGHT CURVE ON LEFT</u> | | | | | |
