**Routine Condition Bridge Inspection Form**  
(except for log stringer or timber stringer bridges)**GENERAL INFORMATION**

| *Site #: <u>CR-2270</u> | *Crossing Name: | *Type/Class: <input checked="" type="checkbox"/> Temporary bridge<br><input type="checkbox"/> Permanent bridge | *Project File ID# <u>8013</u> |
| *FSR Name:<br><u>Star River</u> | *Forest District:<br><u>CIC</u> | *Kilometres: | User km: |

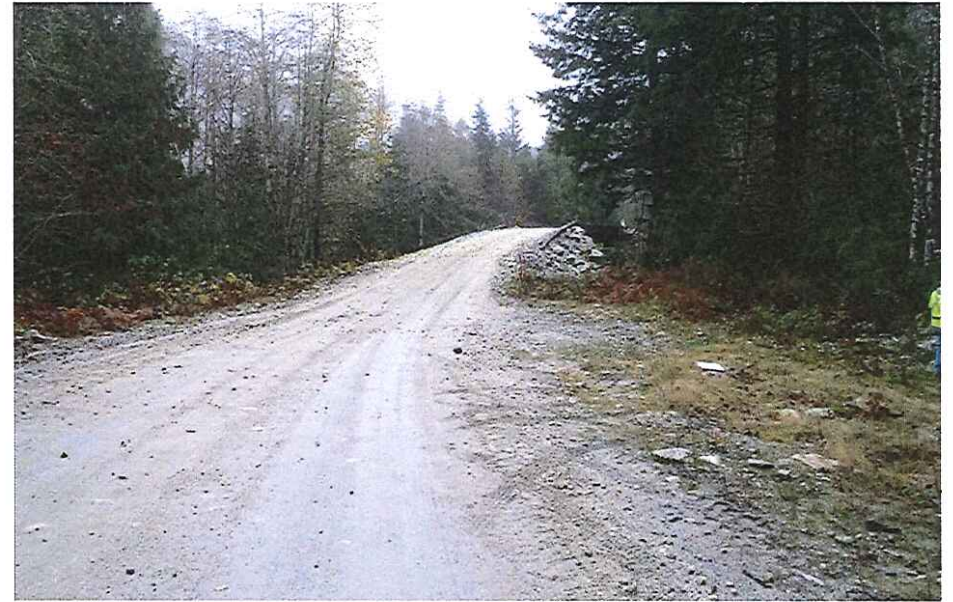
CK2270 Left to Right Approach

| Item | Present Condition (circle or fill-in) | Comments (a comment is mandatory if condition "Poor" is selected) |
|---|---|---|
| Alignment | E G <u>P</u> UR | Right vertical → overtopper |
| Bridge Ahead Signs Missing | 0 1 <u>2</u> | |

| GENERAL INFORMATION | | | |
|---|---|---|---|
| Repair damaged guardrail and post bridge ahead signs. | | | |

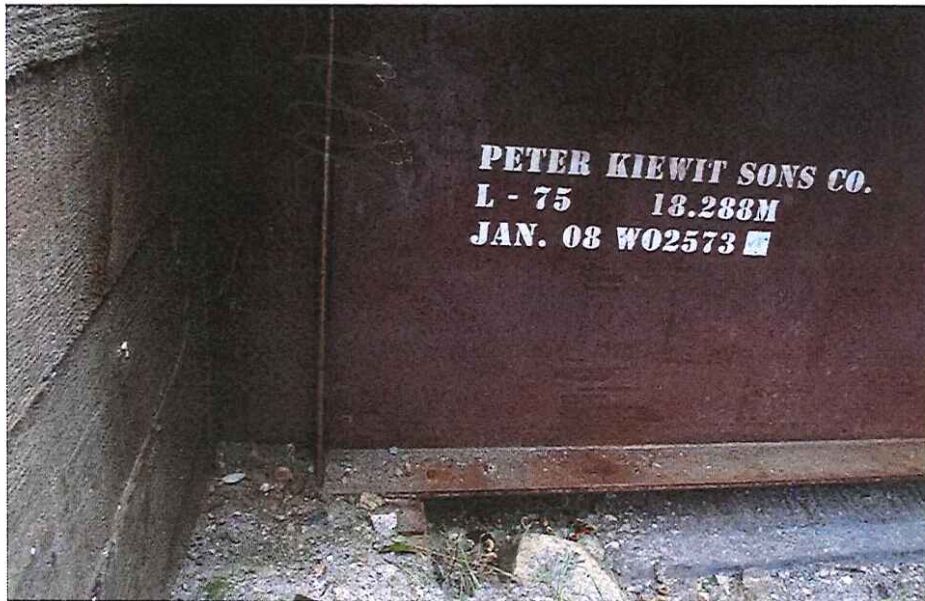
CK2270 Left Bearing

| Item | Present Condition (circle) | Comments (a comment is mandatory if condition "Poor" is selected) |
|---|---|---|
| Bearings | E G <u>P</u> P N/A UR | New bearing over old crib on two corners |

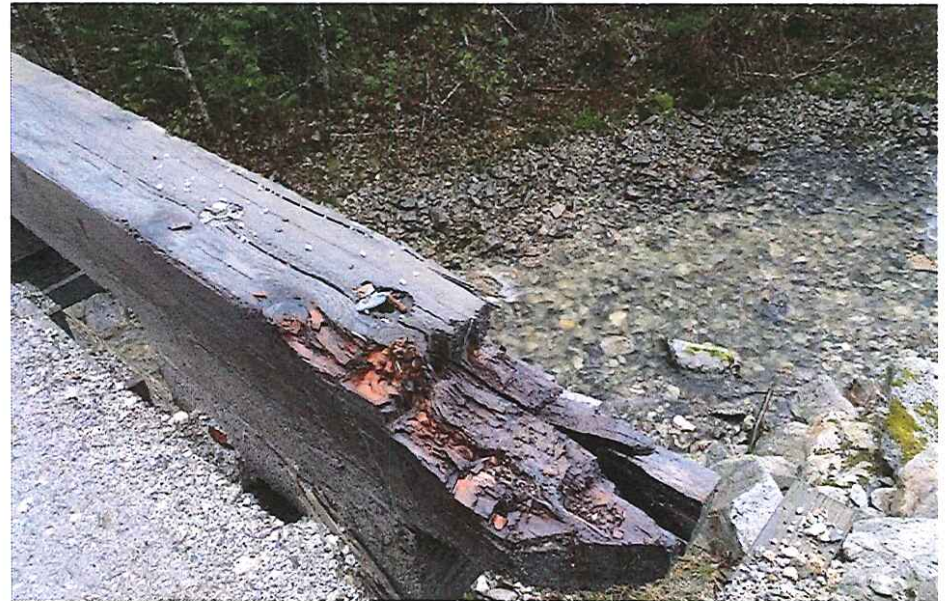
CK2270 Guard Rails

| Item | Present Condition (circle) | Comments (a comment is mandatory if condition "Poor" is selected) |
|---|---|---|
| Curb Rail/Blocks/Posts | E G <u>P</u> P UR | Some damage to right d/s |

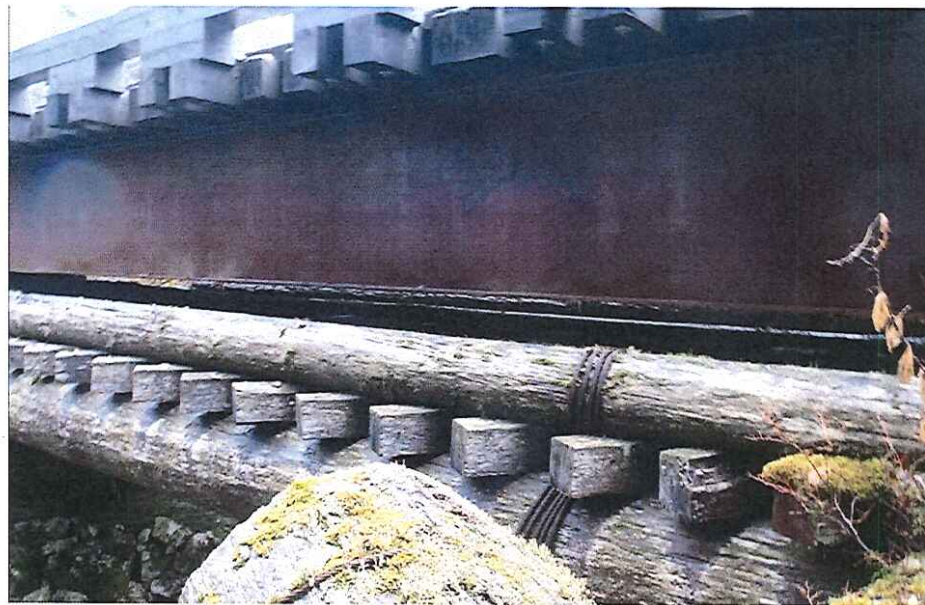
CK2270 Girders

| GENERAL INFORMATION | | | |
|---|---|---|---|
| Girders | E <u>(G)</u> F P UR | | |
| PEng Reviewer's Comment:<br><u>Steel identification indicates L75 or 68 tonnes rating,</u> | | | |

| GENERAL INFORMATION | | | |
|---|---|---|---|
| send asbuilts for confirmation. | | | |
