**Routine Condition Bridge Inspection Form**  
(for log stringer or timber stringer bridges)**GENERAL INFORMATION**

| *Site #: CK2284 | *Crossing Name: Tikwalus | *Type/Class: <input type="checkbox"/> Major Culvert<br><input type="checkbox"/> Woodbox/Log Culvert | *Project File ID# 7978 |
| *FSR Name: Islenh FSL | *Forest District: LK | *Kilometres: 4.4 km | User km: |

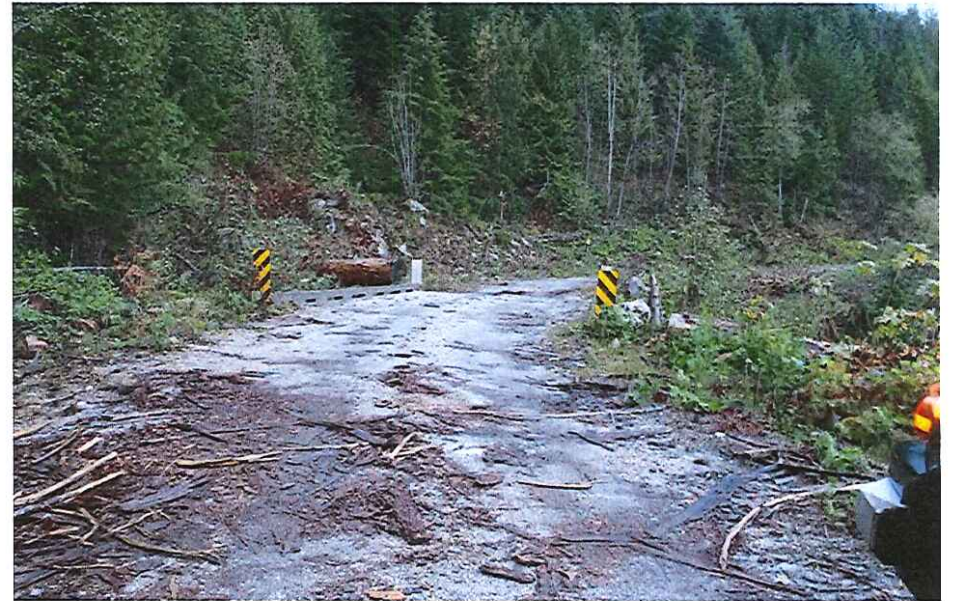
CK2284 Right to Left Approach

| Item | Present Condition (circle or fill-in) | Comments (a comment is mandatory if condition "Poor" is selected) |
|---|---|---|
| Delineator Missing Right | (0) 1 2 | Revised on right hand approach |

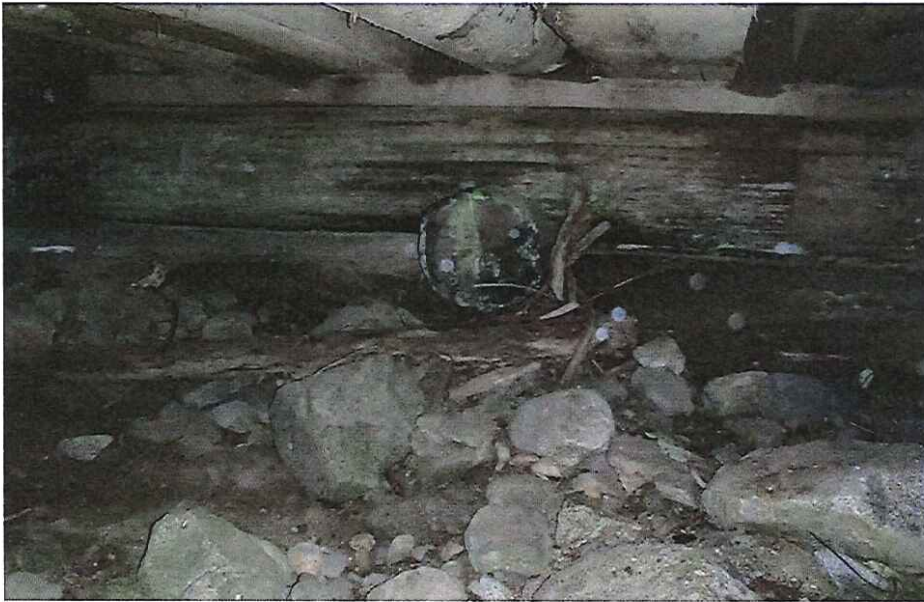
CK2284 Right Abutment

| Item | Present Condition (circle) | Comments (a comment is mandatory if condition "Poor" is selected) |
|---|---|---|
| Caps or Sills | E (G) F P N/A UR | On right side only left side has notched upper |

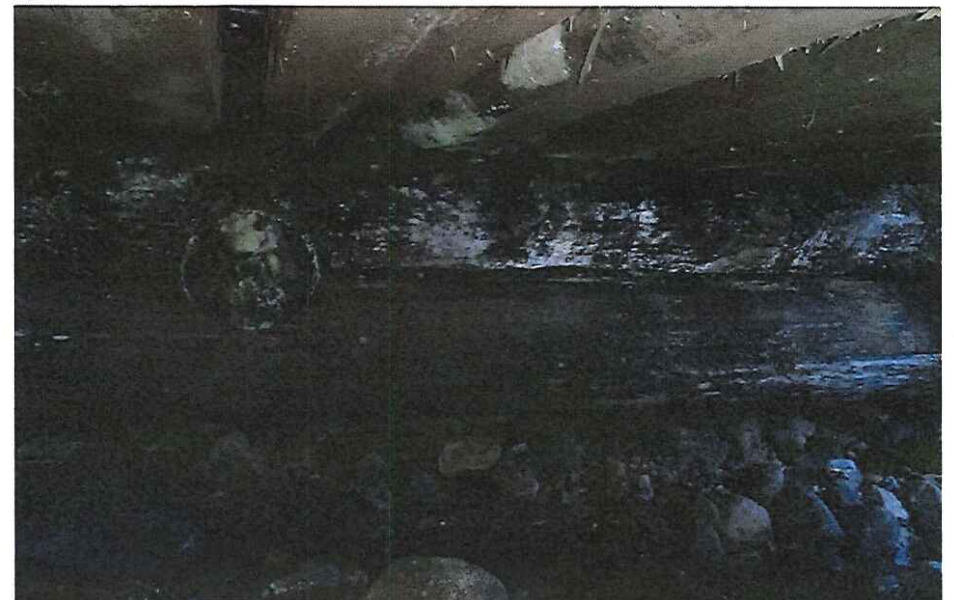
CK2284 Left Abutment

| Item | Present Condition (circle) | Comments (a comment is mandatory if condition "Poor" is selected) |
|---|---|---|
| Log/Timber Cribs | E (G) (F) P N/A UR | 2 high cedar strapped together - LEFT IS - LANDING - SEEMS STABLE |
| Fill | E G (P) P N/A UR | Frothing on left side |
| Riprap | E G F (P) N/A UR | Scoured under left crib |

Monitor woods abutment for scour and replace missing fenders.
