**Routine Condition Bridge Inspection Form**  
(except for log stringer or timber stringer bridges)**GENERAL INFORMATION**

| *Site #: <u>CK2296</u> | *Crossing Name: <u>Uztilus Crk</u> | *Type/Class: <input type="checkbox"/> Temporary bridge<br><input checked="" type="checkbox"/> Permanent bridge | *Project File ID# <u>7972</u> |
| *FSR Name: <u>CIZTLIUS</u> | *Forest District: <u>ChWK</u> | *Kilometres: | User km: <u>7.5</u> |

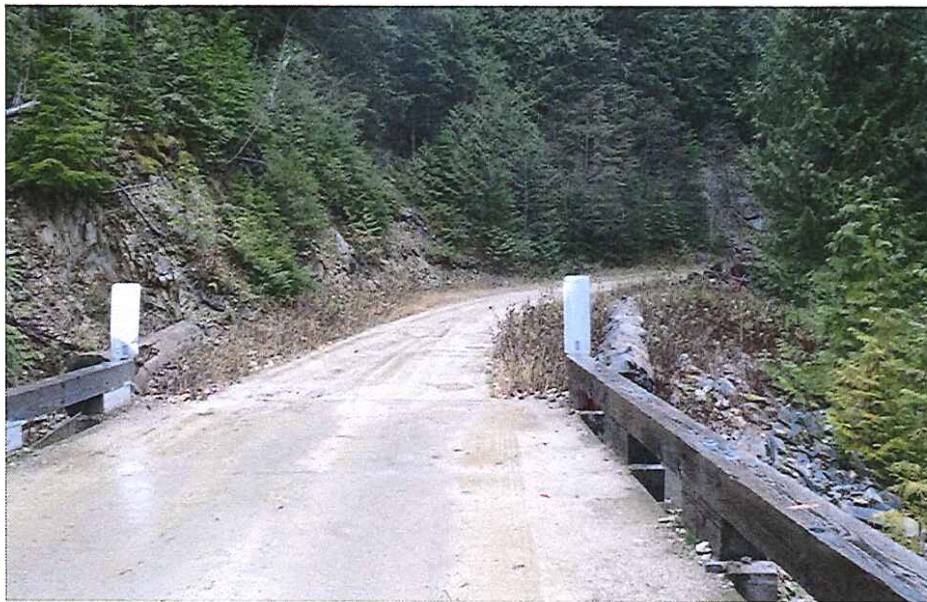
CK2296 Right Approach

| Item | Present Condition<br>(circle or fill-in) | Comments<br>(a comment is mandatory if condition "Poor" is selected) |
|---|---|---|
| Alignment | E G <b>(F)</b> P UR | RIGHT CORNERS |

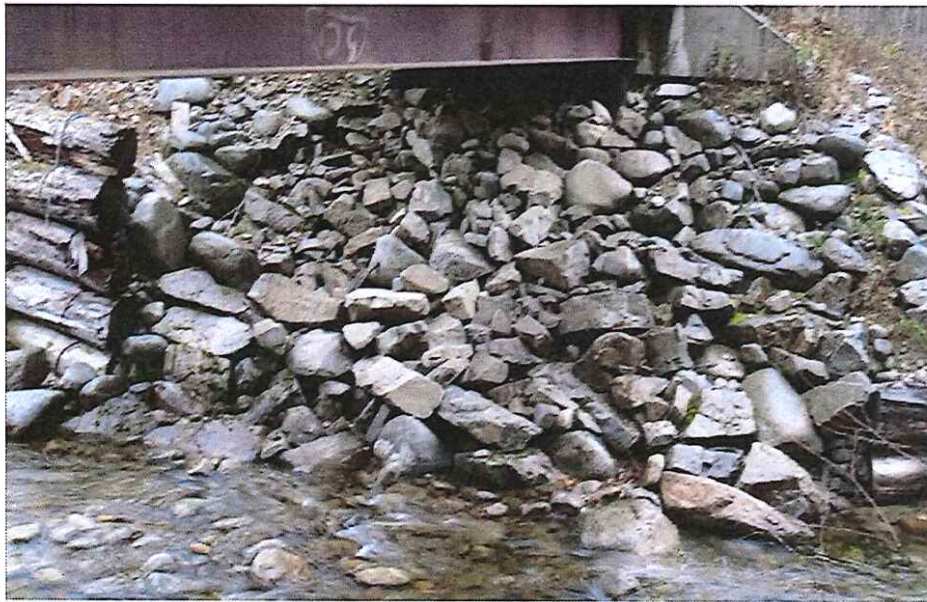
CK2296 Left Abutment

| Item | Present Condition<br>(circle) | Comments<br>(a comment is mandatory if condition "Poor" is selected) |
|---|---|---|
| Log/Timber Cribs | E G <b>(F)</b> P N/A UR | U.S. LEFT, NOT STRUCTURAL - DEBRIS DELETED ONLY |

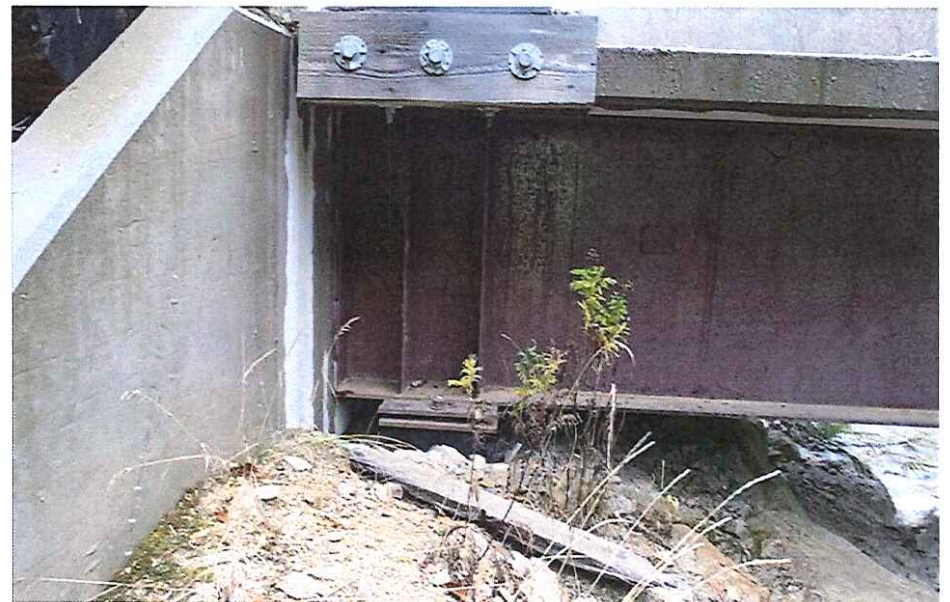
CK2296 Right Abutment bearing

| Item | Present Condition<br>(circle) | Comments<br>(a comment is mandatory if condition "Poor" is selected) |
|---|---|---|
| Concrete (cast in place; lock blocks, precast) | E G F P N/A UR | BARRIED, CHIP RIGHT, LIKELY PADS LEFT ON BRIDGE |
