**Routine Condition Bridge Inspection Form**  
(except for log stringer or timber stringer bridges)

| GENERAL INFORMATION | | | |
|---|---|---|---|
| *Site #: <u>CR 2308</u> | *Crossing Name: <u>Unknown</u> | *Type/Class: <input checked="" type="checkbox"/> Temporary bridge<br><input type="checkbox"/> Permanent bridge | (enter either long/lat or UTM below - not both)<br>*Project File ID# <u>7972</u><br>*Br. <u>02</u> |
| *FSR Name: <u>VERLUS E ANDERSON</u> | *Forest District: <u>CR</u> | *Kilometres: | User km: <u>29.4</u> |

| GENERAL INFORMATION | | | |
|---|---|---|---|
| *Date of Inspection (yyyy/mm/dd)<br><u>2011/11/11</u> | *Inspection Company Name<br><u>ONSITE ENG LTD</u> | *Inspector's Name (print)<br><u>Gregory ARAKI</u> | Inspector's Signature<br> |

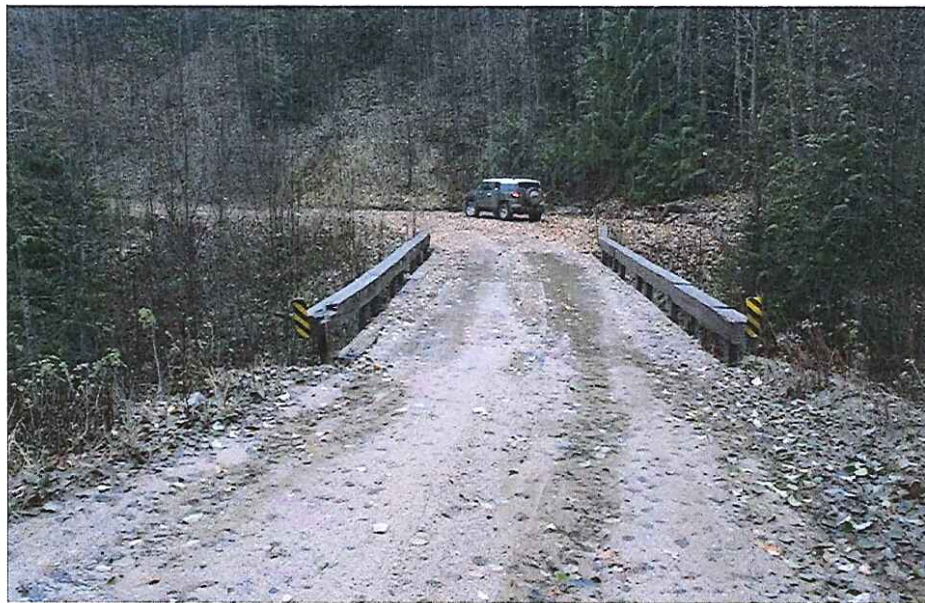
CK2308 Left to Right Approach

| GENERAL INFORMATION | | | |
|---|---|---|---|
| Alignment | E G <u>(F)</u> P UR | <u>TIGHT CURVE</u> | |

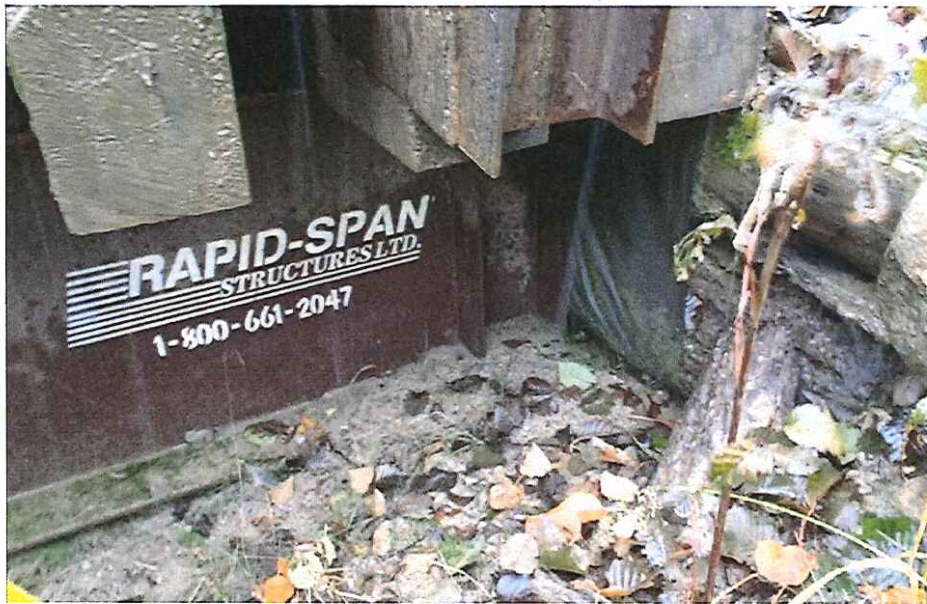
CK2308 Left Abutment Bearing

| GENERAL INFORMATION | | | |
|---|---|---|---|
| Bearings | E G F <u>(P)</u> N/A UR | <u>UNDERMINED ON L.S., RIGHT CORNER</u> | |

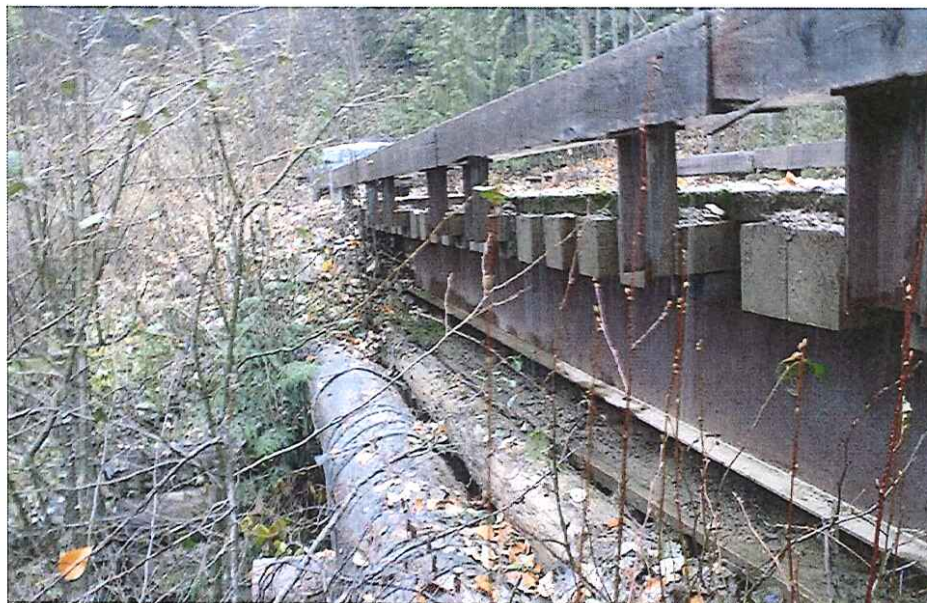
CK2308 Girders

| GENERAL INFORMATION | | | |
|---|---|---|---|
| Girders | E (G) F P UR | CANNOT SEE UNDER - RIGHT ABUT | |

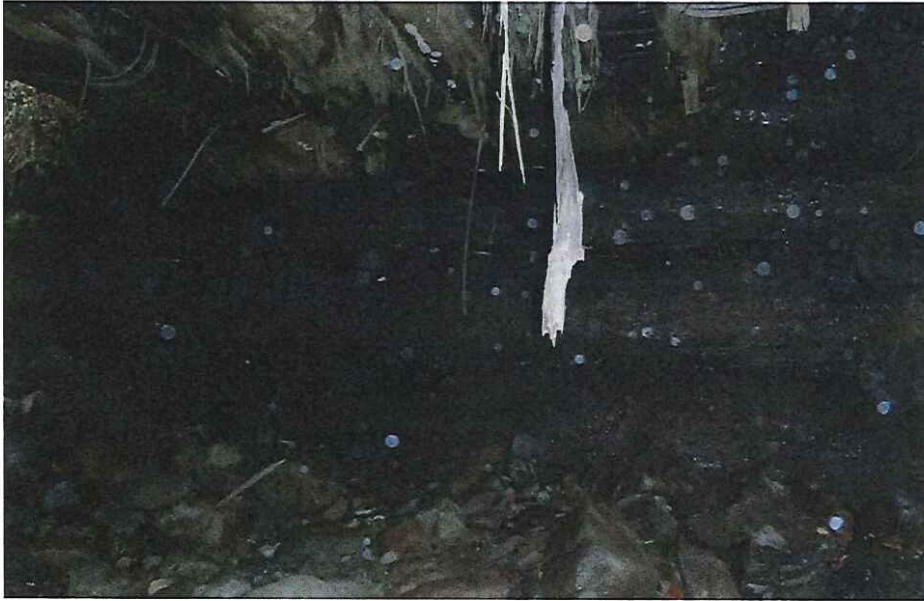
CK2308 Left Abutment Crib

| GENERAL INFORMATION | | | |
|---|---|---|---|
| Log/Timber Cribs | E G F <u>(P)</u> N/A UR | <u>UNDERMINED &amp; OLD</u> | |

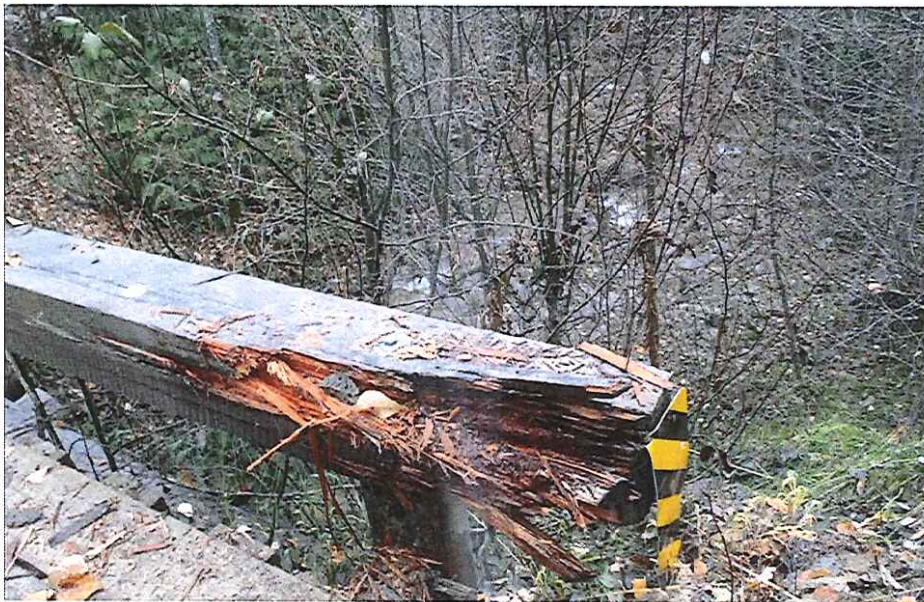
CK2308 Guard Rails

| GENERAL INFORMATION | | | |
|---|---|---|---|
| Curb Rail/Blocks/Posts | E G <u>(F)</u> P UR | <u>SOME DAMAGE - STEEL RISERS</u> | |

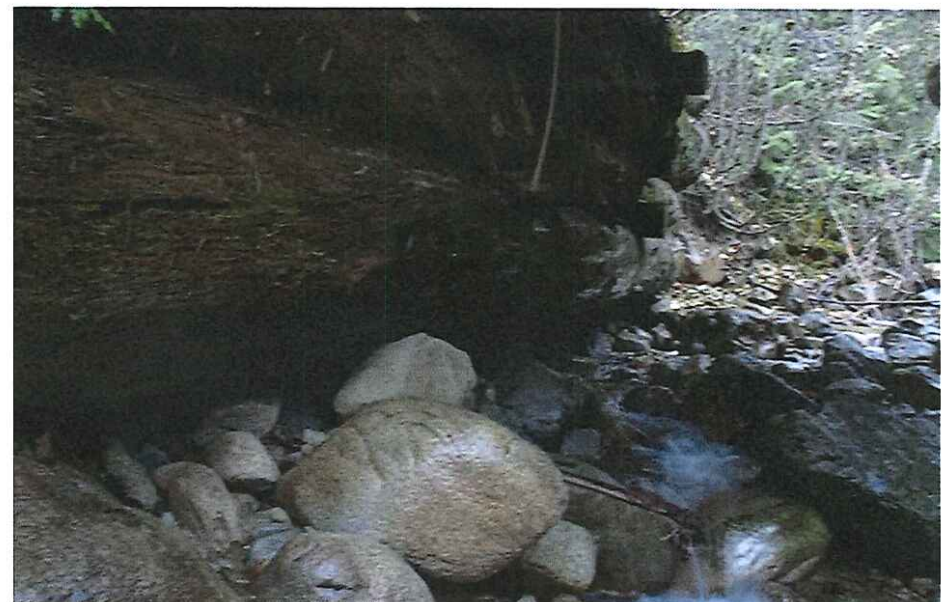
CK2308 Right Abutment Crib

| GENERAL INFORMATION | | | |
|---|---|---|---|
| P Eng Reviewer's Comments<br>Due to undermined crib and failing fill under new sill, present load rating of 5 tonnes to continue. | | | |

| GENERAL INFORMATION | | | |
|---|---|---|---|
| 1 | H M L | | FILL ON RIGHT - SUGGEST REMOVING & INSTALLING CN NEW ABUTMENTS |

Agree with inspector, suggest remove and replace on new new abutments.

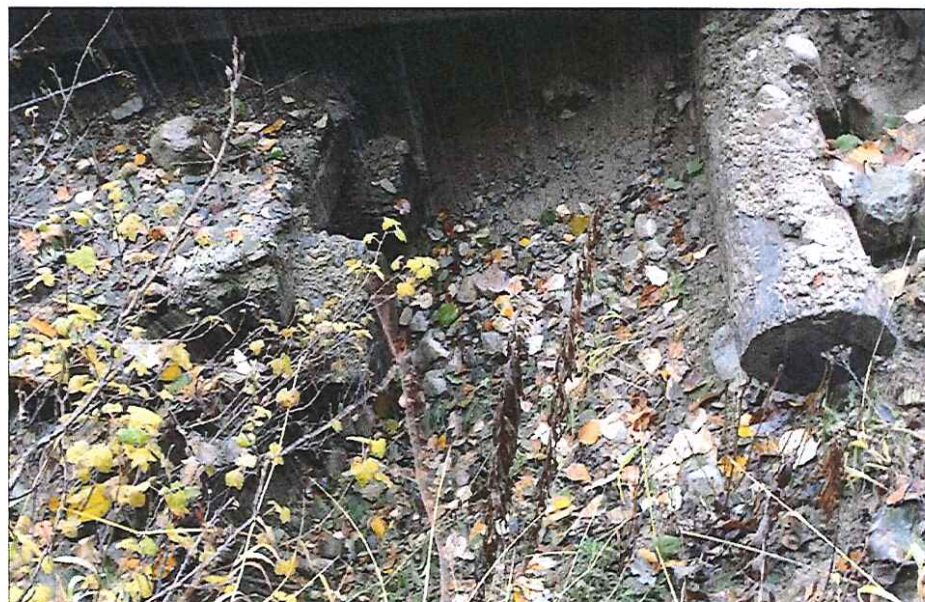
CK2308 Right upstream fill

| GENERAL INFORMATION | | | |
|---|---|---|---|
| Fill | E G <u>(F)</u> P N/A UR | <u>FAILED IN RIGHT U.S. CORNER</u> | |

| GENERAL INFORMATION | | | |
|---|---|---|---|
| 1 | FILL ON RIGHT | | |
