**Routine Condition Bridge Inspection Form**  
(for log stringer or timber stringer bridges)

| GENERAL INFORMATION | | | | (enter either long/lat or UTM below - not both) | | |
|---|---|---|---|---|--|--|
| *Site #: <u>CK-2315</u> | *Crossing Name: <u>Berkkey Crk</u> | *Type/Class: <input type="checkbox"/> Major Culvert<br><input checked="" type="checkbox"/> Woodbox/Log Culvert | *Project File ID# <u>B113</u> | | | |
| *FSR Name: <u>Windy - Berkkey Creek</u> | *Forest District: <u>CK</u> | *Kilometres: <u>4.2km</u> | User ID: _____ | | | |

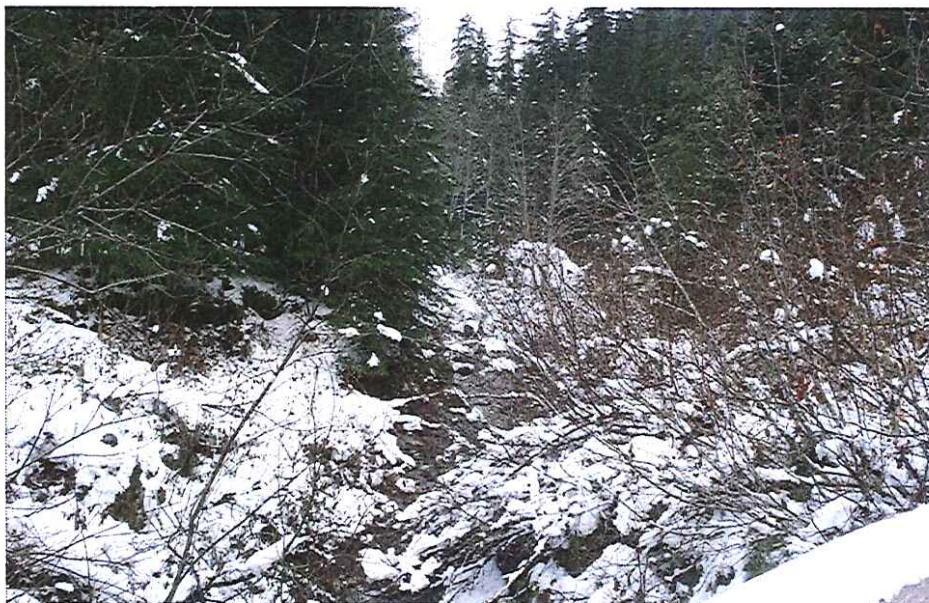
CK2315 Upstream

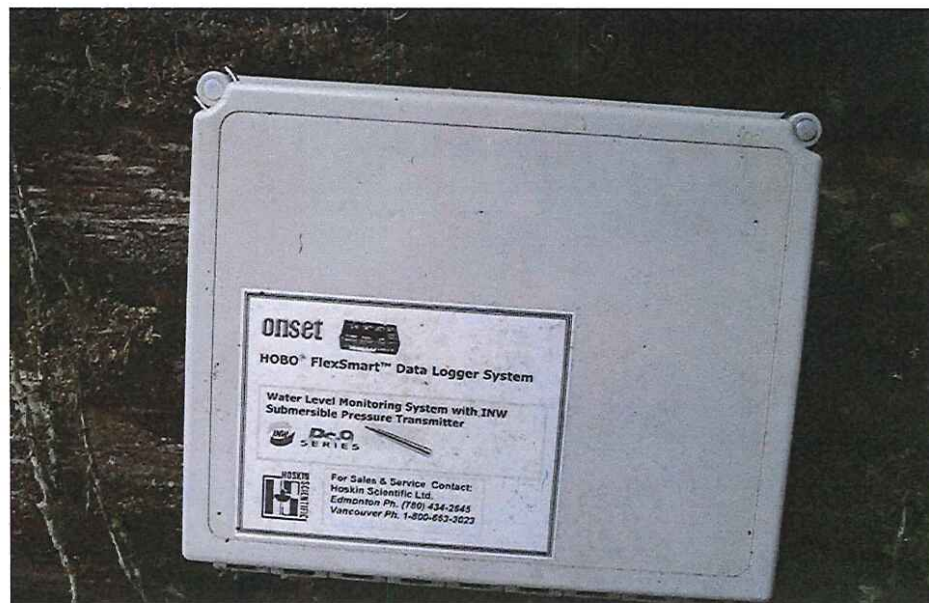
CK2315 data logger

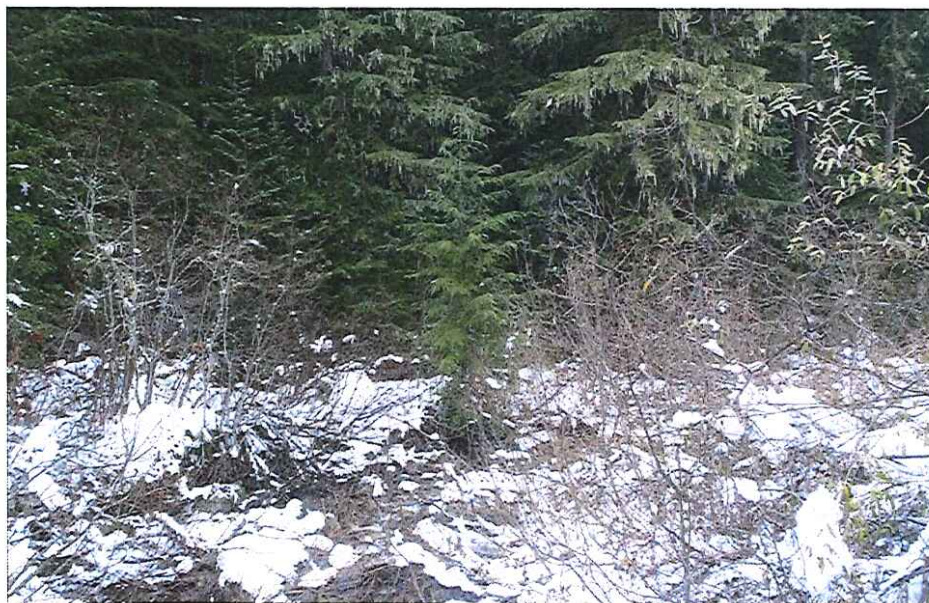
CK2315 Downstream

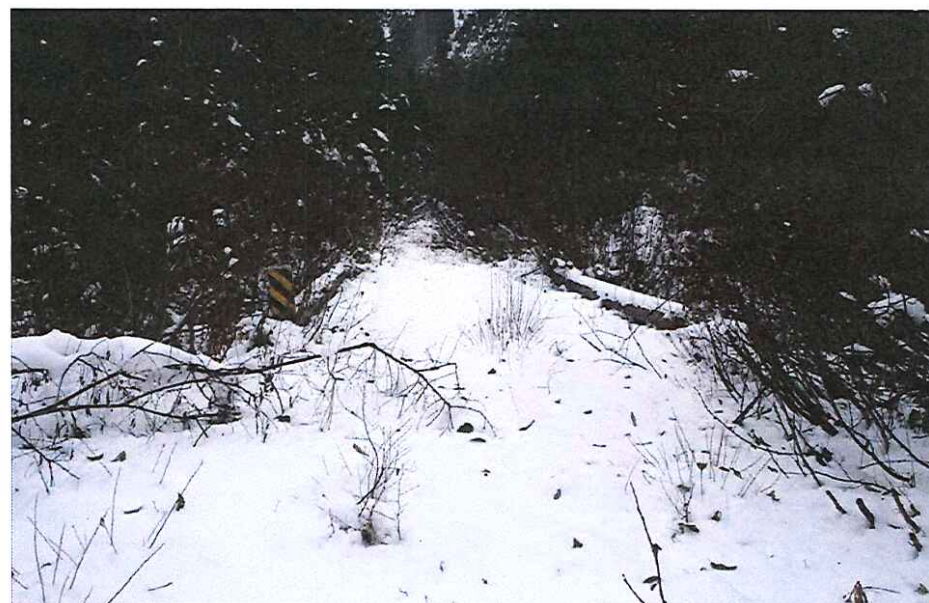
CK2315 Right to Left Approach

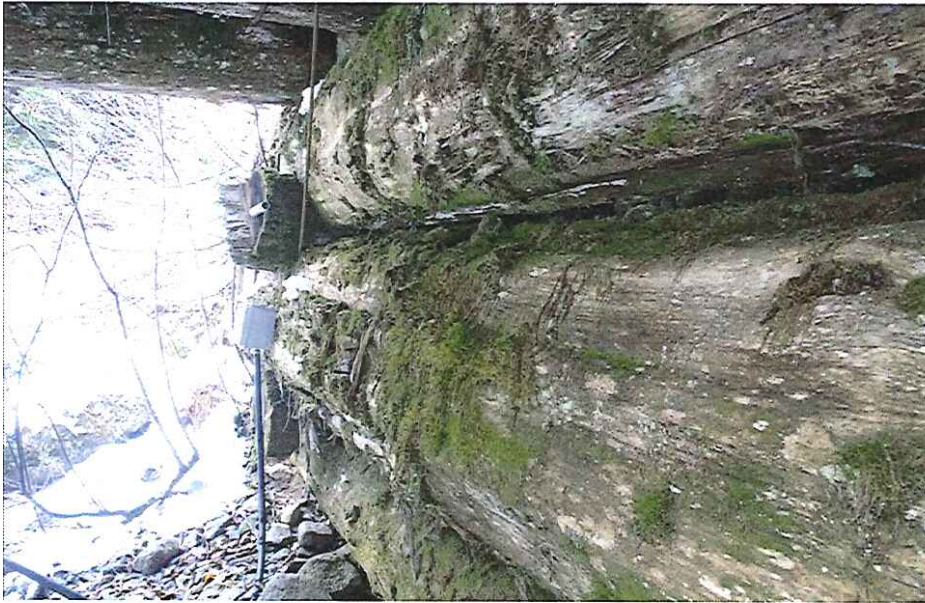
CK2315 Left Abutment

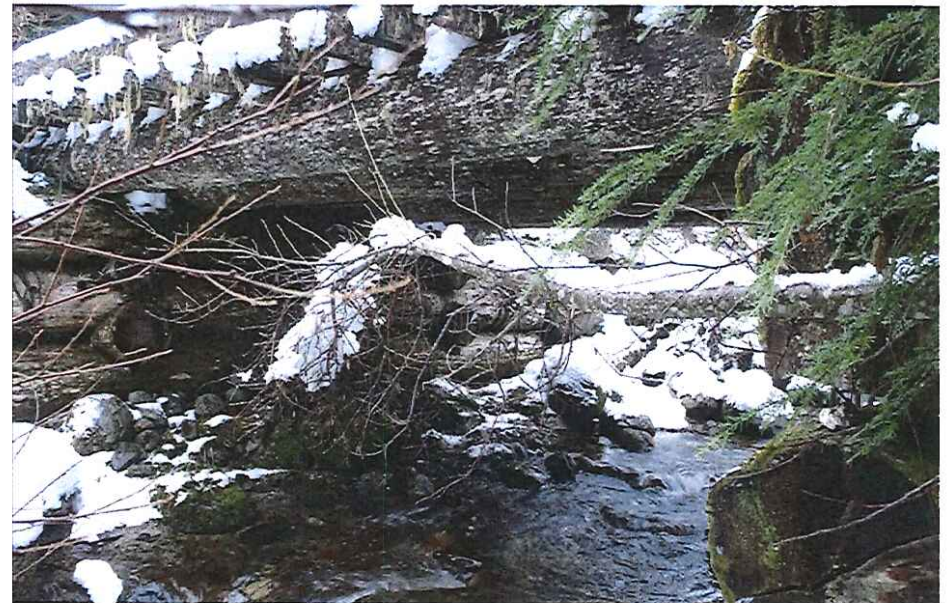
CK2315 From Downstream

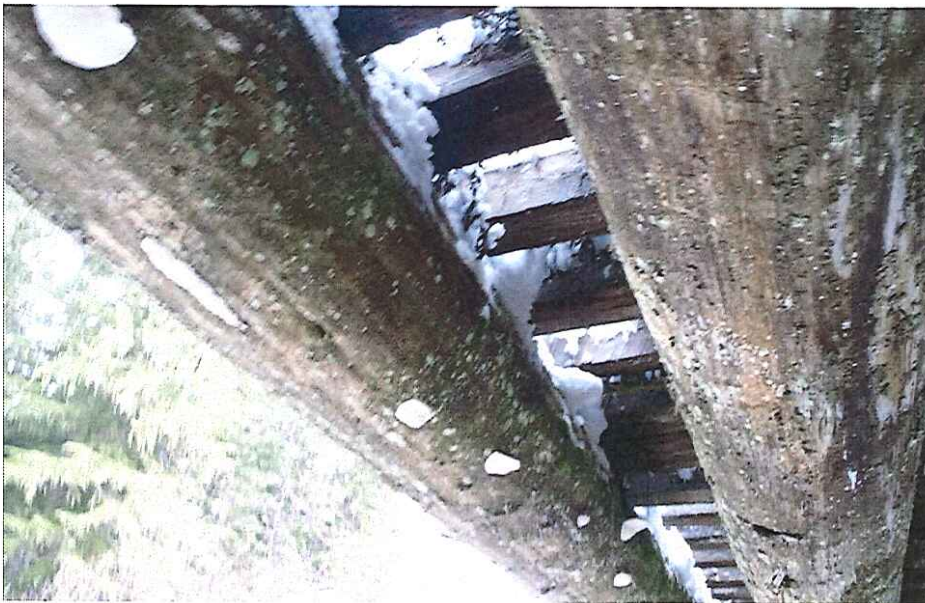
CK2315 stringers

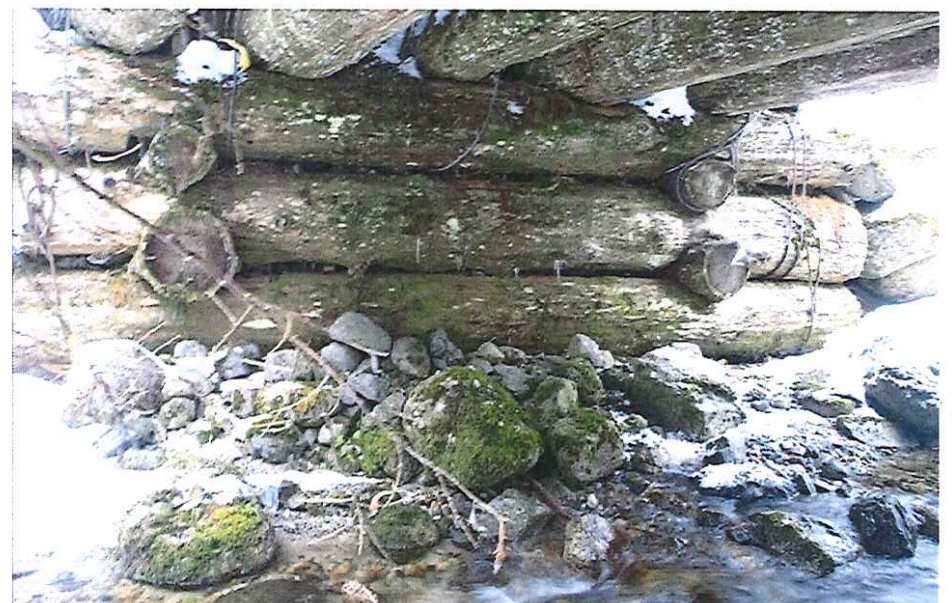
CK2315 Right Abutment
