**Routine Condition Bridge Inspection Form**  
(except for log stringer or timber stringer bridges)**GENERAL INFORMATION**

| *Site #: <u>CK-2319</u> | *Crossing Name: | *Type/Class: <input checked="" type="checkbox"/> Temporary bridge<br><input type="checkbox"/> Permanent bridge | *Project File ID# <u>7550</u> |
| *FSR Name: <u>Garnet Creek</u> | *Forest District: <u>CK</u> | *Kilometres: <u>1</u> | User km: <u>10.1</u> |

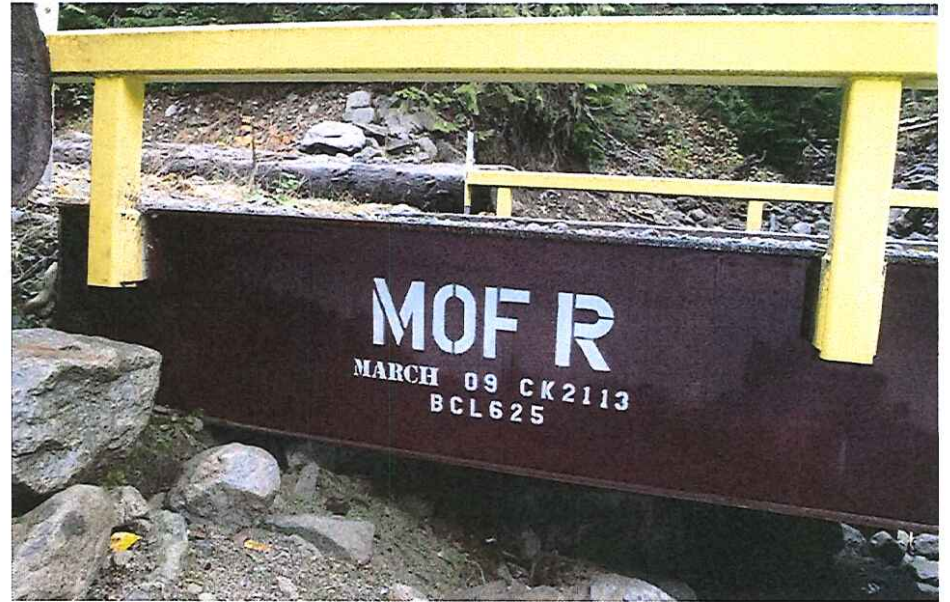
CK2319 Bridge ID

| Item | Present Condition<br>(circle or fill-in) | Comments<br>(a comment is mandatory if condition "Poor" is selected) |
|---|---|---|
| Posted Load Rating | (tonnes) or <b>(None)</b> | <u>LOGS</u><br><u>(BCL 625 MARKED ON GIRDER)</u> |

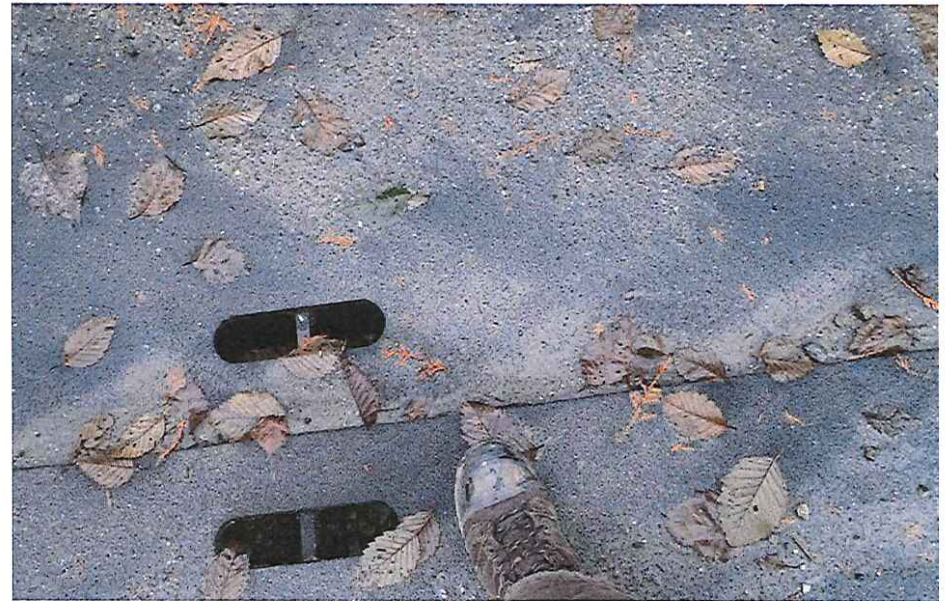
CK2319 Deck

| Item | Present Condition<br>(circle) | Comments<br>(a comment is mandatory if condition "Poor" is selected) |
|---|---|---|
| Steel Deck Plate | <b>(E)</b> G F P N/A UR | <u>All steel portable</u> |
| Curb Rail/Blocks/Posts | <b>(E)</b> G F P UR | <u>STEEL (PAINTED)</u> |
| Overall Deck Condition | <b>(E)</b> G F P UR | <u>NEW BRIDGE</u> |

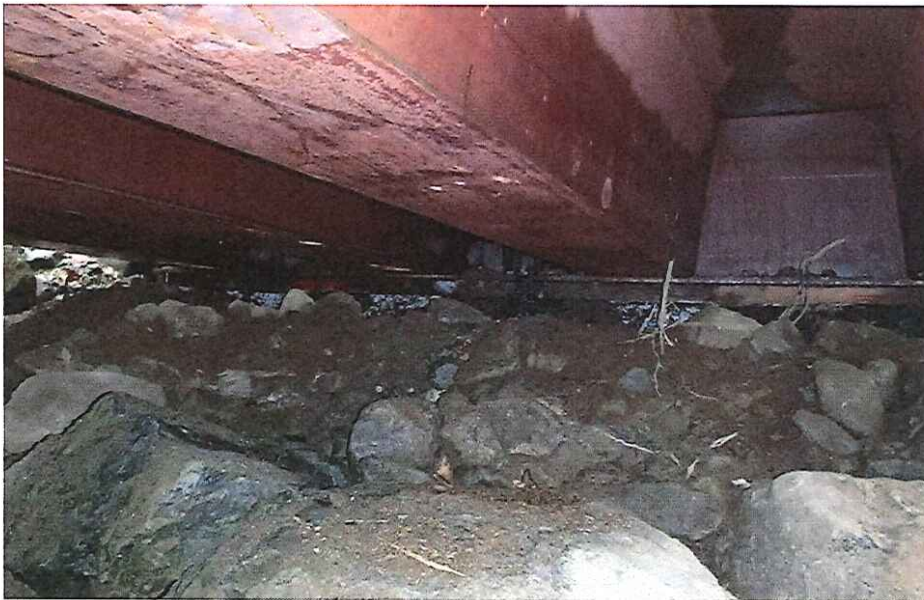
CK2319 Left Abutment

| Item | Present Condition<br>(circle) | Comments<br>(a comment is mandatory if condition "Poor" is selected) |
|---|---|---|
| Log/Timber Crib | E <b>(G)</b> F P N/A UR | <u>FD SILL LOGS ON ROCK FILL</u> |
| Bearings | E <b>(G)</b> F P N/A UR | <u>LOG CUT FLAT</u> |
