**Routine Condition Bridge Inspection Form**  
(for log stringer or timber stringer bridges)

| GENERAL INFORMATION | | | | (enter either long/lat or UTM below - not both) | | |
|---|---|---|---|---|--|--|
| *Site #: <u>CK-2331</u> | *Crossing Name:<br><u>Unknown</u> | *Type/Class: <input type="checkbox"/> Major Culvert<br><input checked="" type="checkbox"/> Woodbox/Log Culvert | *Project File ID# <u>8013</u> | | | |
| *FSR Name:<br><u>Slave River</u> | *Forest District:<br><u>CK</u> | *Kilometres: | User km: <u>4.4</u> | | | |

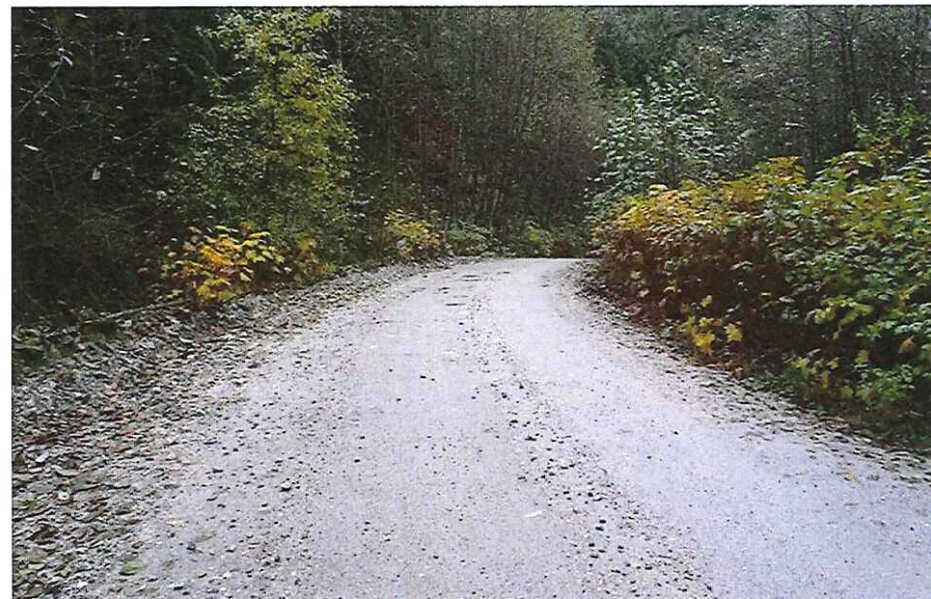
CK2331 Right to Left Approach

| GENERAL INFORMATION | | | | (enter either long/lat or UTM below - not both) | | |
|---|---|---|---|---|--|--|
| Alignment | E G <u>(F)</u> P UR | <u>right curve around bridge</u> | | | | |

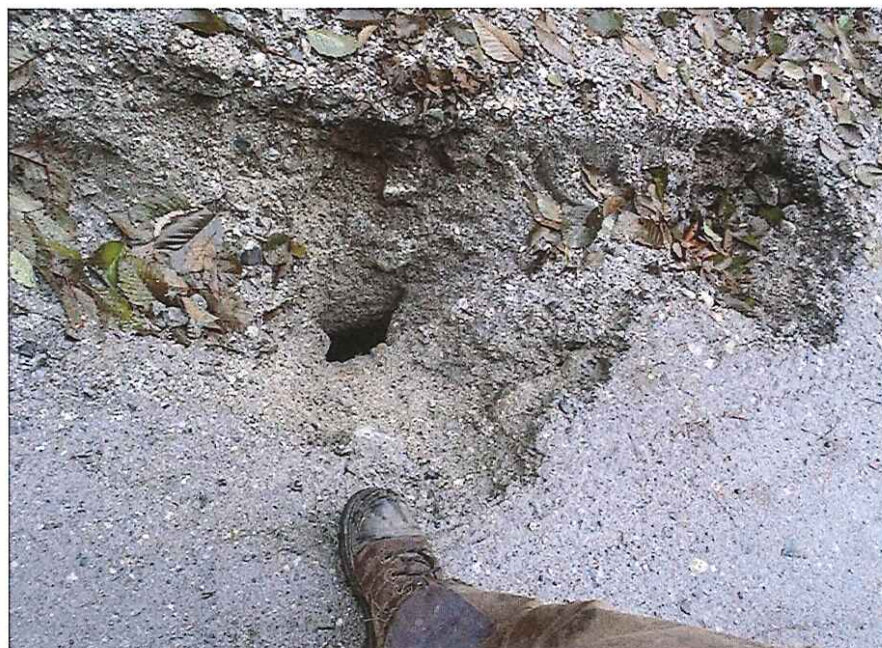
| GENERAL INFORMATION | | | | (enter either long/lat or UTM below - not both) | | |
|---|---|---|---|---|--|--|
| Gravel Surface | E G F <u>(P)</u> N/A UR | <u>Sandy fill w/ no dentile, slipping through</u> | | | | |

CK2331 Hole in deck fill

| GENERAL INFORMATION | | | | | | | |
|---|---|---|---|---|---|---|---|
| P Eng Reviewer's Comments<br>Remove running surface gravel fill, lay geotextile over stringers and replace fill, ensure a minimum of 600mm depth. | | | | | | | |

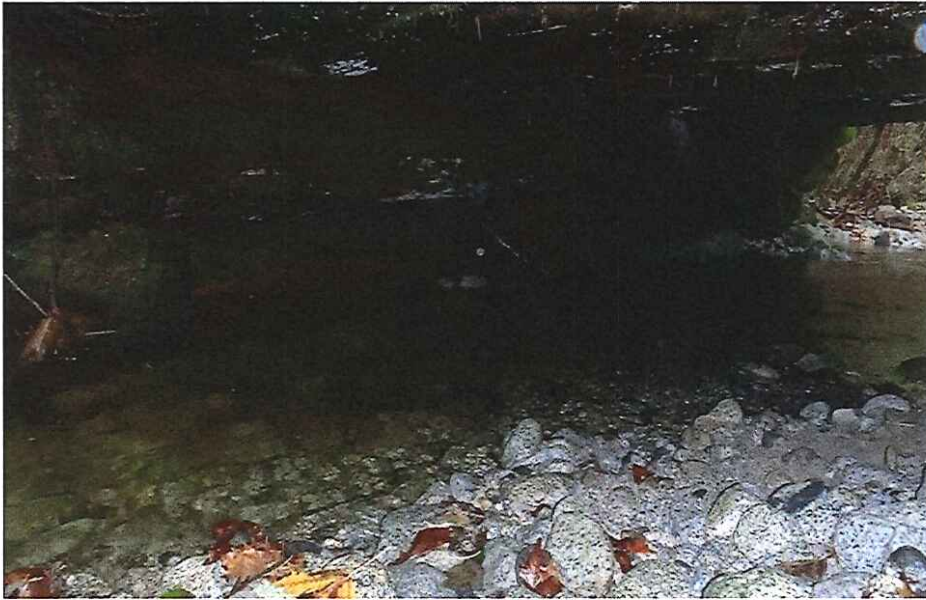
CK2331 Left Abutment

| GENERAL INFORMATION | | | | (enter either long/lat or UTM below - not both) | | |
|---|---|---|---|---|--|--|
| Log/Timber Cribbs | E G <u>(F)</u> P N/A UR | <u>Top cribbs loose ahead of bottom face low</u> | | | | |
| Fill | E G <u>(F)</u> <u>(P)</u> N/A UR | <u>All fill failing</u> | | | | |
| Bearings | E G <u>(P)</u> P N/A UR | <u>Water erosion</u> | | | | |
