## Routine Condition Culvert Inspection Form

| GENERAL INFORMATION | | | | (enter either long/lat or UTM below - not both) | | | |
|---|---|---|---|---|--|--|--|
| *Site #: <u>CK-2333</u> | *Crossing Name: <u>CK</u> | *Type/Class: <input type="checkbox"/> Major Culvert<br><input checked="" type="checkbox"/> Woodbox/Log Culvert | *Project File ID# <u>8013</u> | | | | |
| *FSR Name: <u>Stave River</u> | *Forest District: <u>CK</u> | *Kilometres: <u>11.1</u> | User km: | | | | |

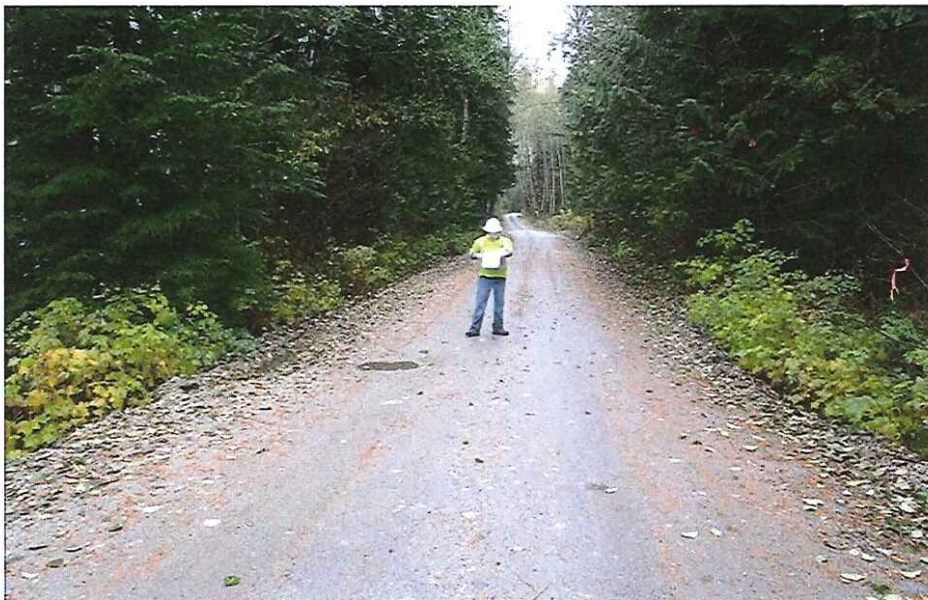
CK2338 Left to Right Approach

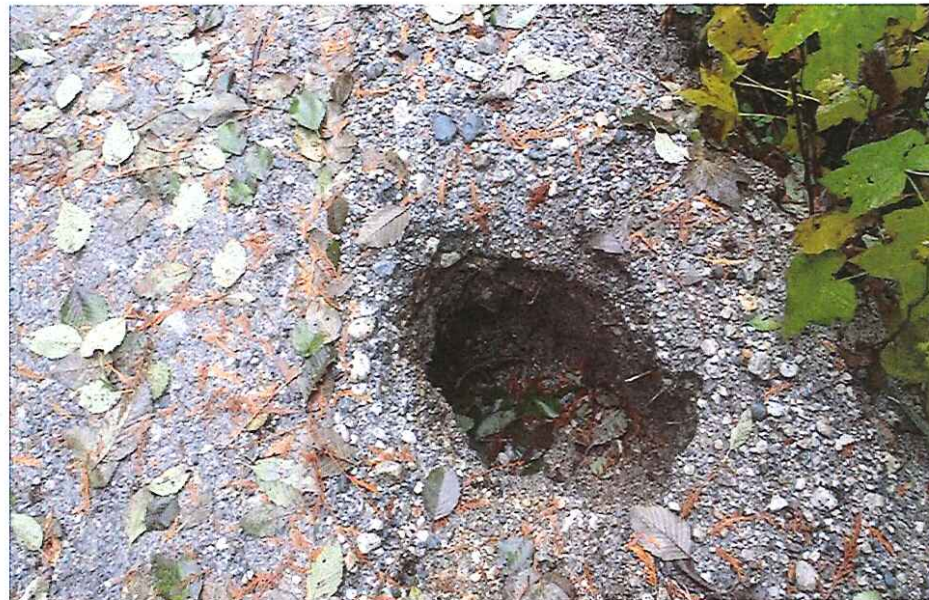
| GENERAL INFORMATION | | | | (enter either long/lat or UTM below - not both) | | | |
|---|---|---|---|---|--|--|--|
| Road Surface | E G <u>(F)</u> P UR | <u>Hole in d/s fill</u> | | | | | |

CK2338 Deck hole

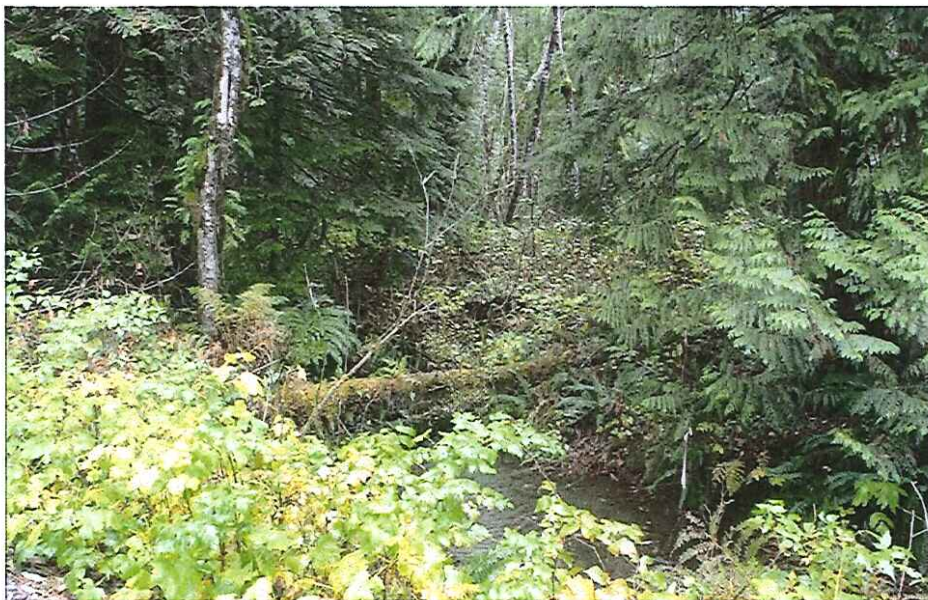
CK2338 Upstream

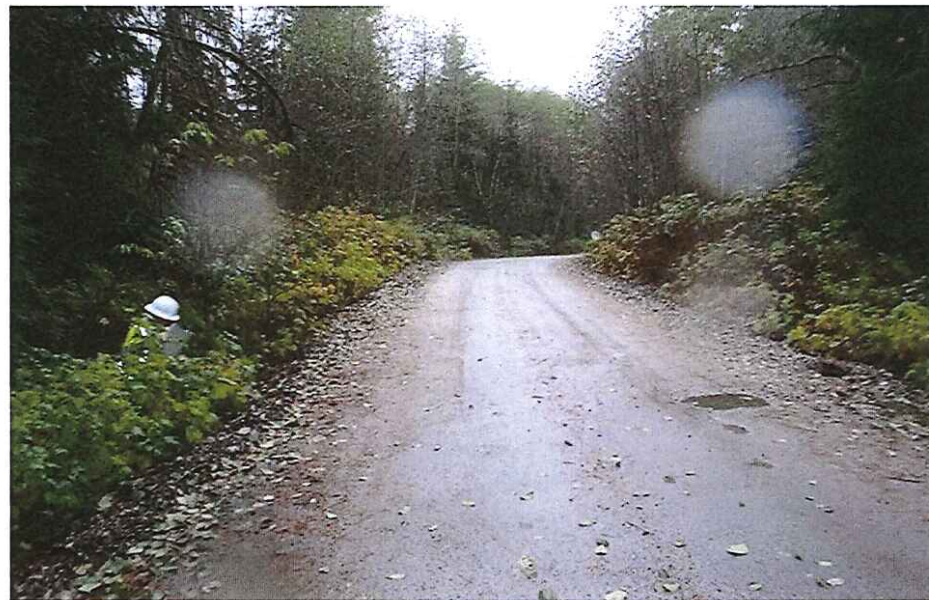
CK2338 Right to Left Approach

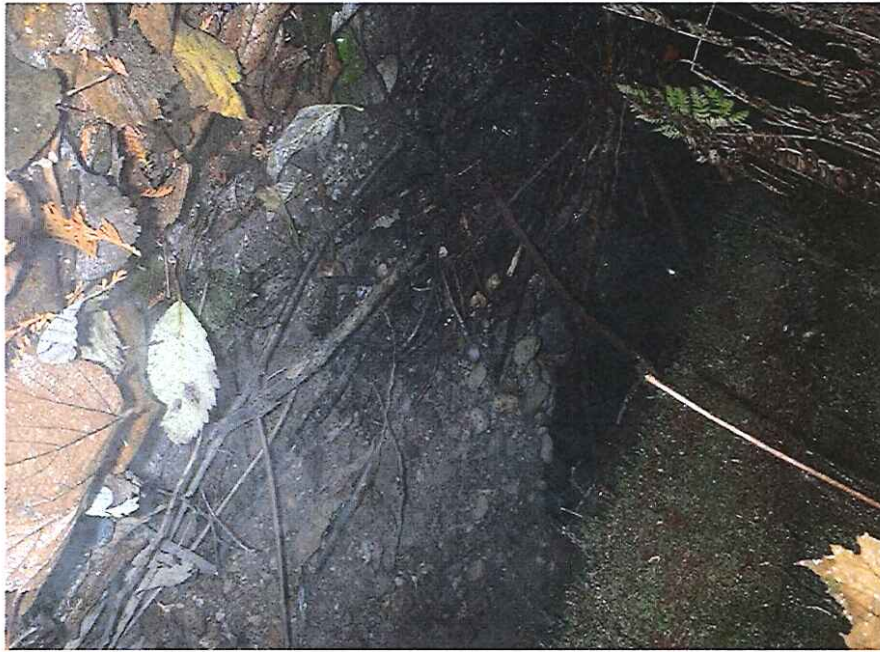
| GENERAL INFORMATION | | | | (enter either long/lat or UTM below - not both) | | | |
|---|---|---|---|---|--|--|--|
| Fill | E G F P <u>(UR)</u> | <u>Failure in d/s left corner 1.2m corner</u> | | | | | |
| Roof | E G F P UR | <u>FILL FAILING THROUGH</u> | | | | | |

CK2338 Failed fill inside Outlet

| Repair Item # | *Priority (circle) | *Estimate (\$) | *Repair Description |
|---|---|---|---|
| 1 | H M L | | REPLACE |

| Inspector's Comments<br>FAILED - REPLACE (LIKELY NOT SAFETY, BUT FOR WASHOUT) | | | |

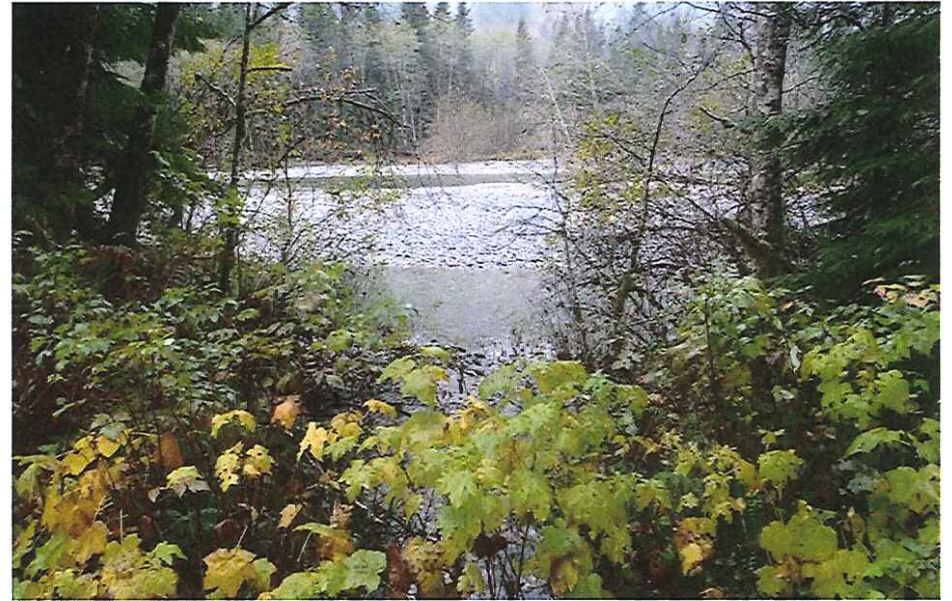
CK2338 Downstream

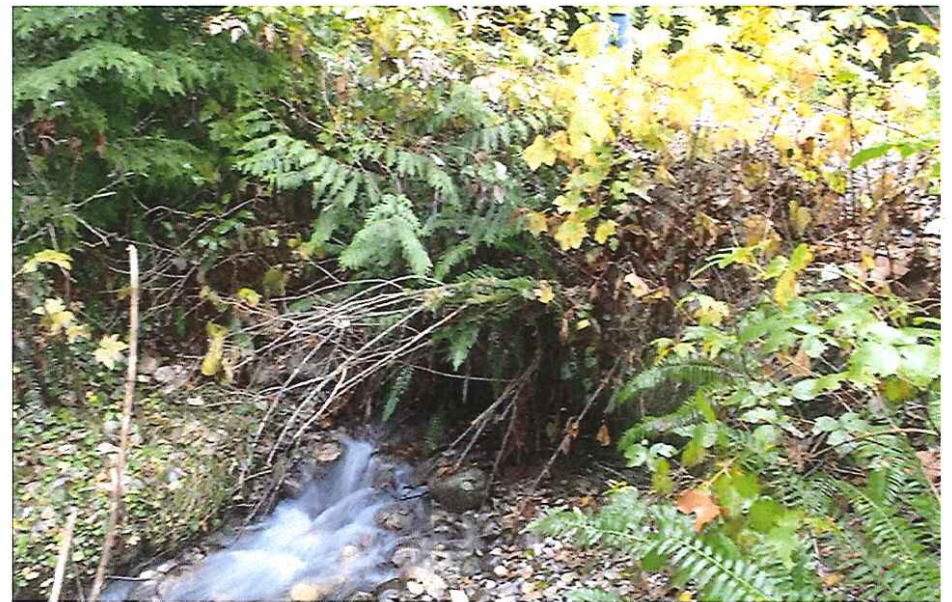
| GENERAL INFORMATION | | | | (enter either long/lat or UTM below - not both) | | | |
|---|---|---|---|---|--|--|--|
| Outlet | E G F <u>(P)</u> UR | <u>Collapsed &amp; filled in</u> | | | | | |

CK2338 Outlet
