## Routine Condition Culvert Inspection Form

| *Site #: CK-2392 | *Crossing Name: Side Creek | *Type/Class: <input checked="" type="checkbox"/> Major Culvert<br><input type="checkbox"/> Woodbox/Log Culvert | (enter either long/lat or UTM below - not both) | |
| *FSR Name: Stave River | | | User km: | |

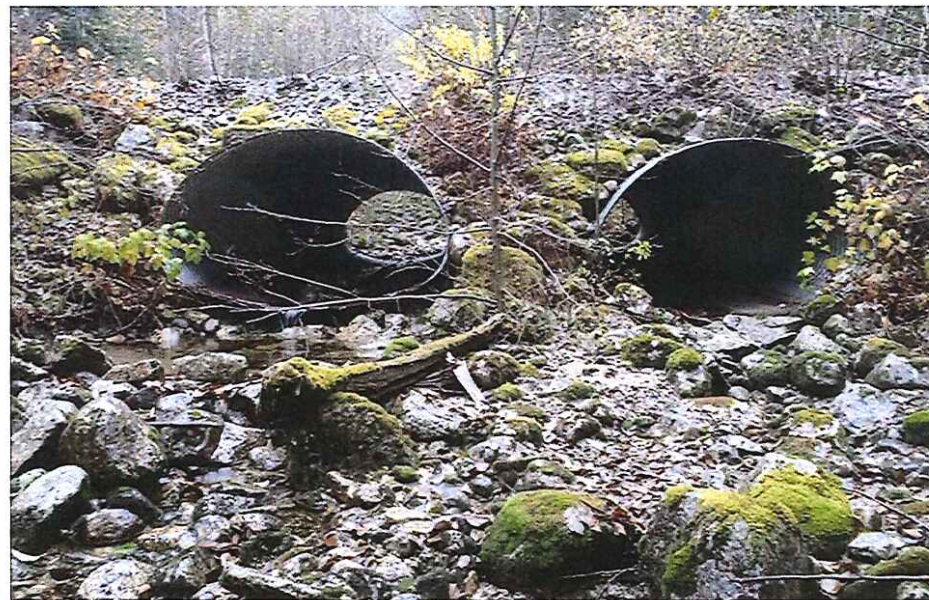
CK2342 Outlet

| Item | Present Condition (circle) | Comments (a comment is mandatory if condition "Poor" is selected) |
|---|---|---|
| Outlet | E <input checked="" type="radio"/> F P UR | Right has planter pool |
| Riprap | E G <input checked="" type="radio"/> F P N/A UR | spread out at outlet |
