**Routine Condition Bridge Inspection Form**  
(for log stringer or timber stringer bridges)**GENERAL INFORMATION**

| *Site #: <u>CK-2346</u> | *Crossing Name:<br><u>Unknown</u> | *Type/Class: <input type="checkbox"/> Major Culvert<br><input checked="" type="checkbox"/> Woodbox/Log Culvert | *Project File ID# <u>8391</u> |
| *FSR Name:<br><u>Pitt - Boise</u> | *Forest District:<br><u>CK</u> | *Kilometres: | User km: <u>0.9</u> |

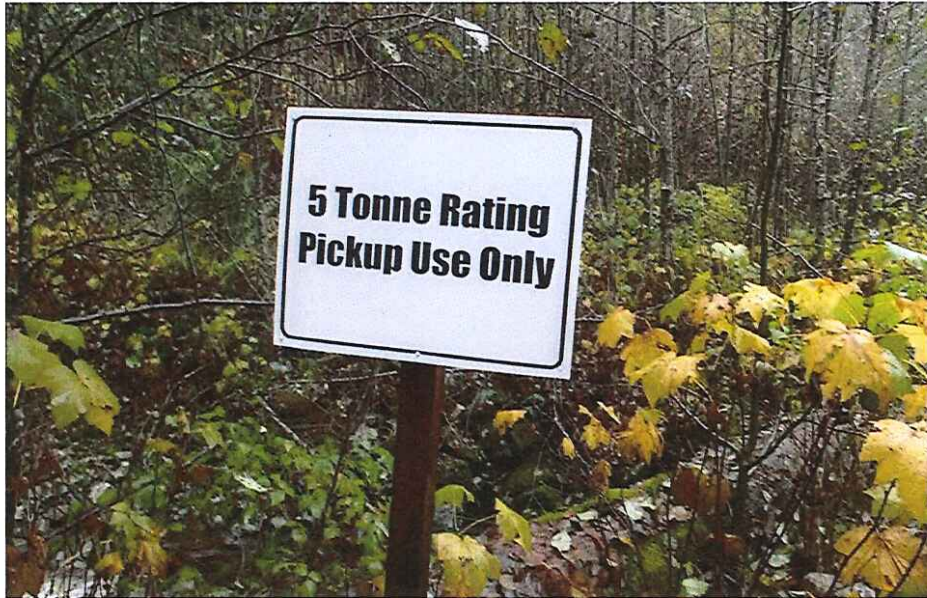
CK2346 Load Rating Sign

| Item | Present Condition<br>(circle or fill-in) | Comments<br>(a comment is mandatory if condition 'Poor' is selected) |
|---|---|---|
| Posted Load Rating | <u>5</u> (tonnes) or None | |

Present load rating of 5 tonnes to continue.

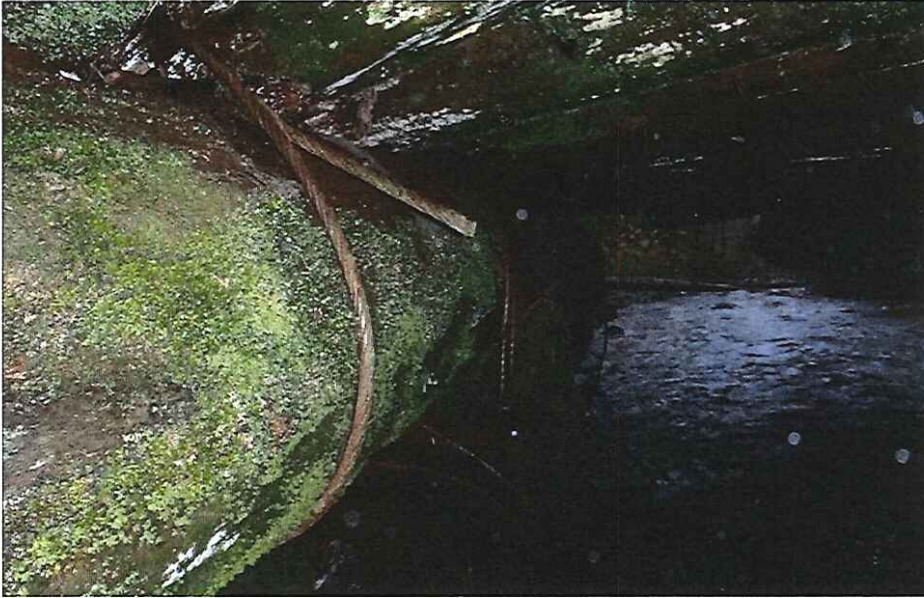
CK2346 Left Abutment

| Item | Present Condition<br>(circle) | Comments<br>(a comment is mandatory if condition 'Poor' is selected) |
|---|---|---|
| Log/Timber Cribbs | E G (F) P N/A UR | |
| Tie-backs | E G (P) P N/A UR | |
| Hardware | E G (P) P N/A UR | |
| Riprap | E G F (P) N/A UR | |

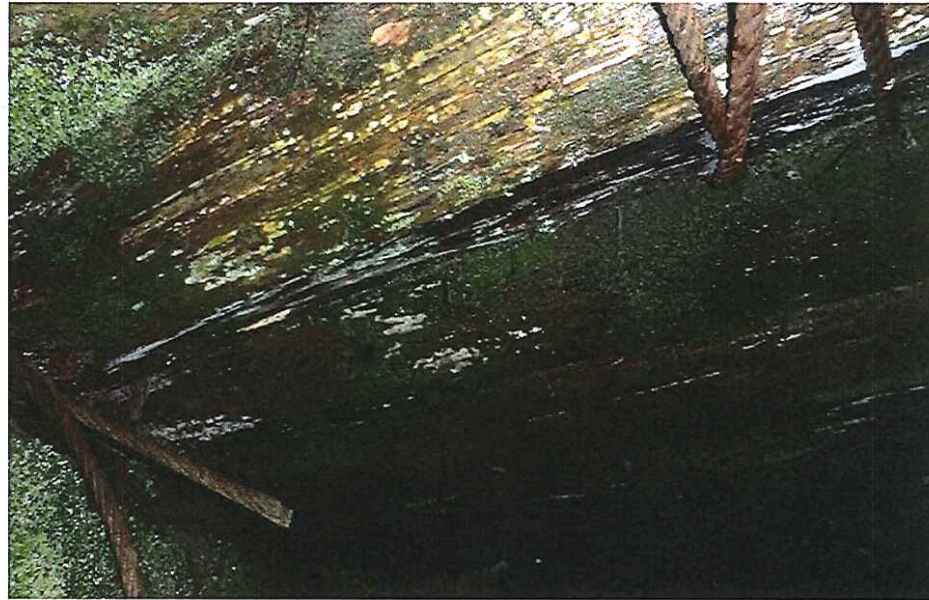
CK2346 Stringers

| Item | | Present Condition (circle) | | | | | Comments<br>(a comment is mandatory if condition "Poor" is selected) | | |
|---|---|---|---|---|---|---|---|---|--|
| 5 | | Y N | | | | | | See 2010 inspection | |
| 6 | | Y N | | | | | | no change | |

| Repair Item # | *Priority (circle) | *Estimate (\$) | *Repair Description |
|---|---|---|---|
| 2 | <u>H</u> M L | | REPLACE |

Recommend bridge replacement.
