**Routine Condition Bridge Inspection Form**  
(except for log stringer or timber stringer bridges)

| GENERAL INFORMATION | | | | (enter either longlat or UTM below – not both) | | | |
|---|---|---|---|---|--|--|--|
| *Site # <u>2360</u> | *Crossing Name: | *Type/Class: <input type="checkbox"/> Temporary bridge<br><input checked="" type="checkbox"/> Permanent bridge | *Project File ID# <u>6996</u> | | | | |
| *FSR Name: <u>NATHALATCH KOOLOPI</u> | *Forest District: <u>CK</u> | *Kilometres: | User km: | | | | |

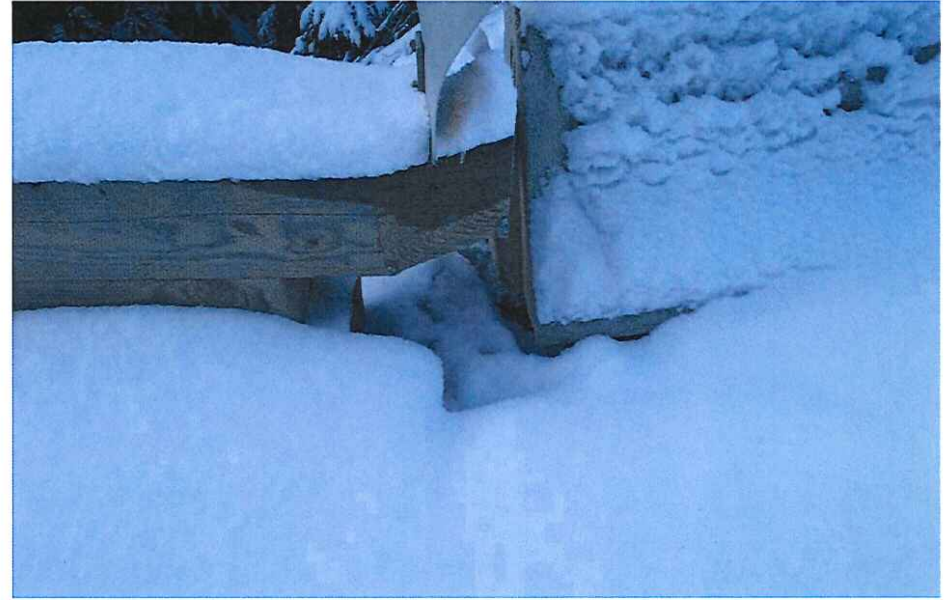
CK2360 Damaged guard rail
