**Routine Condition Bridge Inspection Form**  
(except for log stringer or timber stringer bridges)

| GENERAL INFORMATION | | | | (enter either long/lat or UTM below - not both) | | | |
|---|---|---|---|---|--|--|--|
| *Site #: <u>CK-2378</u> | *Crossing Name:<br><u>Winslow Side Channel</u> | *Type/Class: <input type="checkbox"/> Temporary bridge<br><input checked="" type="checkbox"/> Permanent bridge | *Project File ID# <u>2013</u> | | | | |
| *FSR Name:<br><u>Stave River</u> | *Forest District:<br><u>CK</u> | *Kilometres: | User km: <u>17.7</u> | | | | |

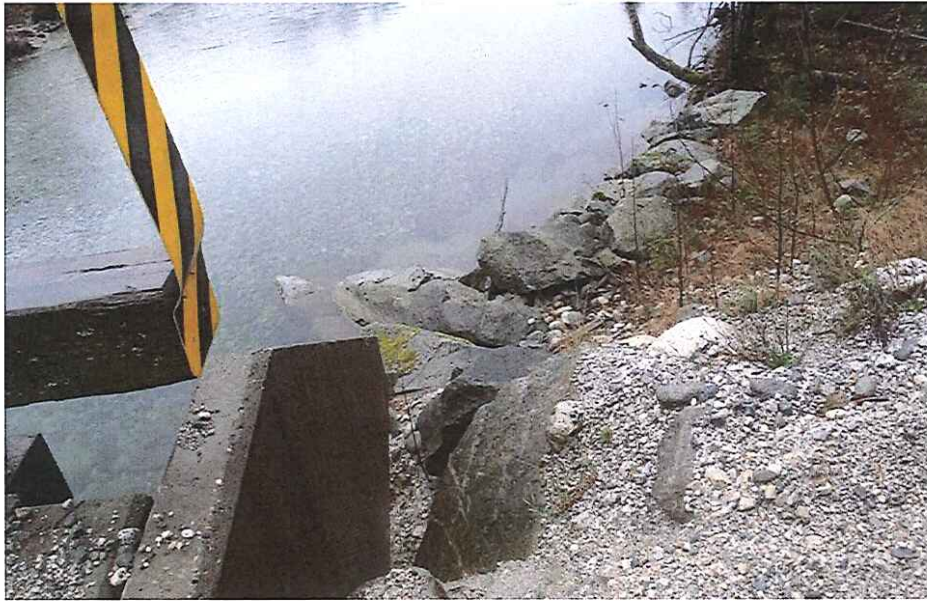
CK2378 Right Abutment fill

| Item | Present Condition<br>(circle) | Comments<br>(a comment is mandatory if condition "Poor" is selected) |
|---|---|---|
| Fill | E G F <u>P</u> N/A UR | FAILING ON D.S. RIGHT ABUT |

| GENERAL INFORMATION | | | |
|---|---|---|---|
| 1 | (H) M L | | FIX FILL ON RIGHT |
| 2 | H M L | | - ADD ROCK AT BOTTOM AND THEN FILL |

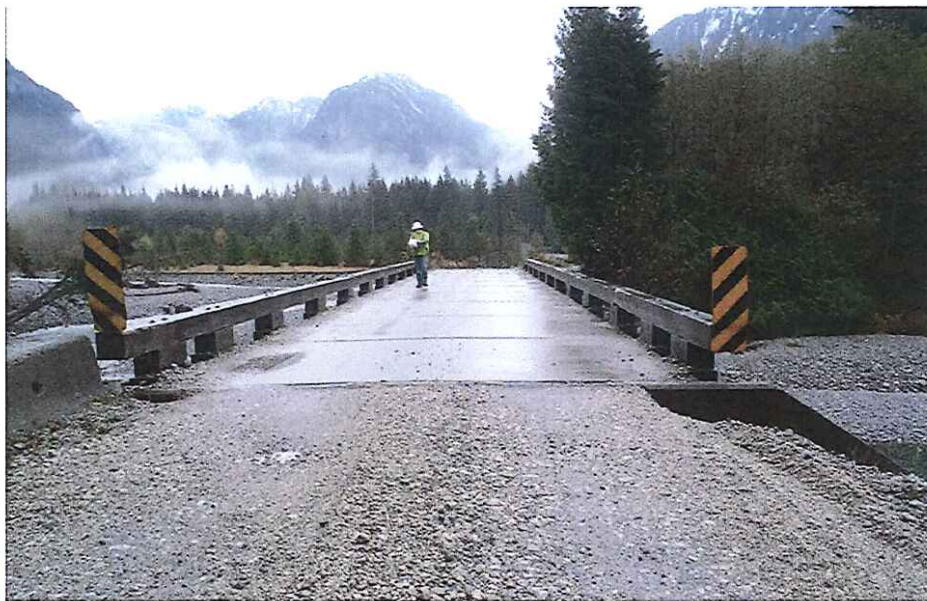
CK2378 Right to Left Approach

| Item | Present Condition<br>(circle or fill-in) | Comments<br>(a comment is mandatory if condition "Poor" is selected) |
|---|---|---|
| Alignment | E G F <u>P</u> UR | Tripod vertical on right side |

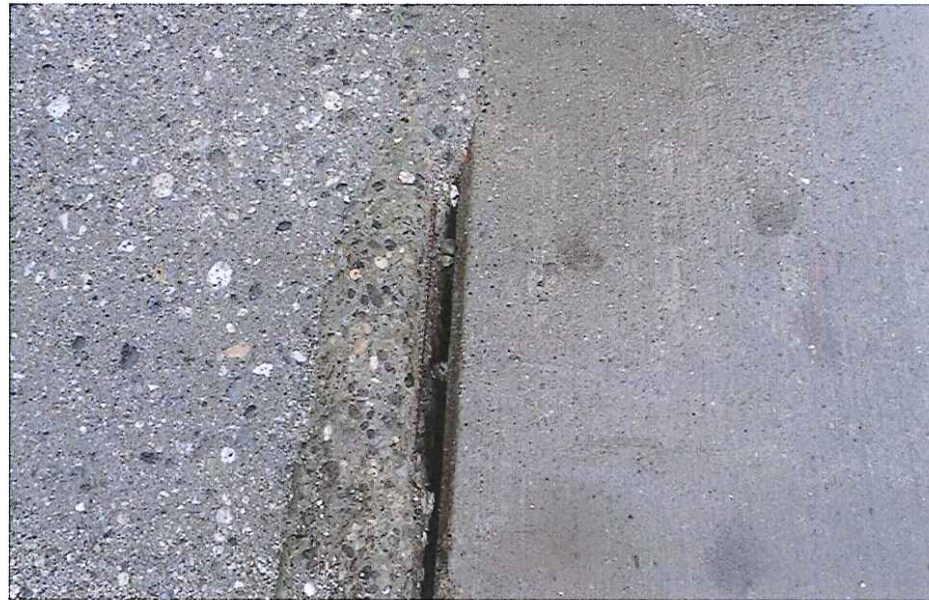
| Item | Present Condition<br>(circle) | Comments<br>(a comment is mandatory if condition "Poor" is selected) |
|---|---|---|
| Ballast Wall | E G F <u>P</u> N/A UR | LEFT GOOD/LIGHT HAS, EXPOSED REPAIR |

CK2378 Right ballast wall damage

| GENERAL INFORMATION | | | |
|---|---|---|---|
| GROUT OVER REBAR IN BALLAST WALL ON RIGHT | | | |
