**Routine Condition Bridge Inspection Form**  
(for log stringer or timber stringer bridges)**GENERAL INFORMATION**

\*Site #: CK-2394

Big Silver  
Creek\*Type/Class: ☐ Major Culvert  
☐ Woodbox/Log Culvert\*Project File ID# 5718

Harrison Forest

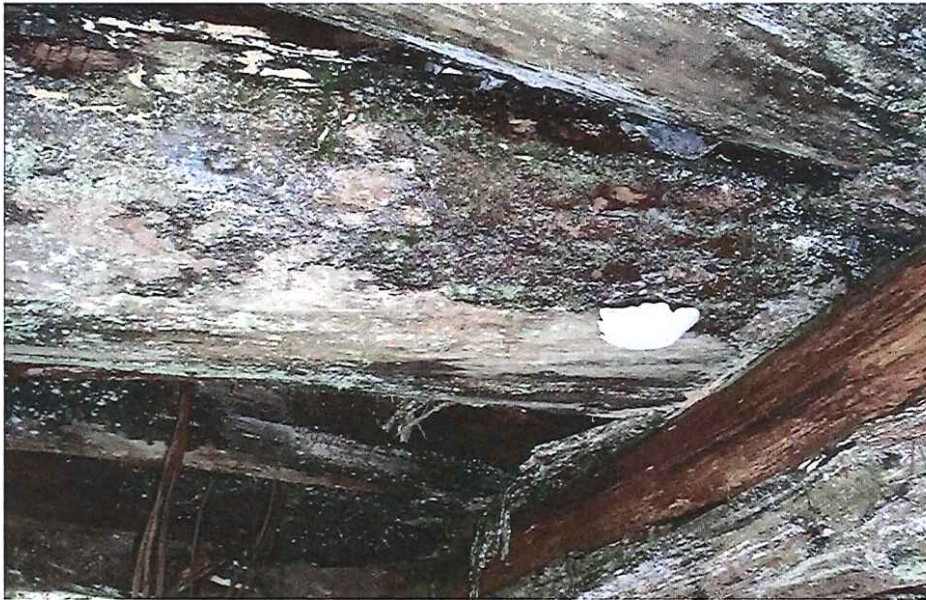
| GENERAL INFORMATION | | | | | | | | |
|---|---|---|---|---|---|---|---|---|
| 5 | | Y <u>N</u> | 85 | | | | } Failed w/ cork | |

CK2394 Stringer conk

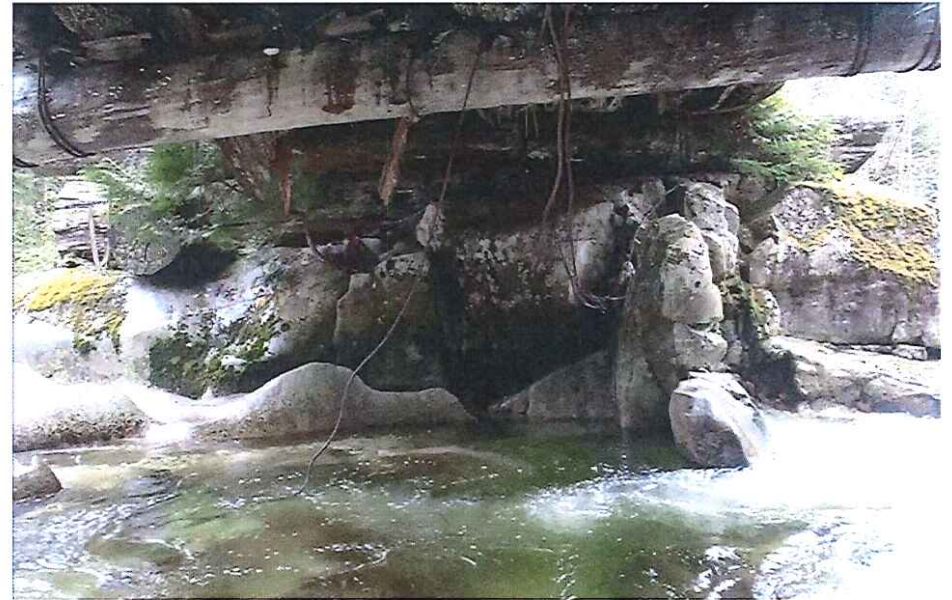
| Item | Present Condition<br>(circle) | Comments<br>(a comment is mandatory if condition "Poor" is selected) |
|---|---|---|
| Log/Timber Cribs | E G F (P) N/A UR | ROTTEN / UNSUPPORTED |
| Bearings | E G F (P) N/A UR | ROTTEN LOGS ON ROTTEN LOGS |

CK2394 Right Abutment

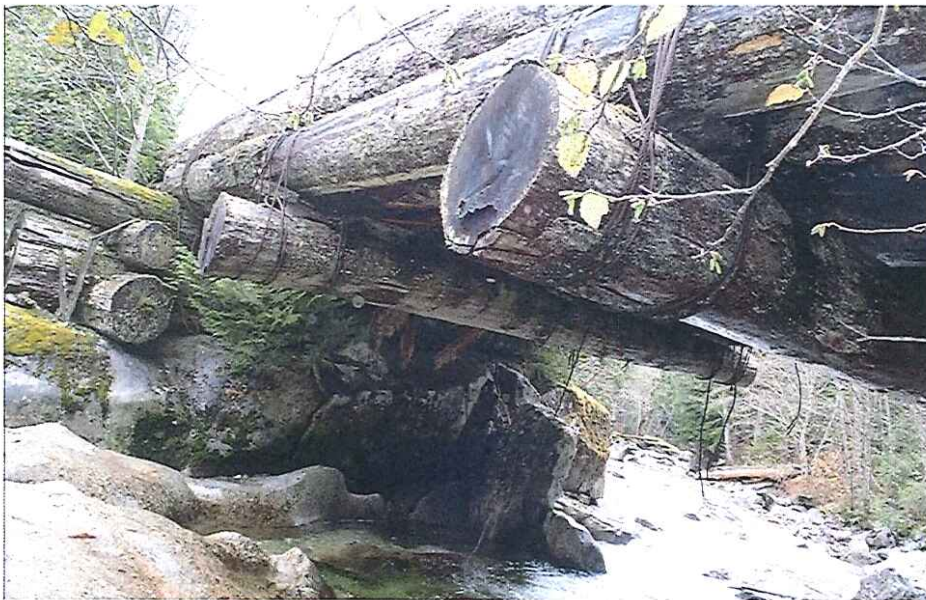
| GENERAL INFORMATION | | | | | | | | |
|---|---|---|---|---|---|---|---|---|
| Needle Beams and Shims | | E G F <u>P</u> N/A UR | | Loose & ineffective - 80cm w/ cork | | | | |

CK2394 Needle beams

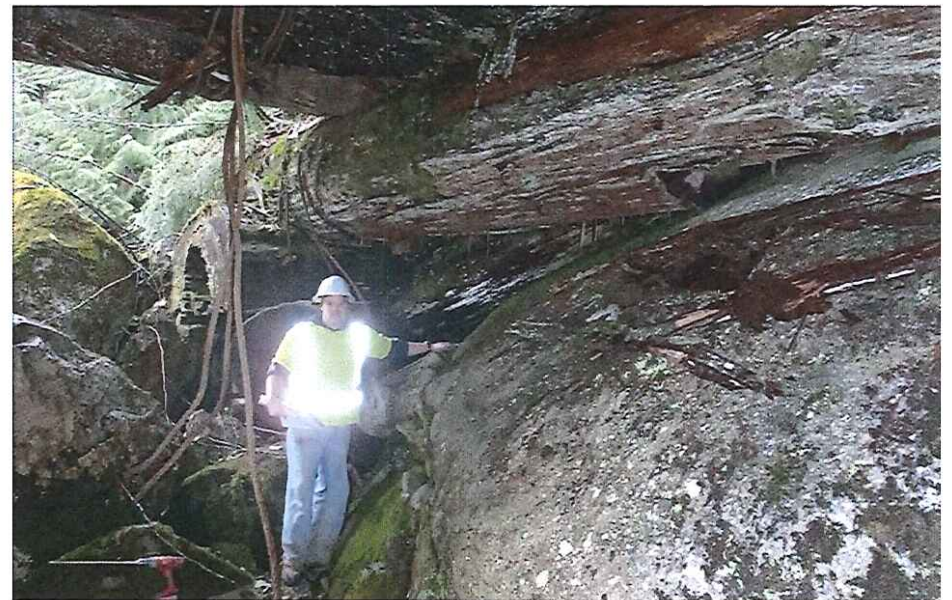
CK2394 Left Abutment

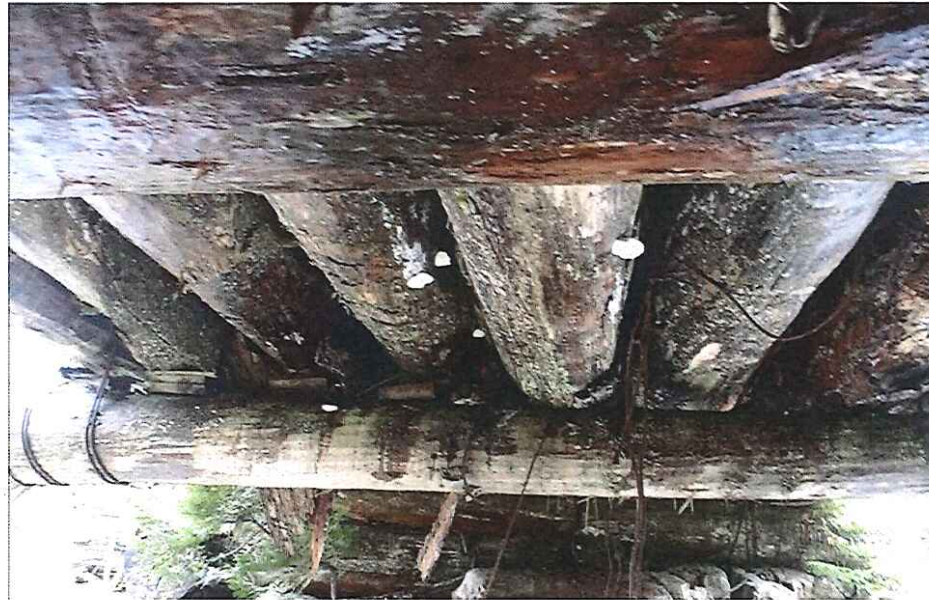
| GENERAL INFORMATION | | | | | | | | |
|---|---|---|---|---|---|---|---|---|
| Inspector's Comments<br>CLD PD CORED OAK, BUT EXPECT POCKET ROT 2 FAILED PERIOD POST OF ELEVATE | | | | | | | | |

CK2394 Stringers

| GENERAL INFORMATION | | | | | | | | |
|---|---|---|---|---|---|---|---|---|
| PEng Reviewer's Comments<br>Bridge condemned. Post and barricade or replace. | | | | | | | | |
