**Routine Condition Bridge Inspection Form**  
(except for log stringer or timber stringer bridges)**GENERAL INFORMATION**

| *Site #: <u>CK 2395</u> | *Crossing Name:<br><u>Big Silver River</u> | *Type/Class: <input type="checkbox"/> Temporary bridge<br><input checked="" type="checkbox"/> Permanent bridge | *Project File ID# <u>5748</u> |

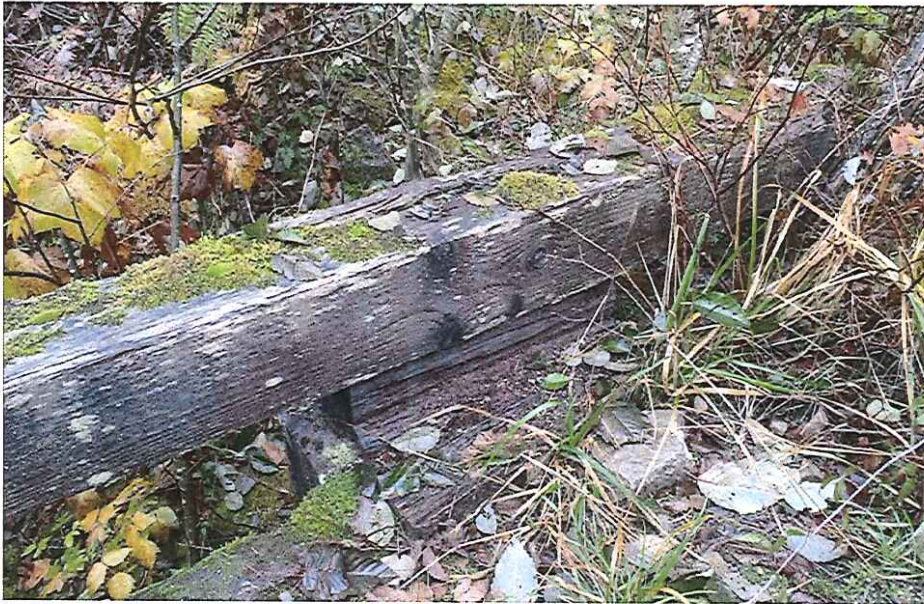
CK2395 Guard Rails

| Item | Present Condition<br>(circle) | Comments<br>(a comment is mandatory if condition "Poor" is selected) |
|---|---|---|
| Curb Rail/Blocks/Posts | E G F <u>(P)</u> UR | Rotten - REPLACE |

| GENERAL INFORMATION | | |
|---|---|---|
| Curb Rail/Blocks/Posts | E G F <u>(P)</u> UR | HIT ON FLARE / ROT |

can be lifted back to design loading. Completely seal (concrete) footings and riprap for protection. Limit loading to 10 tonnes until repair work can be completed. Replace guardrail, risers and sideblocks; grout left ballast wall

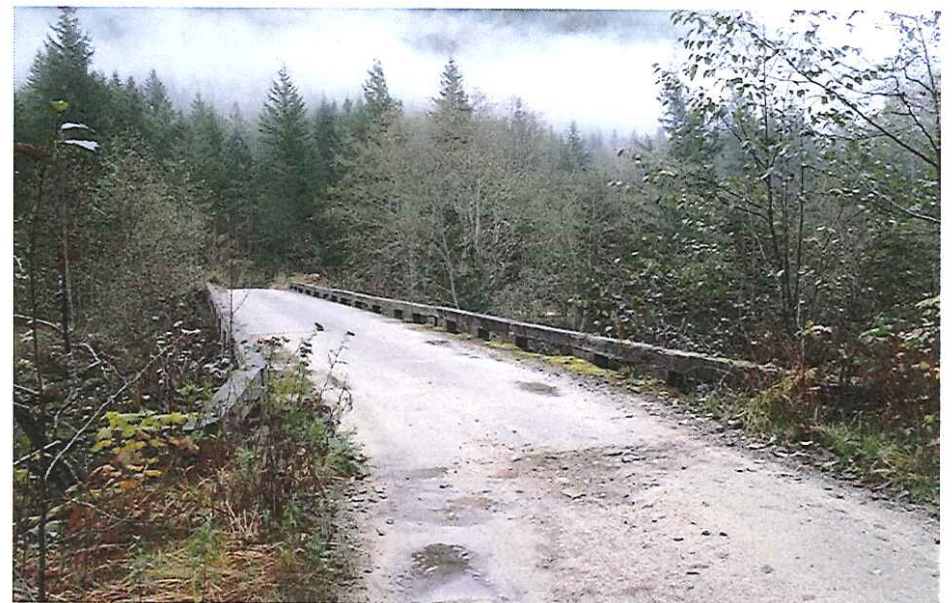
CK2395 Right to Left Approach

| Item | Present Condition<br>(circle or fill-in) | Comments<br>(a comment is mandatory if condition "Poor" is selected) |
|---|---|---|
| Alignment | E G <u>(P)</u> UR | Tight horizontal curves on each side |

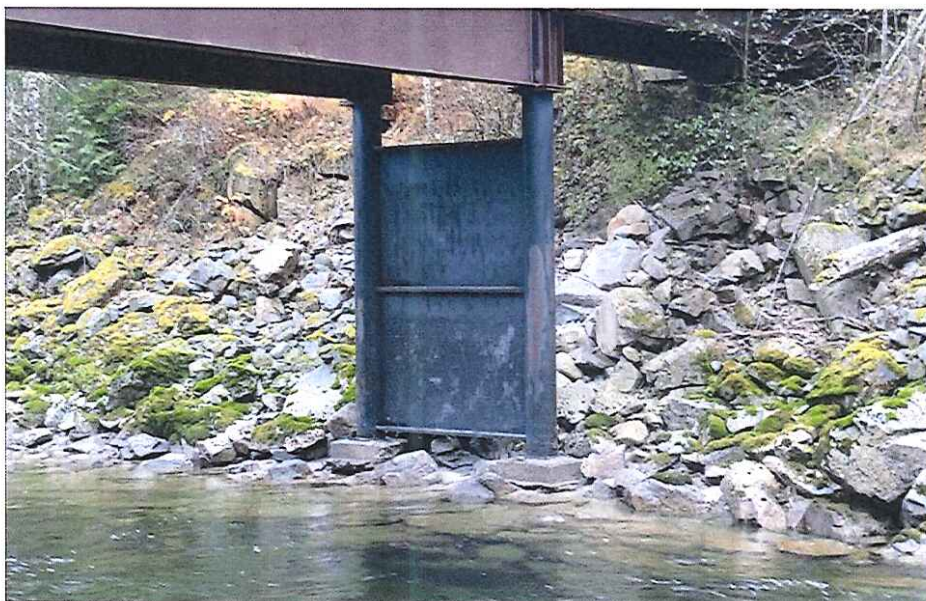
CK2395 Pier from Left

| GENERAL INFORMATION | | |
|---|---|---|
| Concrete | E G F <u>(P)</u> N/A UR | (UNDERMINED) |
| Overall | E G F <u>(P)</u> UR | COLLOUSE ON FOOTINGS UNDERMINED<br>SEE REPAIR |

| GENERAL INFORMATION | | | | |
|---|---|---|---|---|
| 1 | (H) M L | | REPAIR CONCRETE UNDER CIP FOOTINGS ON PIER - HAS SCURED TO BED ROCK! ENSURE THERE IS NO ADDITIONAL FILL EXPOSED UNDER FOOTINGS | |

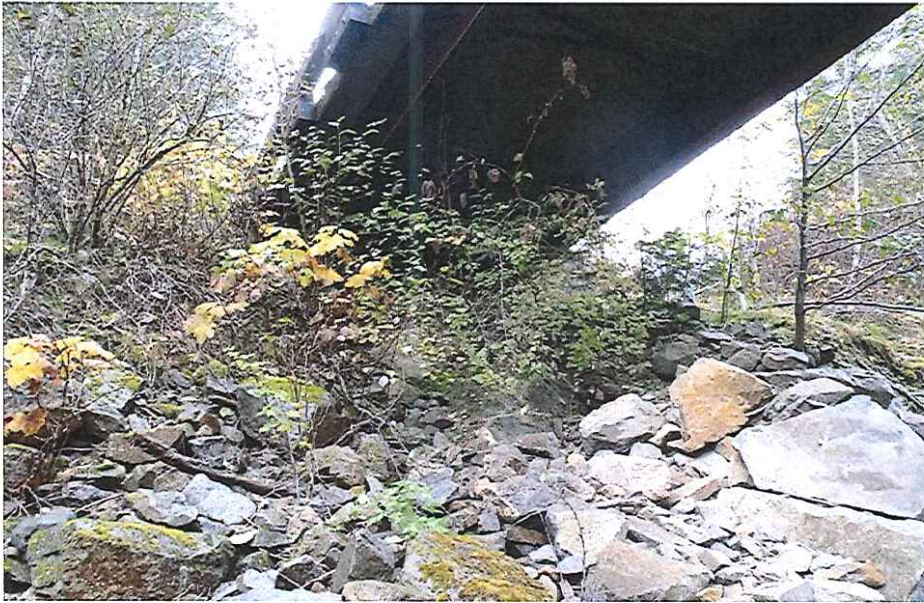
CK2395 Right Abutment

| Item | Present Condition<br>(circle) | Comments<br>(a comment is mandatory if condition "Poor" is selected) |
|---|---|---|
| Caps or Sills | E <u>(G)</u> F P N/A UR | Right slightly undermined |

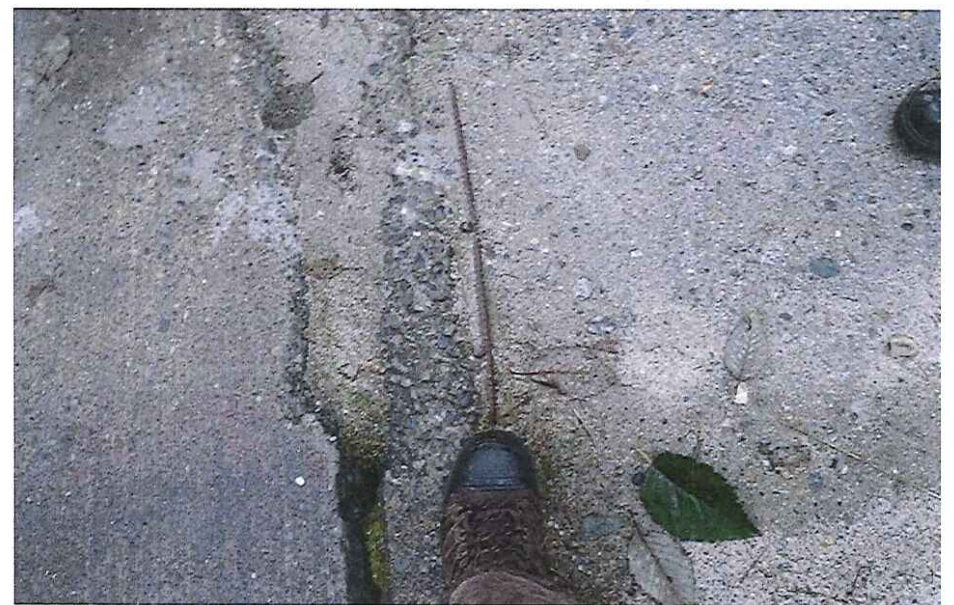
| Item | Present Condition<br>(circle) | Comments<br>(a comment is mandatory if condition "Poor" is selected) |
|---|---|---|
| Ballast Wall | E G F P <u>(N/A)</u> UR | Concrete - left has exposed rebar at top |

CK2395 Left ballast wall damage

to completely seal exposed rebar; replace all 4 delineators; post bridge ahead and updated load rating signs.

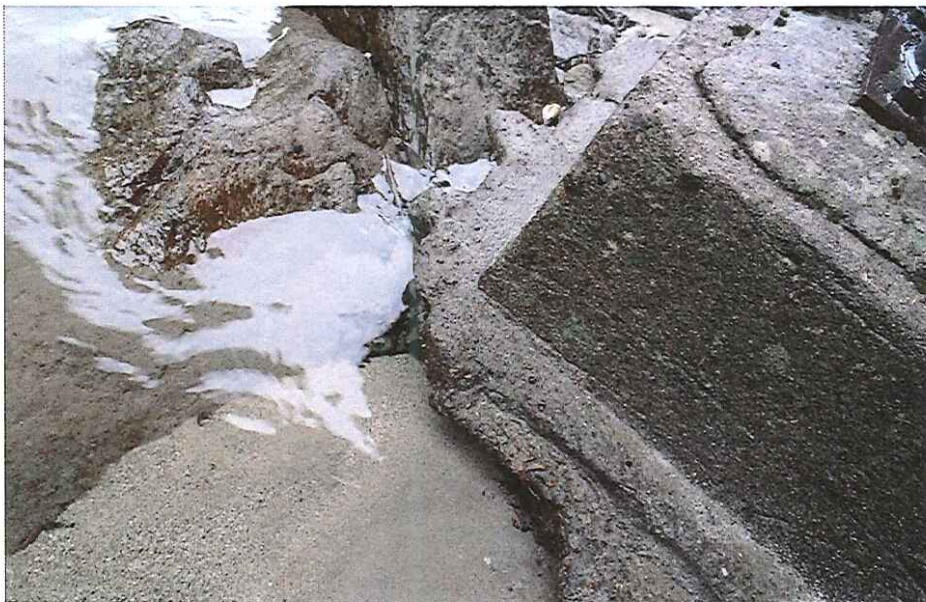
| GENERAL INFORMATION | | | | |
|---|---|---|---|---|
| P Eng Reviewer's Comments<br><u>Cast in place footings on pier have scoured out</u> | | | | |

and need to ensure proper bearing before load rating

CK2395 Pier Undermining 3

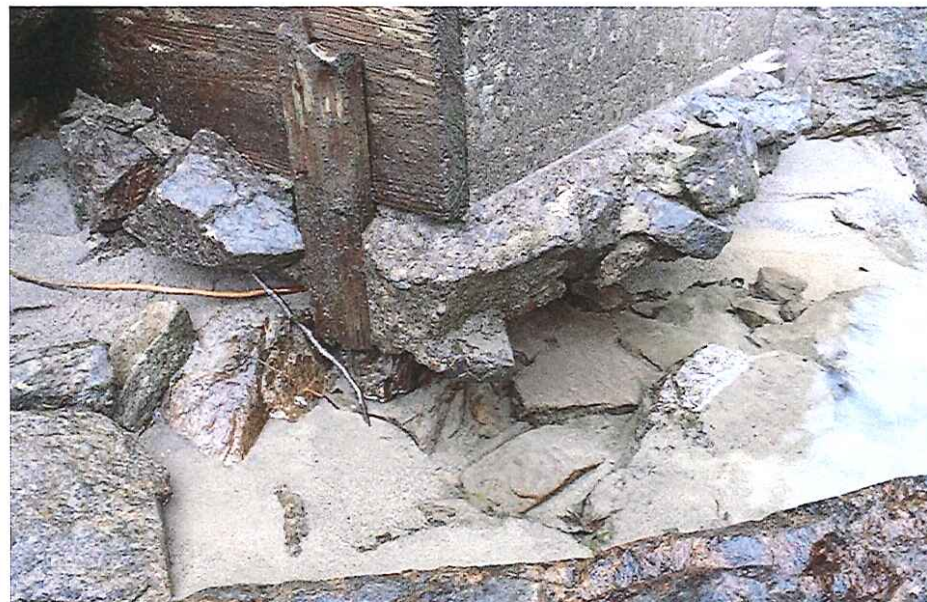
CK2395 Pier Undermining 1

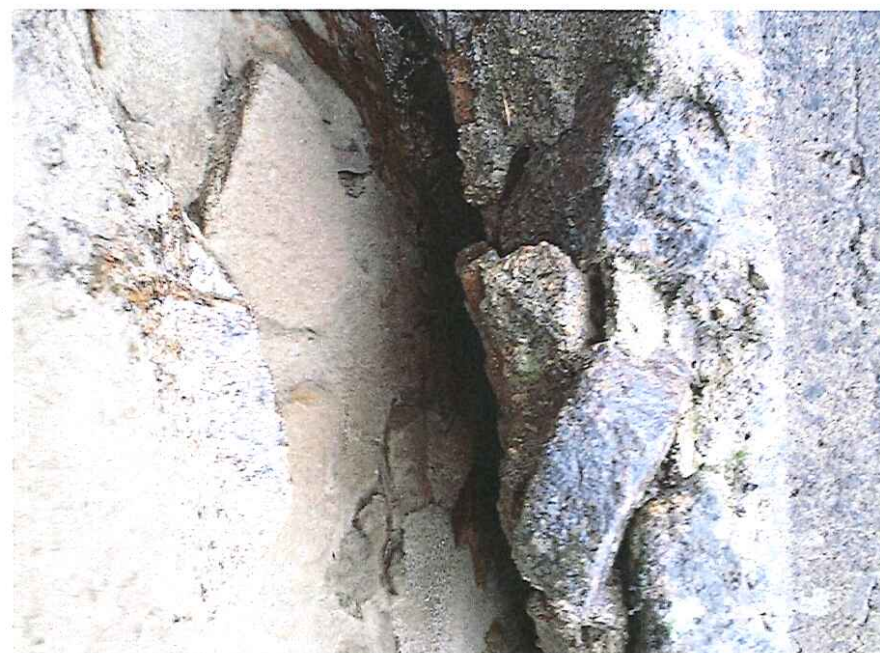
CK2395 Pier Undermining 2
