**Routine Condition Bridge Inspection Form**  
(for log stringer or timber stringer bridges)**GENERAL INFORMATION**

| *Site #: <u>X-CK2463</u> | *Crossing Name: <u>Hungar Crk</u> | *Type/Class: <input type="checkbox"/> Major Culvert<br><input checked="" type="checkbox"/> Woodbox/Log Culvert | *Project File ID# <u>5748</u> |
| *FSR Name: <u>Harrison Lake East</u> | *Forest District: <u>CK</u> | *Kilometres: _____ | User km: <u>64.4</u> |

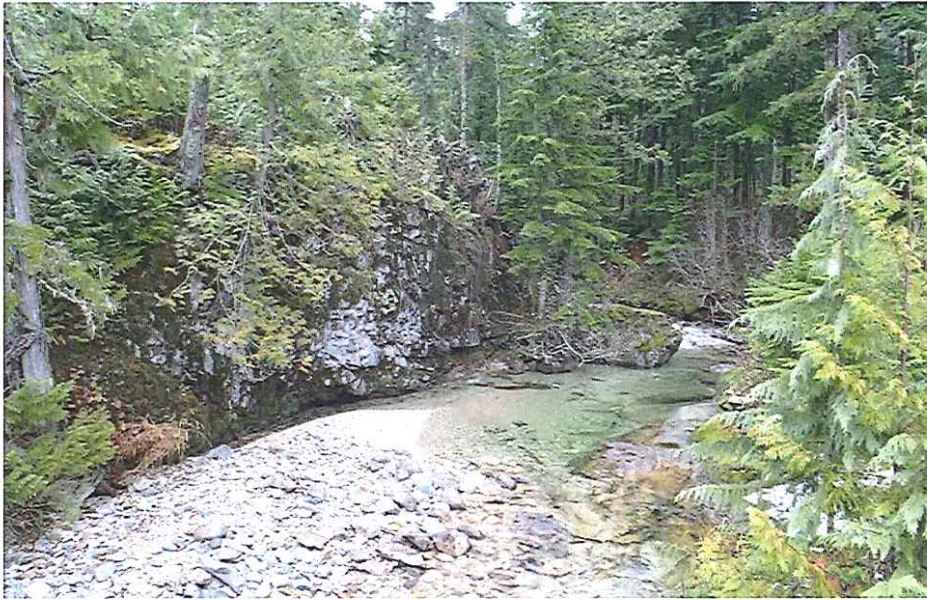
CK2463 Upstream

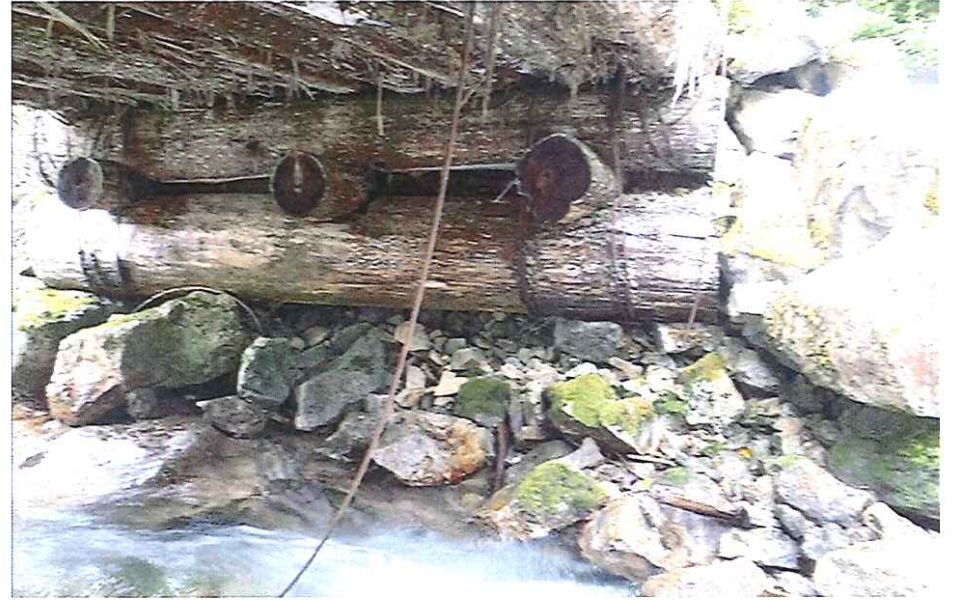
| Item | Present Condition<br>(circle) | Comments<br>(a comment is mandatory if condition "Poor" is selected) |
|---|---|---|
| Riprap | E G <u>(F)</u> P N/A UR | RIGHT IS UNDERMINED |

CK 2463 Right Abutment

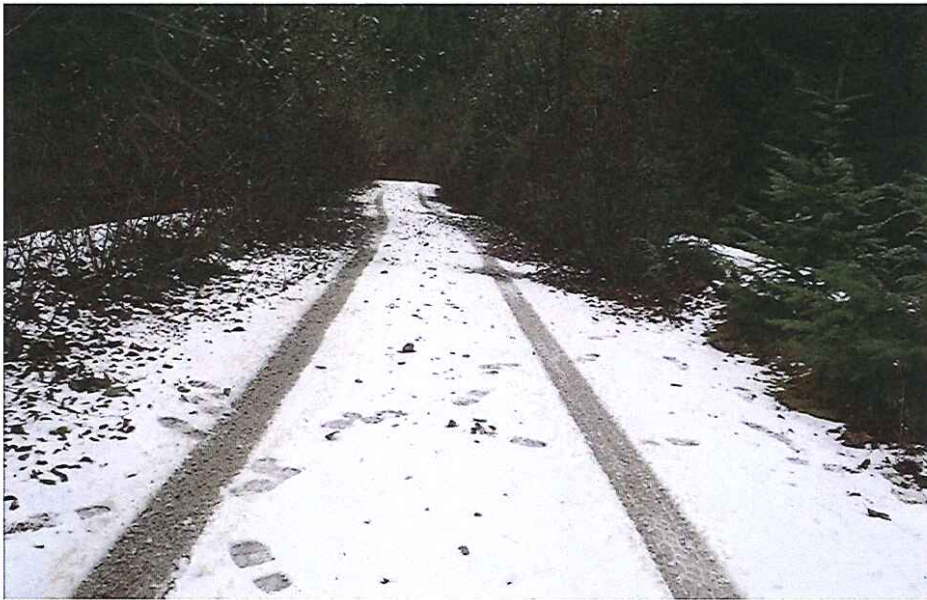
CK2463 Left to Right Approach

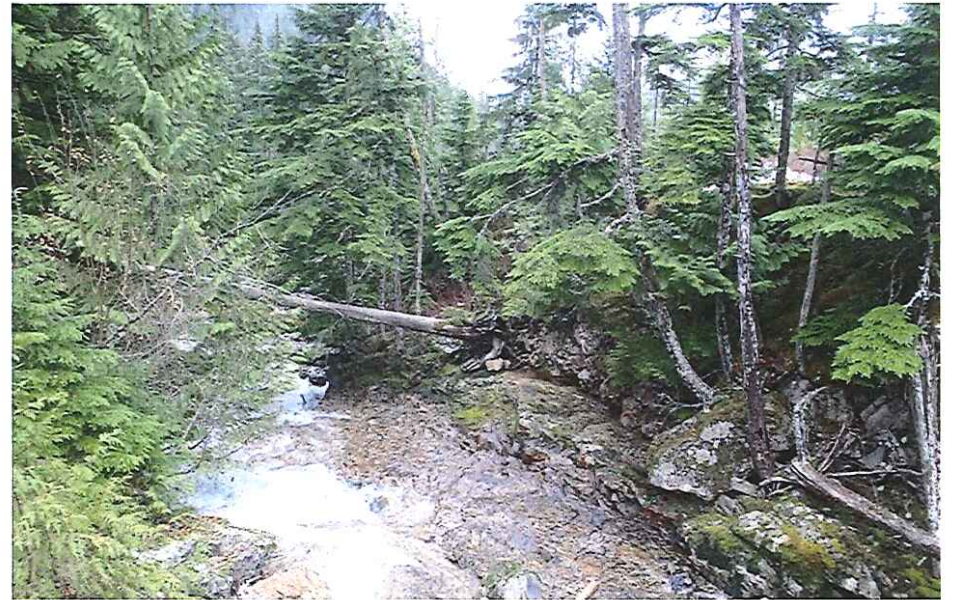
CK2463 Downstream

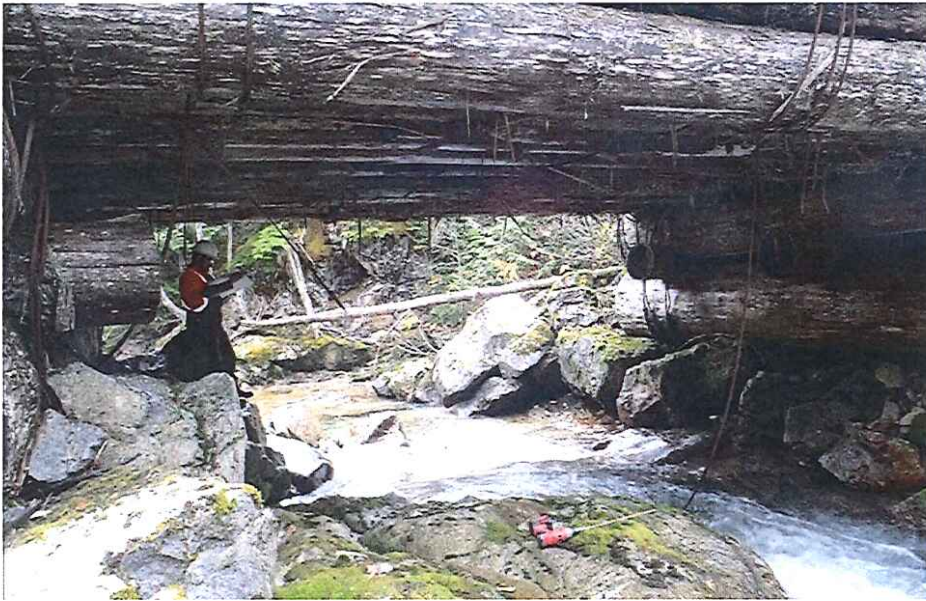
CK2463 From Upstream

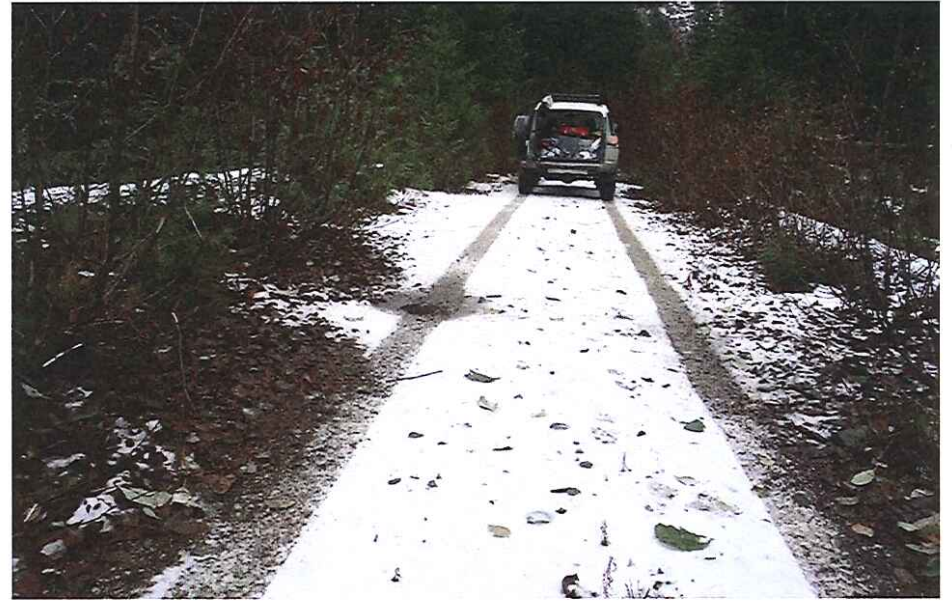
CK2463 Right to Left Approach

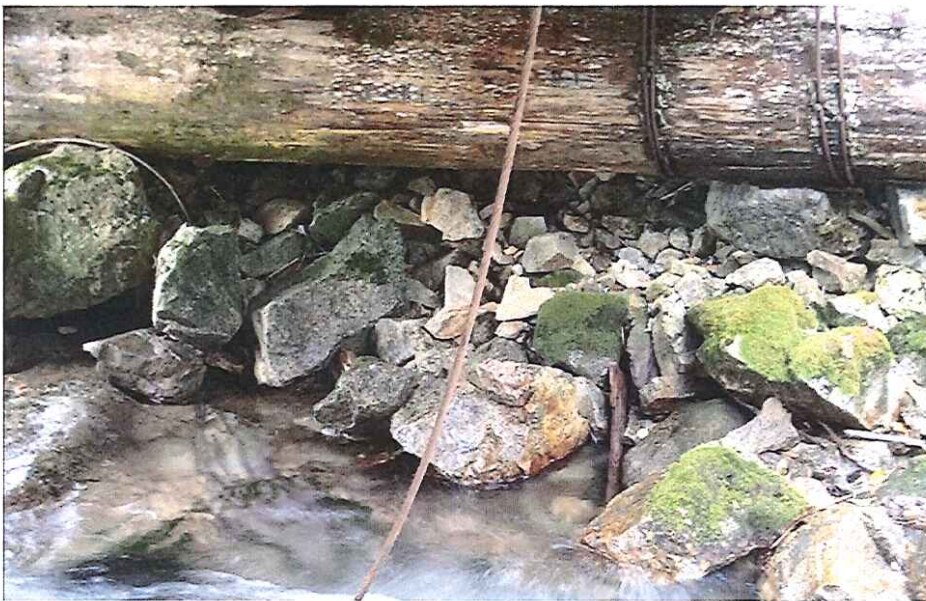
High Water? Yes (N) Scour? (Yes) No Ice? (Yes) No Debris? Yes (N) Aggradation? Yes (N)

CK2463 Right Abutment Scour

| Monitor Item # | *Monitor Description |
|---|---|
| 1 | SCOUR |

Replace delineators and monitor crib scour on town end.

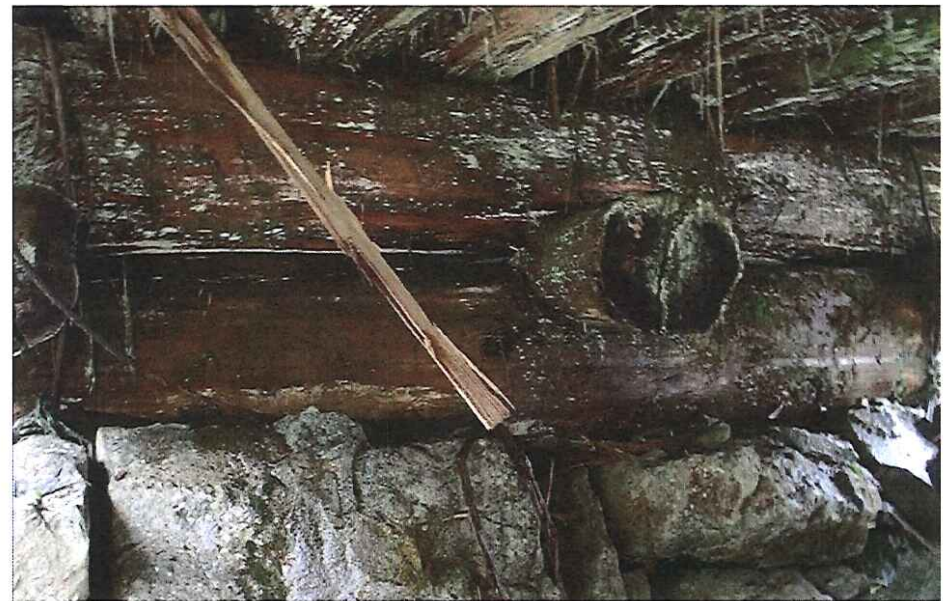
CK2463 Left Abutment
