**Routine Condition Bridge Inspection Form**  
(except for log stringer or timber stringer bridges)**GENERAL INFORMATION**

| *Site #: <u>CK 2466</u> | *Crossing Name: <u>Unknown</u> | *Type/Class: <input type="checkbox"/> Temporary bridge<br><input checked="" type="checkbox"/> Permanent bridge | *Project File ID# <u>7558</u> |
| *FSR Name: <u>GARLUGT CRK</u> | *Forest District: <u>CK</u> | *Kilometres: _____ | User km: <u>8.2</u> |

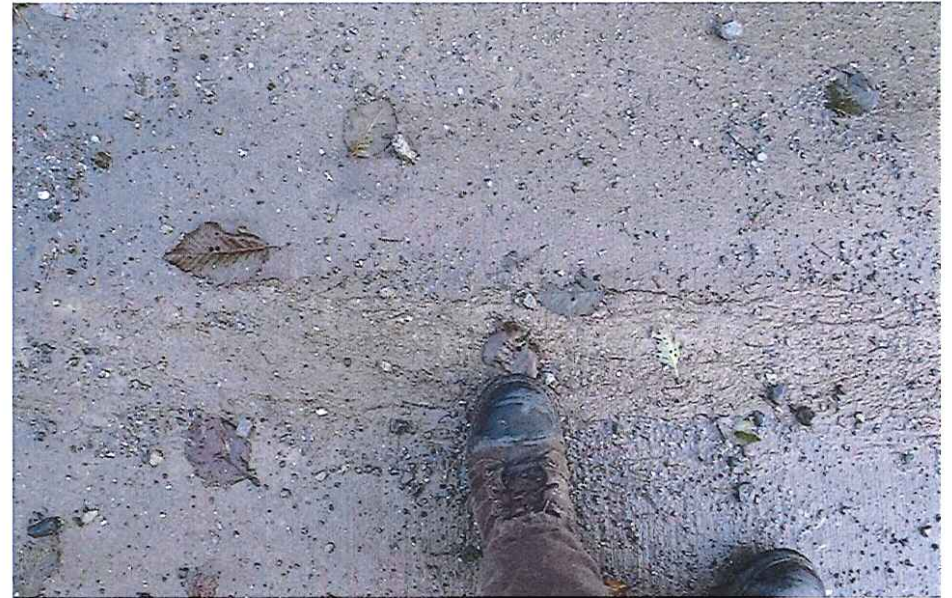
CK2466 Deck

| Item | Present Condition (circle) | Comments (a comment is mandatory if condition "Poor" is selected) |
|---|---|---|
| Overall Deck Condition | <u>(E)</u> G F P UR | <u>NGW</u> |

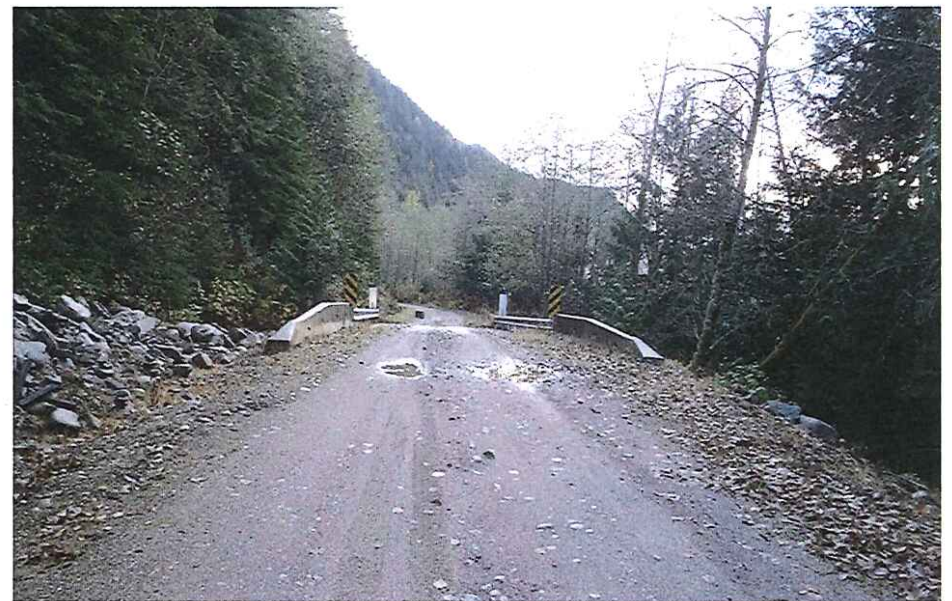
CK2466 Right to Left Approach

| Item | Present Condition (circle or fill-in) | Comments (a comment is mandatory if condition "Poor" is selected) |
|---|---|---|
| Bridge Ahead Signs Missing | 0 1 <u>(2)</u> | |

| GENERAL INFORMATION | | | |
|---|---|---|---|
| P Eng Reviewer's Comments<br><u>Post bridge ahead signs. Present load rating of L75 or 68 tonnes to continue.</u> | | | |

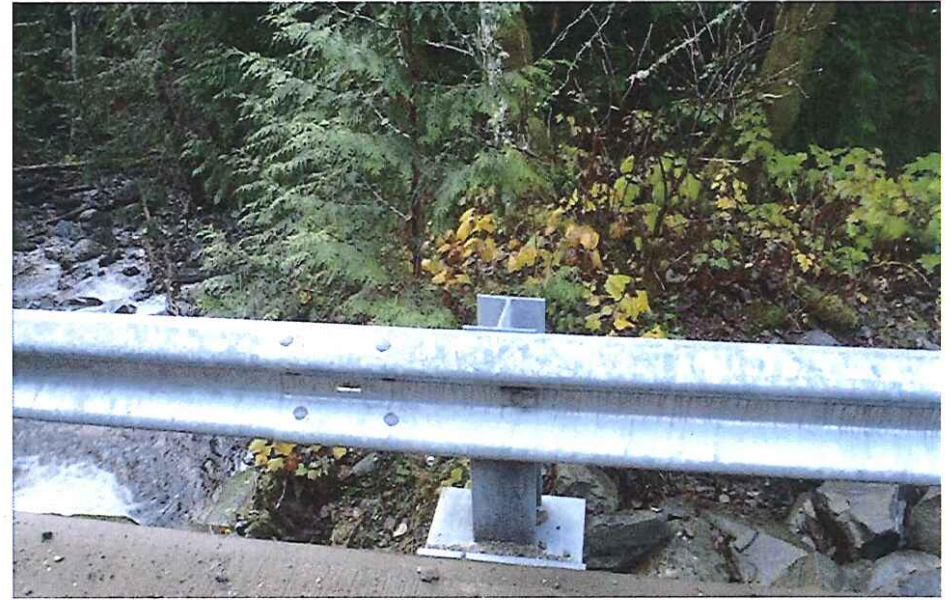
CK2466 Guard Rails

| Item | Present Condition (circle) | Comments (a comment is mandatory if condition "Poor" is selected) |
|---|---|---|
| Curb Rail/Blocks/Posts | <u>(E)</u> G F P UR | <u>w-beams</u> |

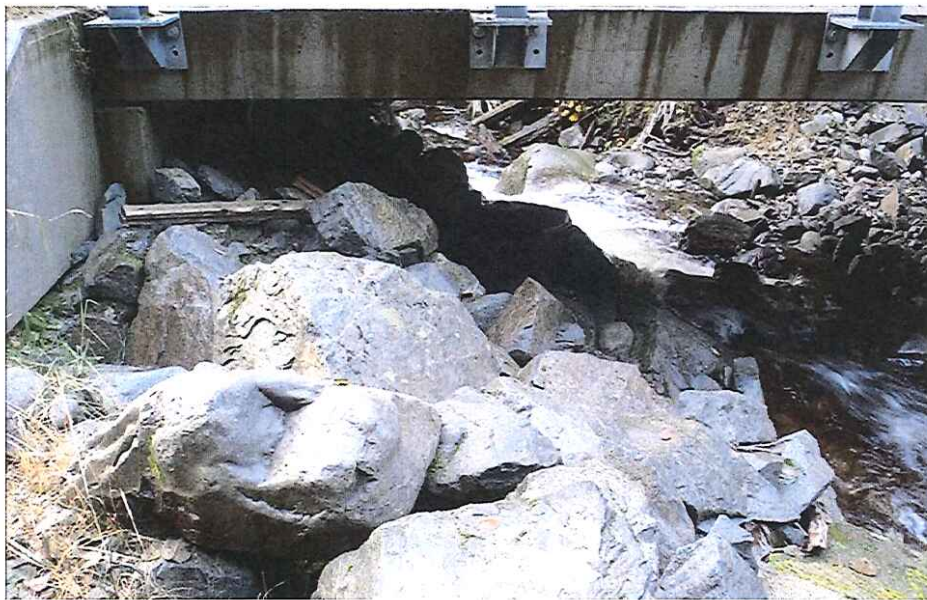
CK2466 Left Abutment Riprap

| Item | Present Condition (circle) | Comments (a comment is mandatory if condition "Poor" is selected) |
|---|---|---|
| Riprap | E <u>(G)</u> F P <u>(N/A)</u> UR | |
