**Routine Condition Bridge Inspection Form**  
(except for log stringer or timber stringer bridges)

| GENERAL INFORMATION | | | | (enter either long/lat or UTM below – not both) | | | |
|---|---|---|---|---|--|--|--|
| *Site #: CK 2472 | *Crossing Name: Upper Maial | *Type/Class: <input type="checkbox"/> Temporary bridge<br><input checked="" type="checkbox"/> Permanent bridge | *Project File ID# 8241 | | | | |
| *Structure #: CK 2472 | *Forest District: Chehalis - Maial | *Kilometres: 6.0 | *Br. 16 | | | | |

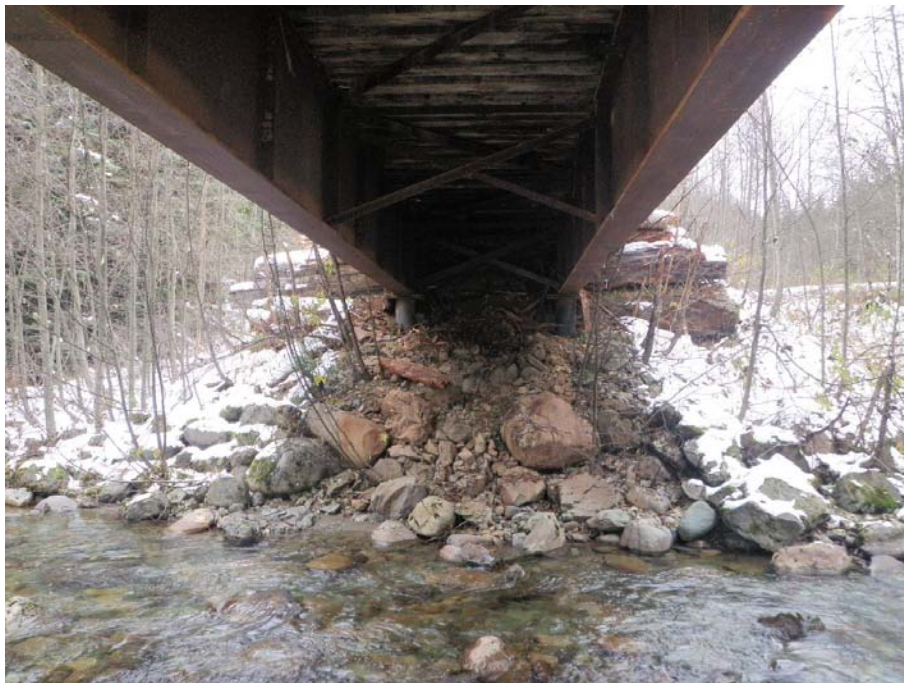
Woods abutment.

| GENERAL INFORMATION | | | | (enter either long/lat or UTM below – not both) | | | |
|---|---|---|---|---|--|--|--|
| Ballast Wall | E G <b>(F)</b> P N/A UR | old logs, woods end partially replaced | | | | | |

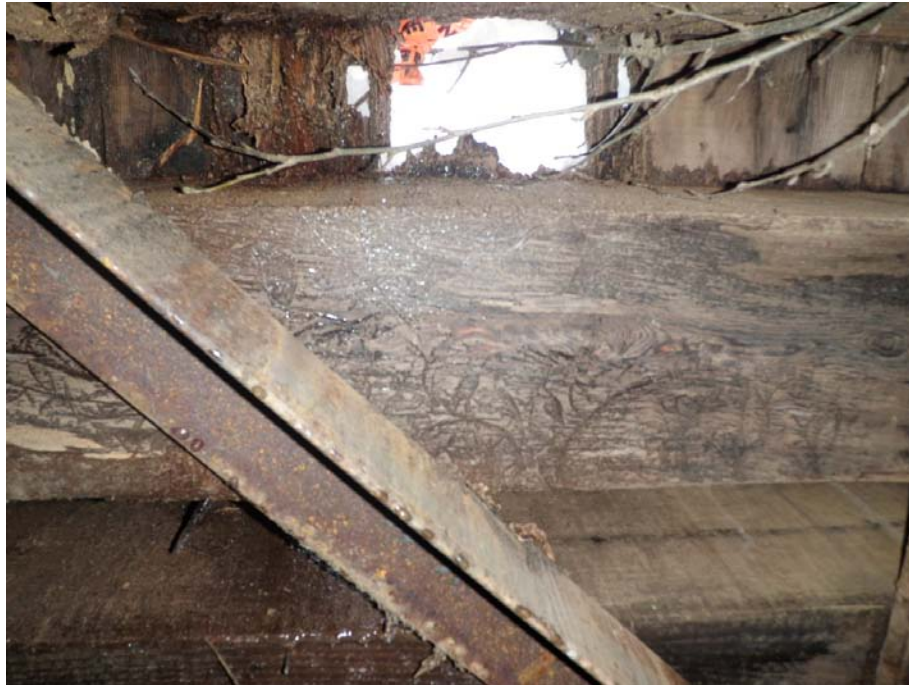
| GENERAL INFORMATION | | | | (enter either long/lat or UTM below – not both) | | | |
|---|---|---|---|---|--|--|--|
| Running Surface (N/A if running surface is gravel or timber planks) | E G F <b>(P)</b> N/A UR | rotten, holes present | | | | | |
| Overall Deck Condition | E G F <b>(P)</b> UR | replace ties, deck, curbs & risers | | | | | |

Holes present in deck.

| GENERAL INFORMATION | | | |
|---|---|---|---|
| <u>1</u> | <u>H</u> M L | | replace ties, deck, curbs, risers, delimiters |
| PEng Reviewer's Comments<br><u>Replace ties, deck, curbs, risers &amp; delimiters. Place no posts or</u> | | | |

log fenders prior to use. Block access until work can be completed. Post updated load rating.

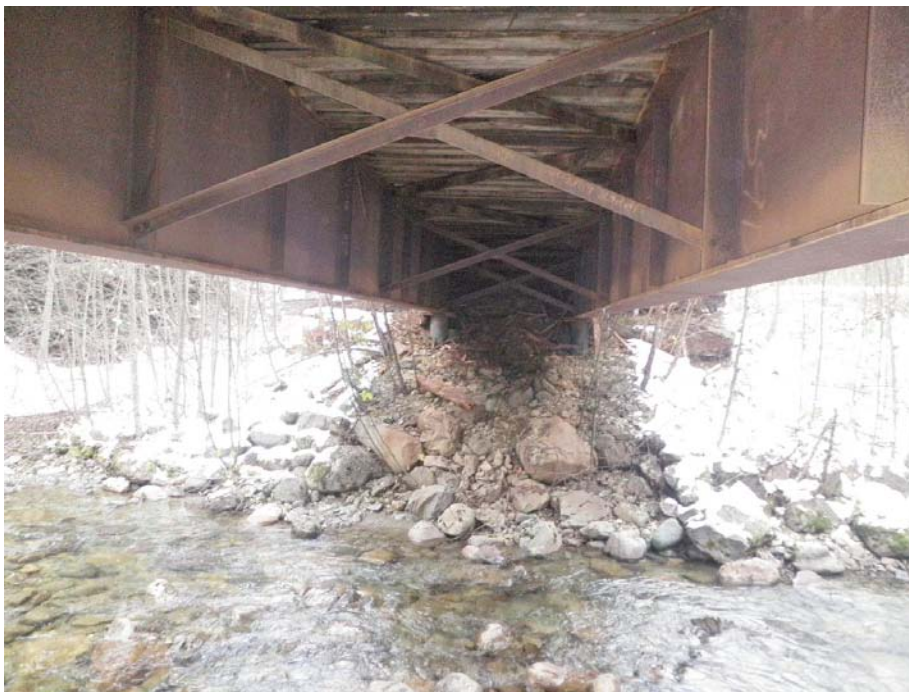
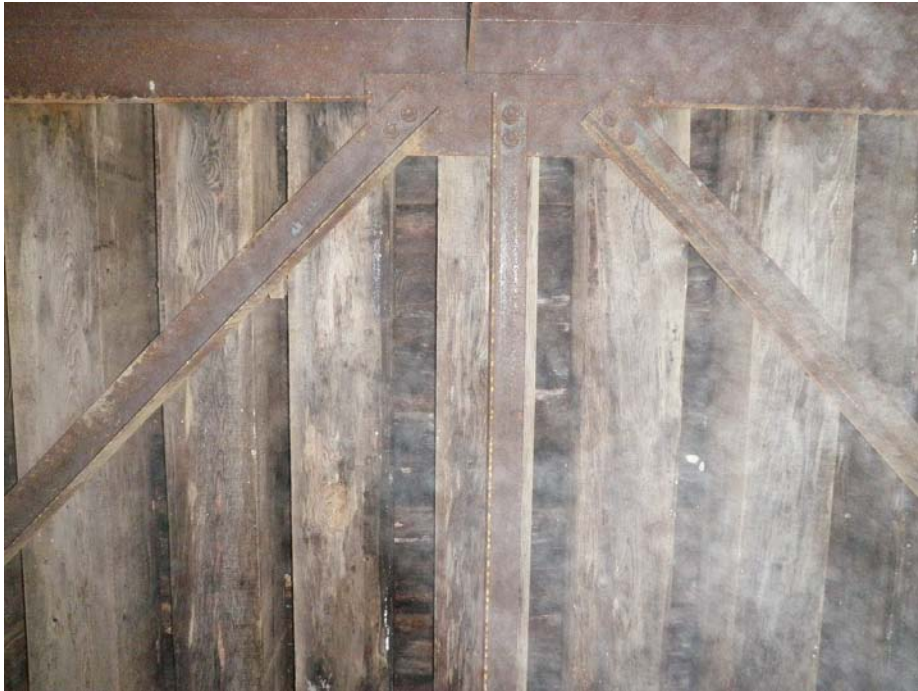
Bracing.

| GENERAL INFORMATION | | | |
|---|---|---|---|
| Bracing | E G <u>F</u> P N/A UR | minor surface rust | |
