**Routine Condition Bridge Inspection Form**  
(except for log stringer or timber stringer bridges)**GENERAL INFORMATION**

| *Site #: <u>CK 2153</u> | *Crossing Name: <u>Boulder Crk</u> | *Type/Class: <input type="checkbox"/> Temporary bridge<br><input checked="" type="checkbox"/> Permanent bridge | *Project File ID# <u>8149</u> |
| *FSR Name: <u>Jones Lake</u> | *User km: _____ | | |

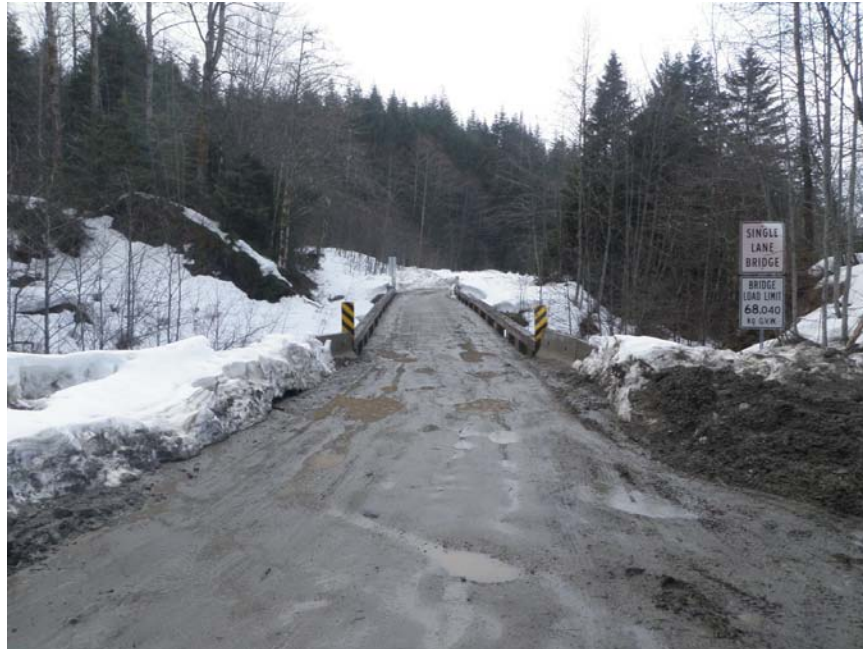
| Item | Present Condition<br>(circle or fill-in) | Comments<br>(a comment is mandatory if condition "Poor" is selected) |
|---|---|---|
| Alignment | E G <b>(F)</b> P UR | <u>S turn</u> |
| Road Surface | E G <b>(F)</b> P UR | <u>minor erosion, town u/s</u> |

Right approach

| 1 | H <u>M</u> L | | <u>grade approaches</u> |

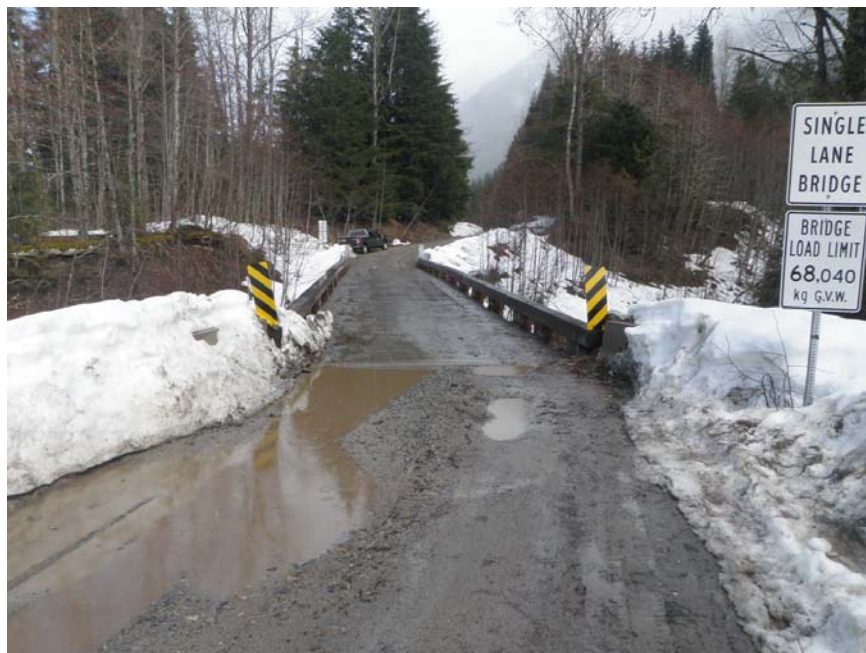
Left Approach

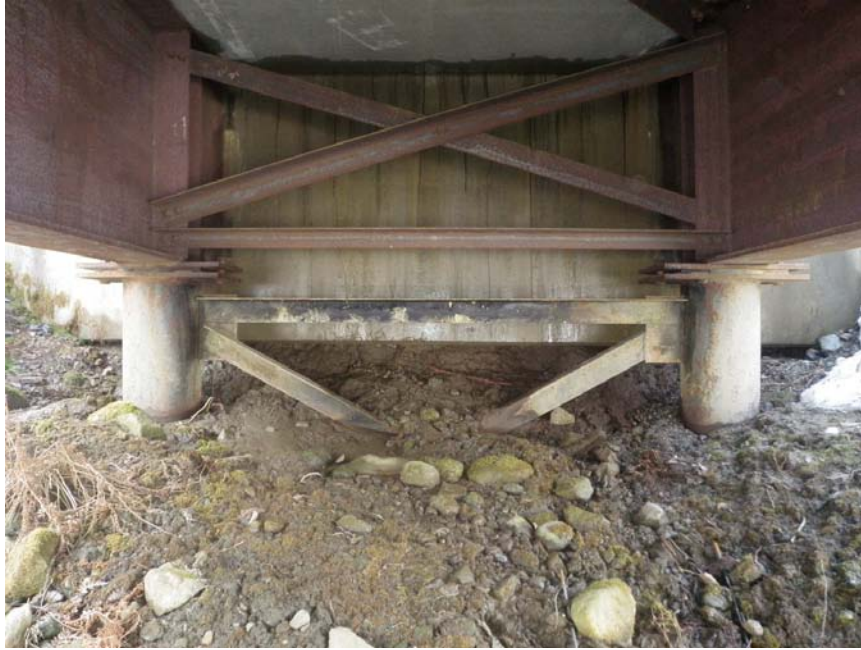
| Item | Present Condition<br>(circle) | Comments<br>(a comment is mandatory if condition "Poor" is selected) |
|---|---|---|
| Piles or Posts | E G <b>(F)</b> P N/A UR | <u>posts - minor rust, painted</u> |

Left abutment

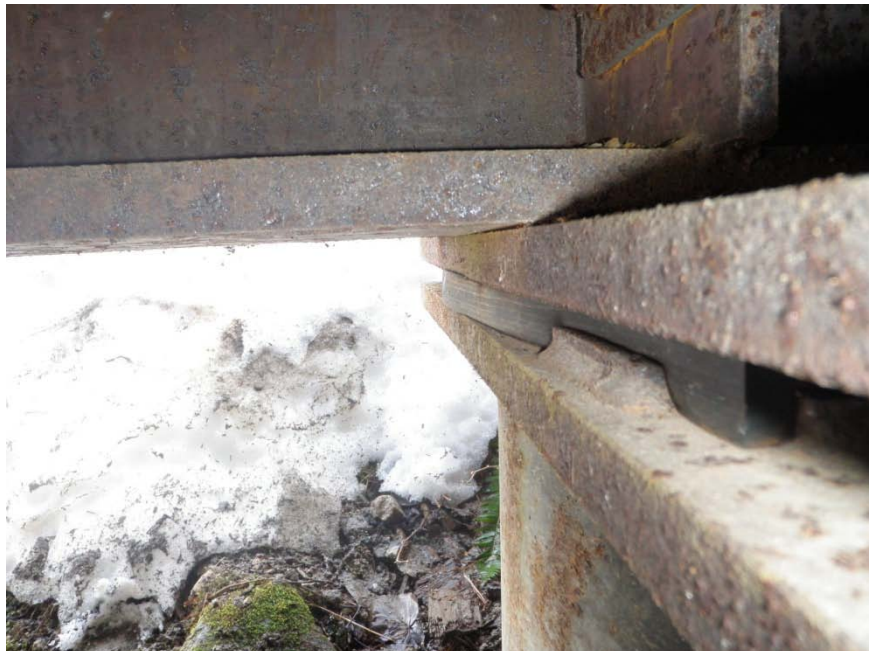
| Item | Present Condition<br>(circle) | Comments<br>(a comment is mandatory if condition "Poor" is selected) |
|---|---|---|
| Bearings | E G <b>(F)</b> P N/A UR | <u>rubber pads starting to bulge</u> |

Bearing pads

| 2 | <u>bearing pads</u> | | |

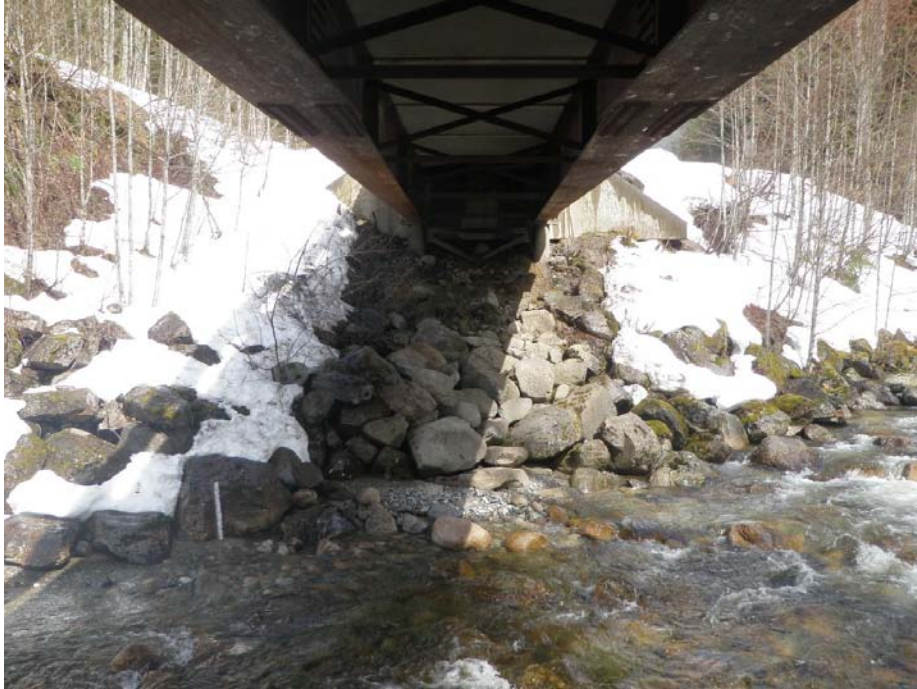
| Item | Present Condition<br>(circle) | Comments<br>(a comment is mandatory if condition "Poor" is selected) |
|---|---|---|
| Riprap | E <b>(G)</b> F P N/A UR | |

Right abutment riprap

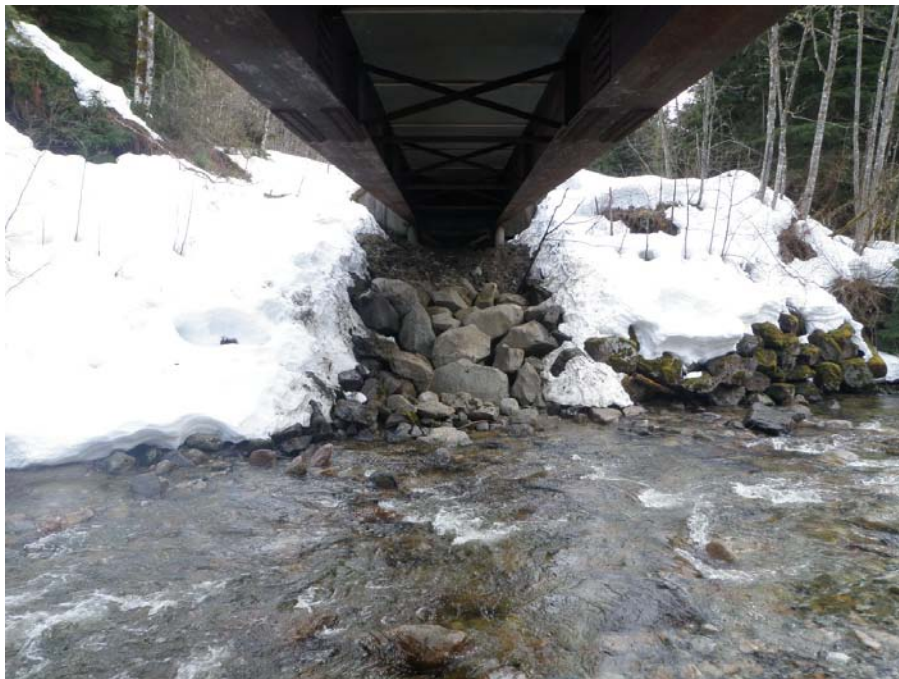
Left abutment riprap

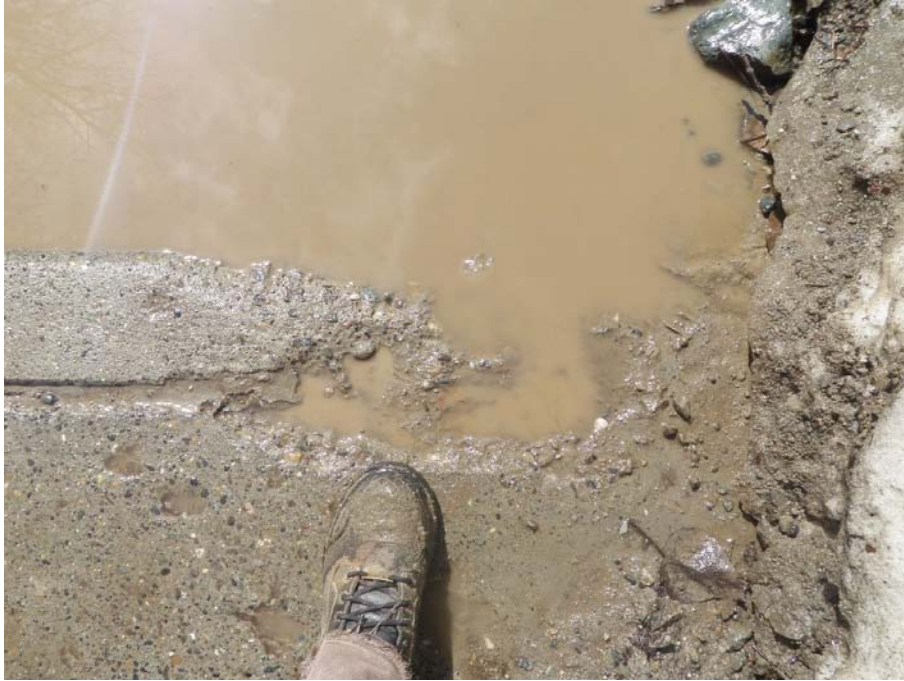
| Item | Present Condition<br>(circle) | Comments<br>(a comment is mandatory if condition "Poor" is selected) |
|---|---|---|
| Ballast Wall | E G <b>(F)</b> P N/A UR | <u>damage on woods end - potholes</u> |

Left ballast wall damage

| 1 | <u>woods ballast wall (top)</u> | | |
| PEng Reviewer's Comments<br><u>Post bridge ahead sign. Monitor ballast wall, bearing pads. Grade approaches when snow melts. Present load rating of <del>47.5</del> 68 tonnes to continue</u> | | | |
