## Corporate Bridge Register (CBR) SITE INVENTORY DATA FORM

**Routine Condition Bridge Inspection Form**  
(for log stringer or timber stringer bridges)

| GENERAL INFORMATION | | | | (enter either long/lat or UTM below – not both) | | | |
|---|---|---|---|---|---|--|--|
| *Site #: CK-2262 | *Crossing Name: Side Creek | *Type/Class: <input checked="" type="checkbox"/> Major Culvert<br><input checked="" type="checkbox"/> Woodbox/Log Culvert | *Project File ID# 8015 | | | | |
| *FSR Name: Stave River | *Forest District: Chilliwack | *Kilometres: 10.50 | User km: | | | | |

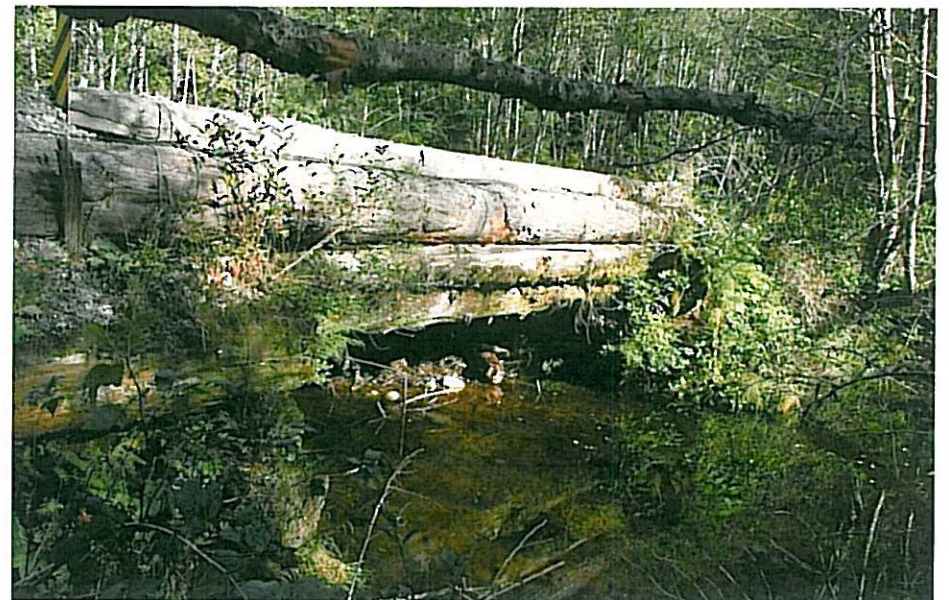
CK-2262 From Downstream

| GENERAL INFORMATION | | | | | | | |
|---|---|---|---|---|---|---|---|
| Comments: Beaver dam at inlet and downstream | | | | | | | |

| GENERAL INFORMATION | | | | | | | |
|---|---|---|---|---|---|---|---|
| 1 | H M L | \$ 1.00 | remove beaver dam | | | | |

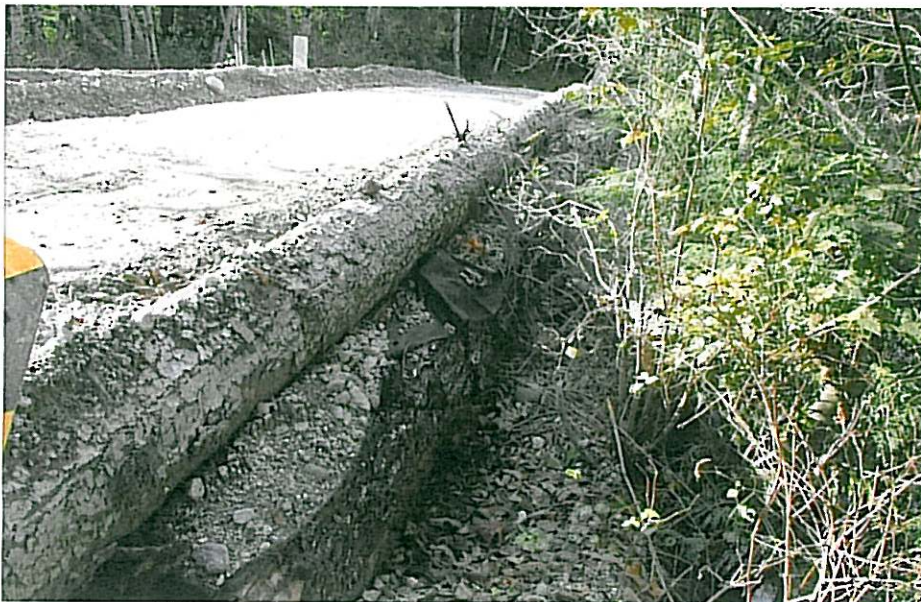
CK-2262 New Deck

| GENERAL INFORMATION | | | | (enter either long/lat or UTM below – not both) | | | |
|---|---|---|---|---|---|--|--|
| Gravel Surface | E G F <u>P</u> N/A UR | | thin layer of gravel over new stringer | | | | |

| GENERAL INFORMATION | | | | | | | |
|---|---|---|---|---|---|---|---|
| 1 | ? | Y N | ? | ? | ? | ? | Cannot inspect new stringers since they are buried. |

| GENERAL INFORMATION | | | | | | | |
|---|---|---|---|---|---|---|---|
| 3 | H M L | | Place fenders and add additional 200mm gravel fill | | | | |

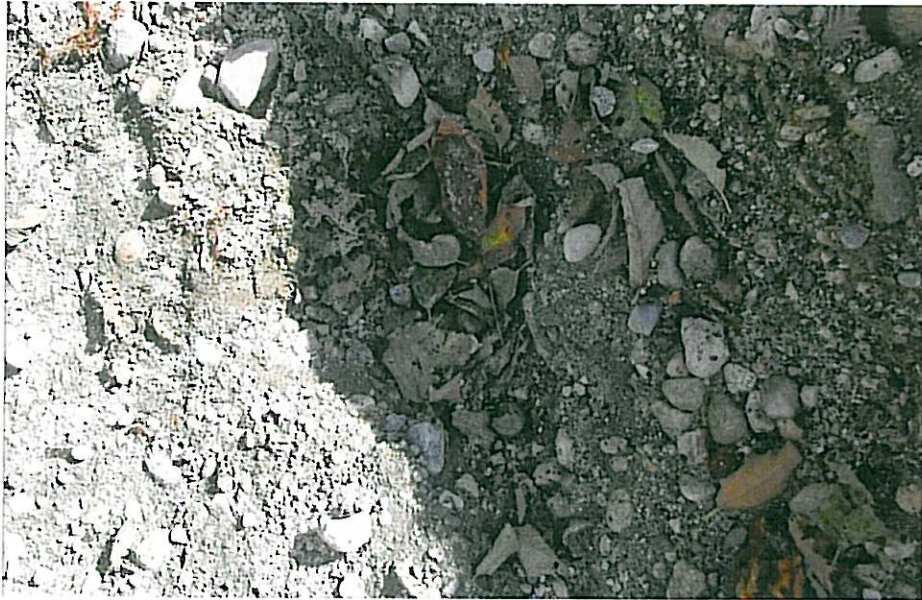
CK-2262 Gravel Fill (2)

| GENERAL INFORMATION | | | | (enter either long/lat or UTM below – not both) | | | |
|---|---|---|---|---|---|--|--|
| Gravel Deck Depth | <u>0.2</u> metres or N/A | | | | | | |
