## Corporate Bridge Register (CBR) SITE INVENTORY DATA FORM

Routine Condition Bridge Inspection Form  
(for log stringer or timber stringer bridges)

\*Site #: CK-2266

\*FSR Name: Stave River

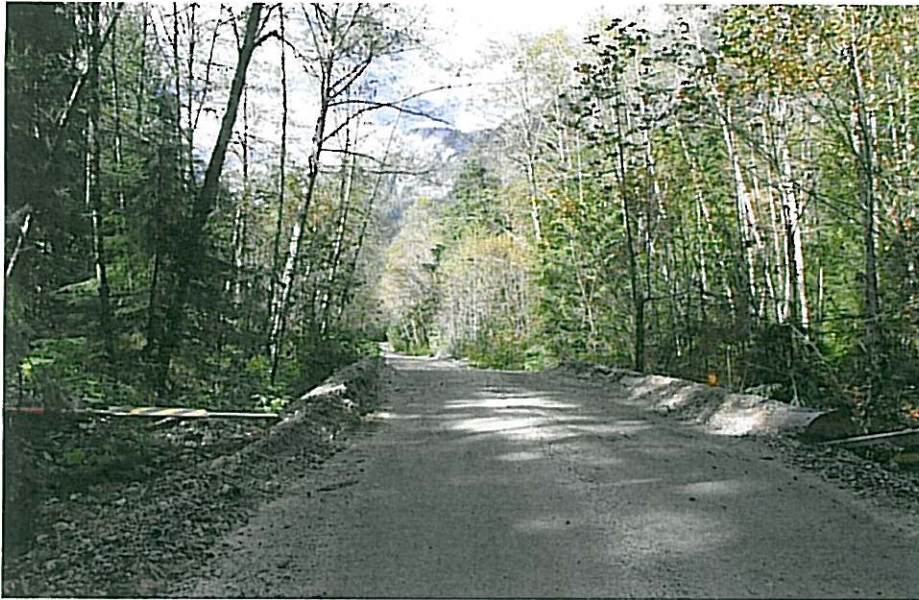
CK-2266 From Left

| Item | Present Condition<br>(circle or fill-in) | Comments<br>(a comment is mandatory if condition "Poor" is selected) |
|---|---|---|
| Delineator Missing Left | 0 1 <u>2</u> | There, but knocked down |
| Delineator Missing Right | 0 1 <u>2</u> | There, but knocked down |

| Repair Item # | Priority (circle) | Estimate (\$) | Repair Description |
|---|---|---|---|
| 1 | H M L | \$1.00 | Place load rating and bridge ahead signs |
| 2 | H M L | \$1.00 | Replace missing delineators |

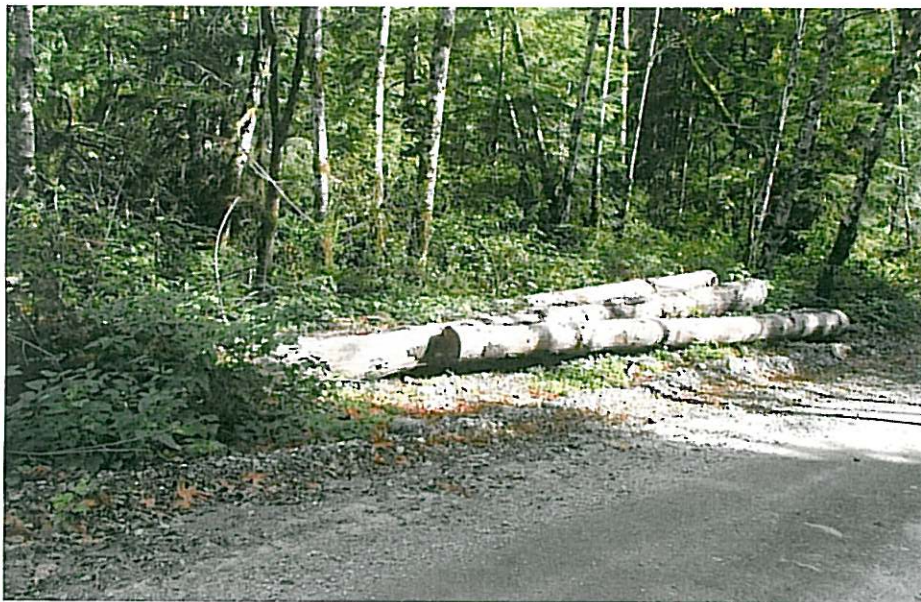
CK-2266 Leftover Stringer

Comments: old log bridge with new stringers over old.

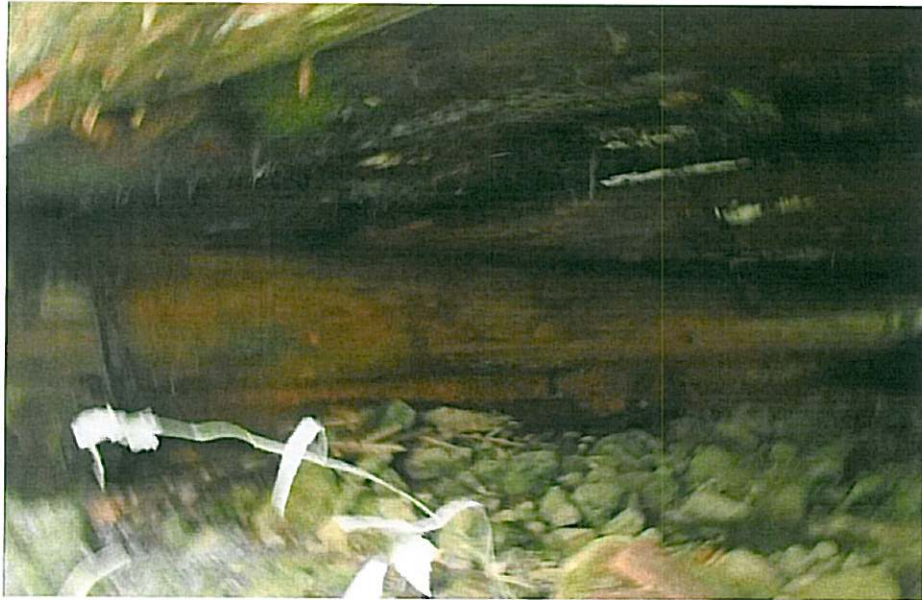
CK-2266 Left Abutment

| Item | Present Condition<br>(circle) | Comments<br>(a comment is mandatory if condition "Poor" is selected) |
|---|---|---|
| Log/Timber Cribs | E G <u>F</u> P N/A UR | Open face |

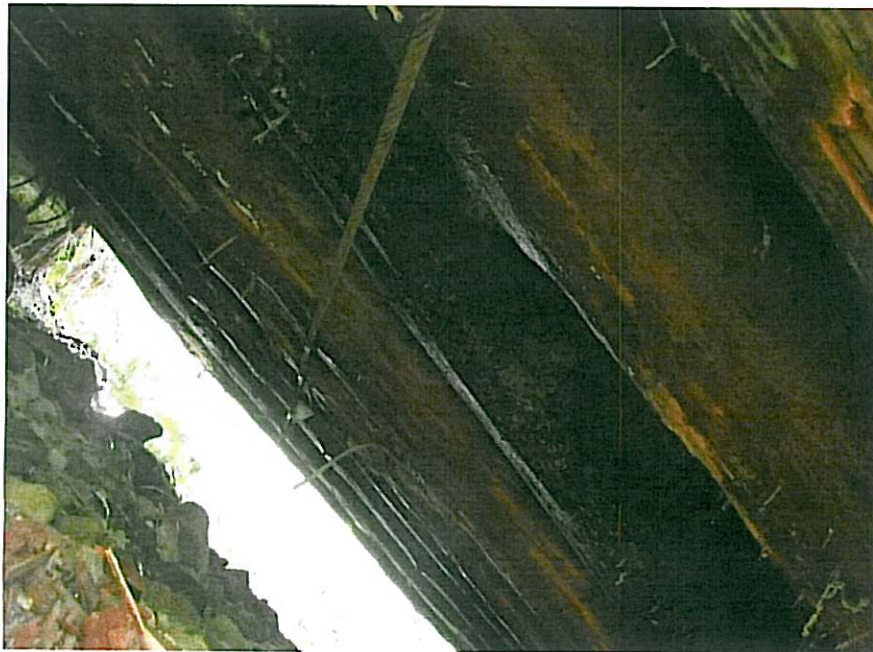
CK-2266 Lower Stringers

| Item | Present Condition (circle) | | | | | Comments<br>(a comment is mandatory if condition "Poor" is selected) | | |
|---|---|---|---|---|---|---|---|---|
| 1 | | Y N | | | | | | New stringers added. Cannot inspect as they are buried. |

| Inspector's Comments<br>New stringers added - cannot inspect as they are buried. | | | |
