## Corporate Bridge Register (CBR) SITE INVENTORY DATA FORM

**Routine Condition Bridge Inspection Form**  
(for log stringer or timber stringer bridges)

| GENERAL INFORMATION | | | | (enter either long/lat or UTM below – not both) | | | |
|---|---|---|---|---|---|--|--|
| *Site #: CK-2267 | *Crossing Name: Ole Creek | *Type/Class: <input type="checkbox"/> Major Culvert<br><input checked="" type="checkbox"/> Woodbox/Log Culvert | *Project File ID# 8013 | | | | |
| *FSR Name: Stave River | *Forest District: Chilliwack | *Kilometres: 19.00 | User km: 17.8 | | | | |

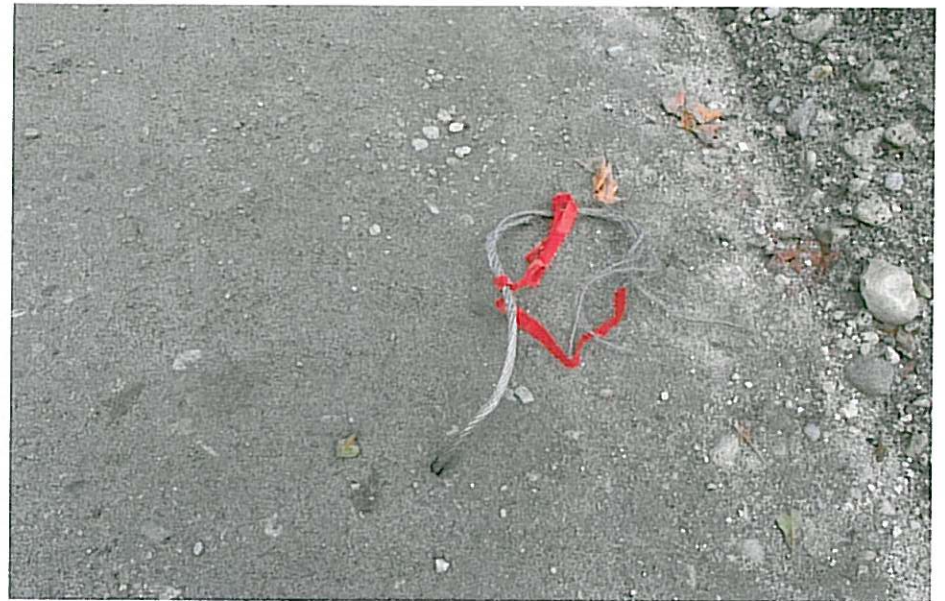
CK-2267 Cable in Road

| Photo # | Description | Photo # | Description |
|---|---|---|---|
| 2 | Cable in mid | 6 | Left abutment |

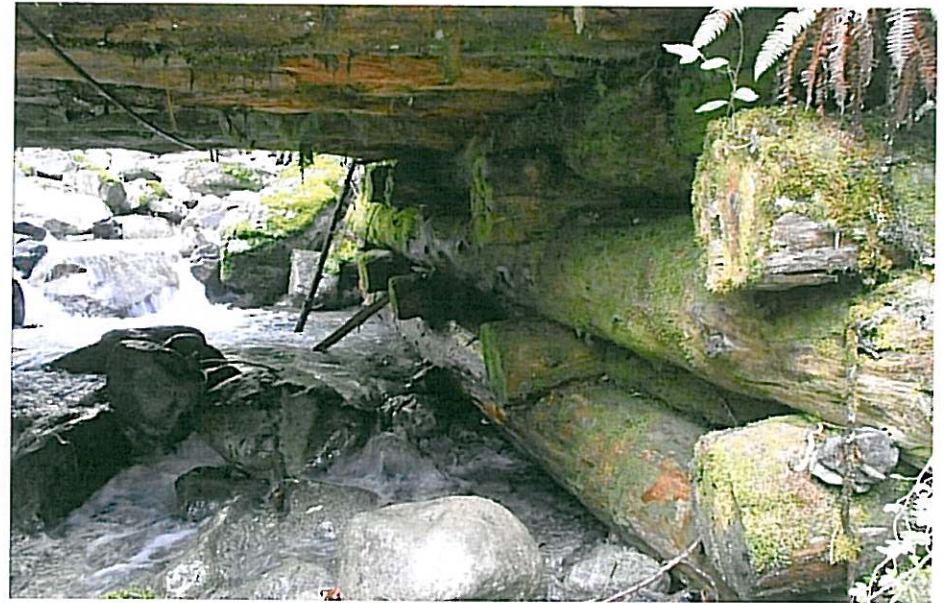
CK-2267 Left Abutment

| GENERAL INFORMATION | | | | (enter either long/lat or UTM below – not both) | | | |
|---|---|---|---|---|---|--|--|
| Log/Timber Cribs | E G F <u>(P)</u> N/A UR | | Fair to poor, cracked top crib log | | | | |
| Tie-backs | E G F <u>(P)</u> N/A UR | | Fair to poor, 4x and crushing | | | | |
| Caps or Sills | E G F <u>(P)</u> N/A UR | | Fair to poor | | | | |
| Riprap | E G F <u>(P)</u> N/A UR | | none, 6 ft scour, right buried | | | | |

| Monitor Item # | *Monitor Description |
|---|---|
| 1 | cribs |
