## Corporate Bridge Register (CBR) SITE INVENTORY DATA FORM

**Routine Condition Bridge Inspection Form**  
(except for log stringer or timber stringer bridges)

| GENERAL INFORMATION | | | | (enter either long/lat or UTM below – not both) | | | |
|---|---|---|---|---|---|--|--|
| *Site #: CK-2277 | *Crossing Name: Beaver Dam Creek | *Type/Class: <input type="checkbox"/> Temporary bridge<br><input checked="" type="checkbox"/> Permanent bridge | *Project File ID# 8013 | | | | |
| *FSR Name: Winslow Creek | *Forest District: Chilliwack | *Kilometres: 0.90 | User km: 0.90 | | | | |

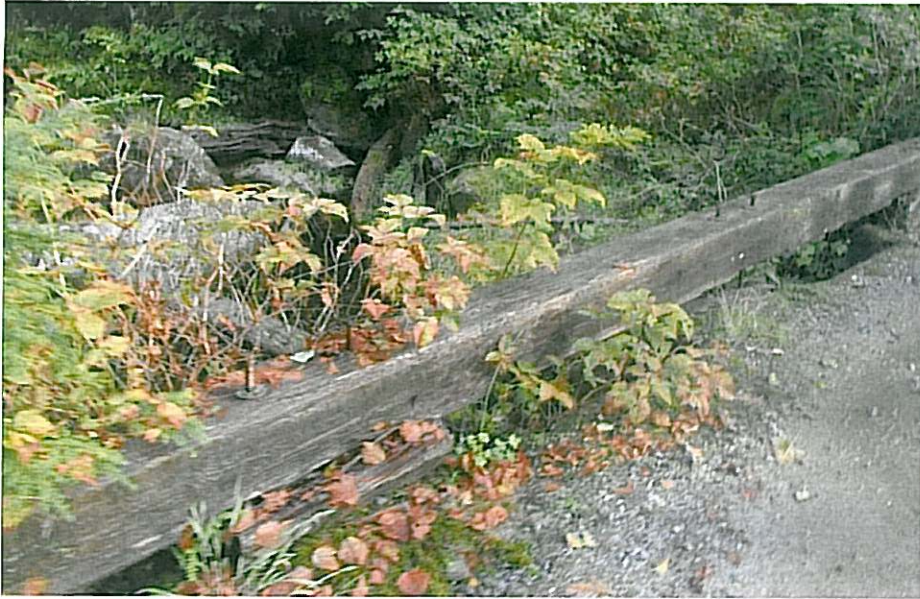
CK-2277 Guard Rails

| GENERAL INFORMATION | | | | (enter either long/lat or UTM below – not both) | | | |
|---|---|---|---|---|---|--|--|
| Curb Rail/Blocks/Posts | E G F <b>P</b> UR | | Rotten rails and risers | | | | |
| Hardware | E G F <b>P</b> N/A UR | | Poor | | | | |

| GENERAL INFORMATION | | | |
|---|---|---|---|
| 2 | <u>H</u> M L | \$1.00 | Replace rails |
| PEng Reviewer's Comments<br>Replace guardrail, risers and blocks prior to industrial activity. Post bridge ahead signs, replace | | | |

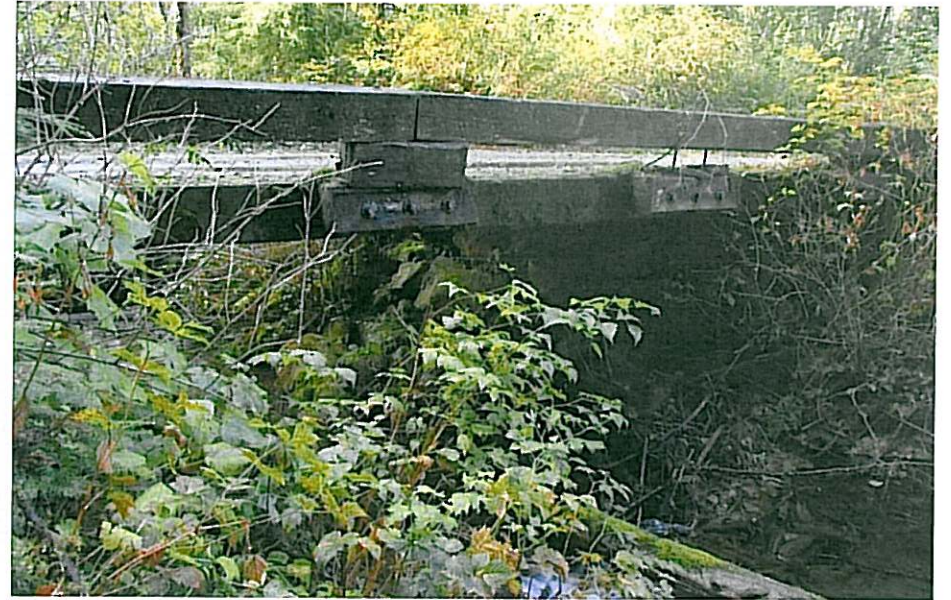
CK-2277 From Upstream

| GENERAL INFORMATION | | | |
|---|---|---|---|
| Comments Beaver dam is partially plugging inlet. | | | |

| GENERAL INFORMATION | | | |
|---|---|---|---|
| 1 | H M <u>L</u> | \$1.00 | Remove beaver dam |
