BC Ministry of  
Forests and Range

## Corporate Bridge Register (CBR) SITE INVENTORY DATA FORM

## Corporate Bridge Register (CBR) Structure Inventory Data Form "BRIDGES"

**Routine Condition Bridge Inspection Form**  
(for log stringer or timber stringer bridges)

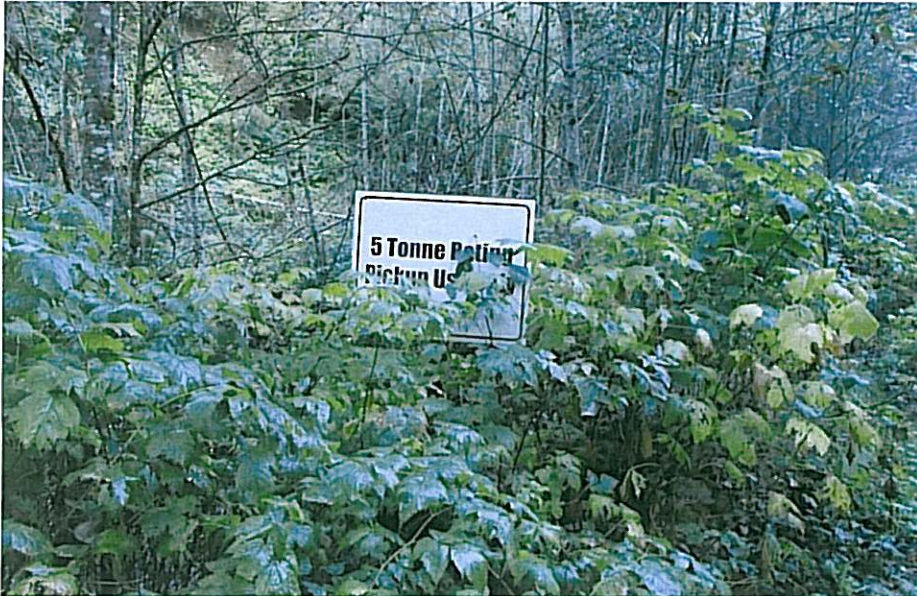
| GENERAL INFORMATION | | | | (enter either long/lat or UTM below – not both) | | | |
|---|---|---|---|---|---|--|--|
| Posted Load Rating | <u>5</u> (tonnes) or None | | SEE PK | | | | |

CK-2346 Load sign

| GENERAL INFORMATION | | | | | | | |
|---|---|---|---|---|---|---|---|
| 1 | H M <u>(L)</u> | <u>\$1.00</u> | <u>Brush and post bridge ahead signs and delineators</u> | | | | |

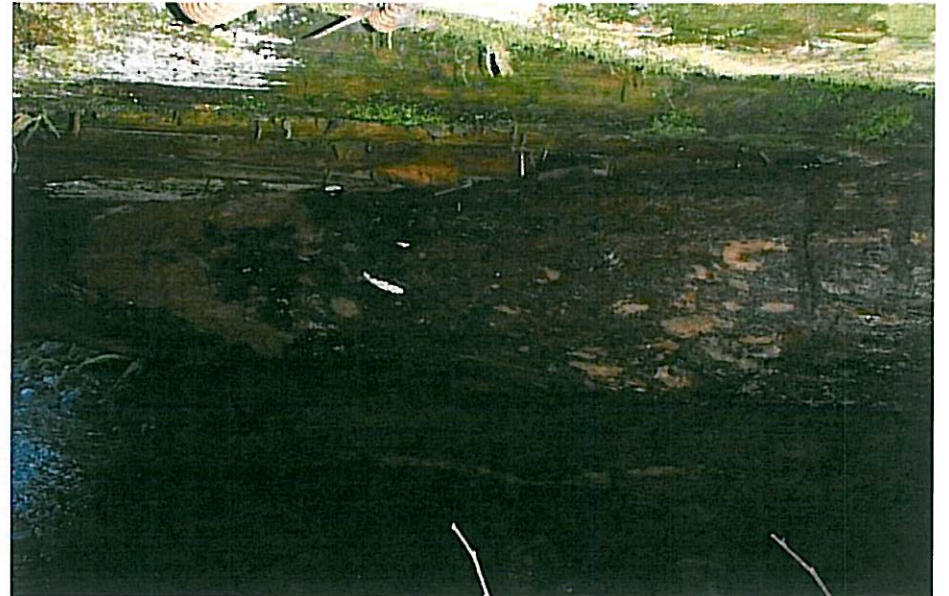
| GENERAL INFORMATION | | | | | | | |
|---|---|---|---|---|---|---|---|
| Needle Beams and Shims | E G F <u>(P)</u> N/A UR | | | <u>Needle beam has conk - not affected</u> | | | |

CK-2346 Conk on needle beam

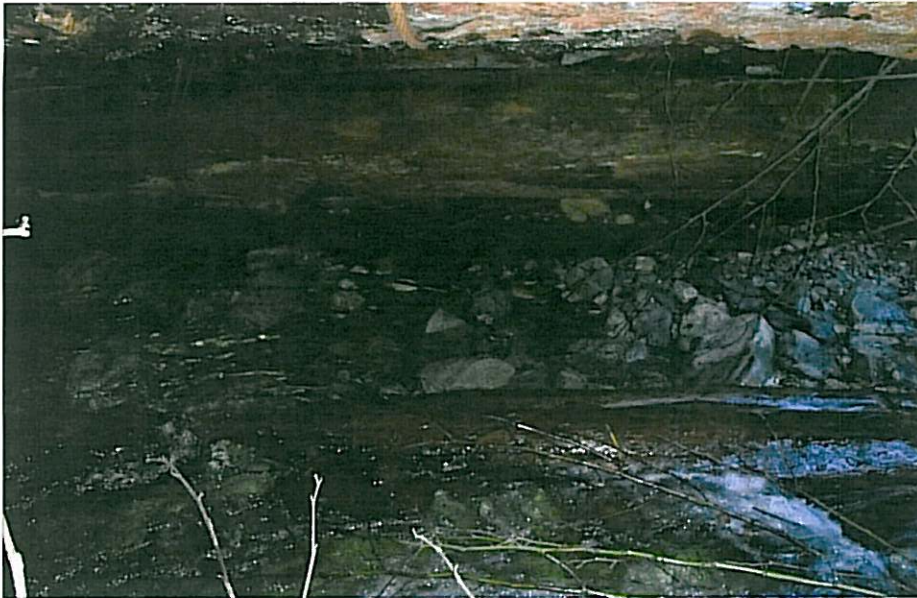
| GENERAL INFORMATION | | | | (enter either long/lat or UTM below – not both) | | | |
|---|---|---|---|---|---|--|--|
| Log/Timber Cribs | E G <u>F</u> P N/A UR | | Both undermined CW | | | | |
| Riprap | E G F <u>P</u> N/A UR | | Chbs undermined | | | | |

CK-2346 Right abutment

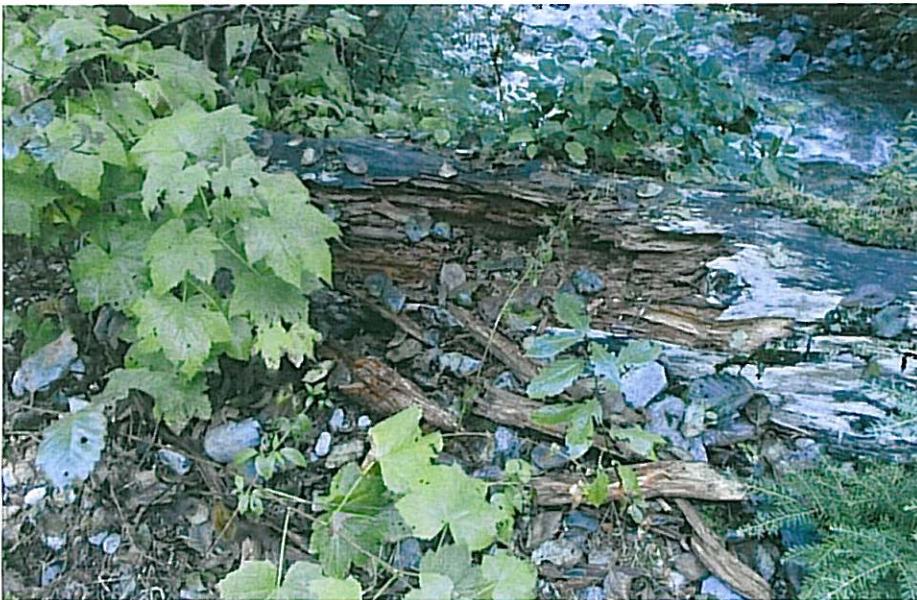
| GENERAL INFORMATION | | | | (enter either long/lat or UTM below – not both) | | | |
|---|---|---|---|---|---|--|--|
| Curb Rail/Blocks/Posts | E G <u>F</u> P UR | | logs / rotten | | | | |

CK-2346 Guard log rotten

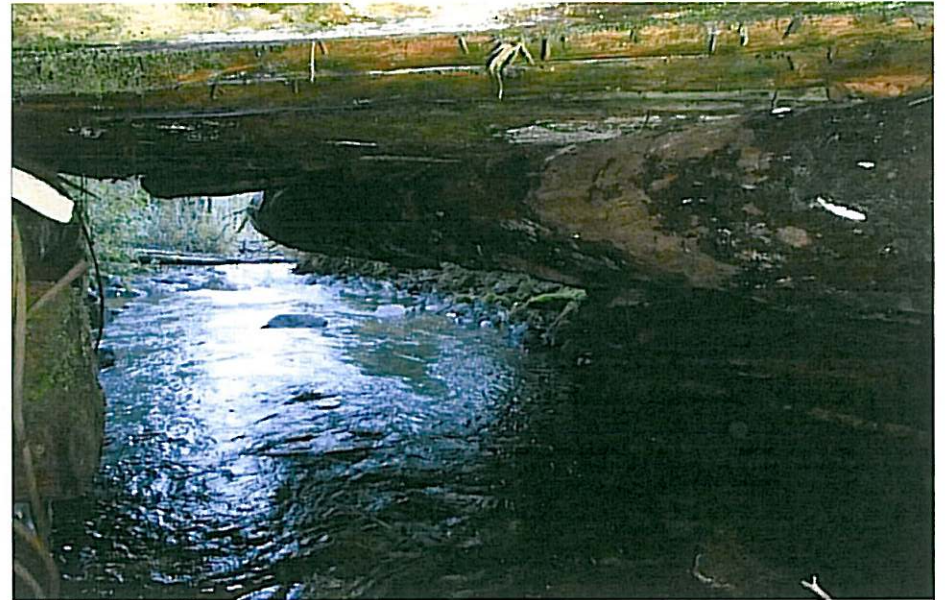
| GENERAL INFORMATION | | | | | | | |
|---|---|---|---|---|---|---|---|
| 1 | <u>CW</u> | Y <u>(N)</u> | <u>1000</u> | <u>10</u> | <u>10</u> | <u>10</u> | <u>Sap rot progressing. No broken stringers.</u> |

CK-2346 Stringers and left abutment

| GENERAL INFORMATION | | | | | | | |
|---|---|---|---|---|---|---|---|
| 2 | <u>(H)</u> M L | <u>\$1.00</u> | <u>Replace structure</u> | | | | |
