## Corporate Bridge Register (CBR) SITE INVENTORY DATA FORM

Routine Condition Bridge Inspection Form  
(except for log stringer or timber stringer bridges)

\*Crossing Name: Side Creek

| GENERAL INFORMATION | | | |
|---|---|---|---|
| 2013/09/25 | ONSITE | Jeremy Araki | C. R. ARAKI #29756 |

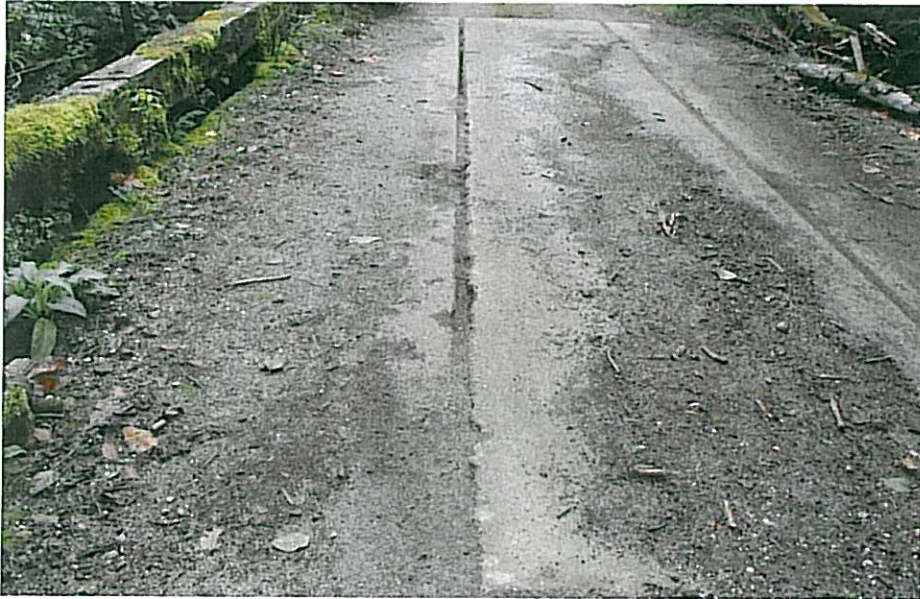
| GENERAL INFORMATION | | | |
|---|---|---|---|
| 1 | Sill displaced | 5 | Upstream |

CK-2353 Slab Displaced

| GENERAL INFORMATION | | | |
|---|---|---|---|
| 1 | H M L | \$1.00 | Replace sills. Replace rails before industrial activity occurs. |

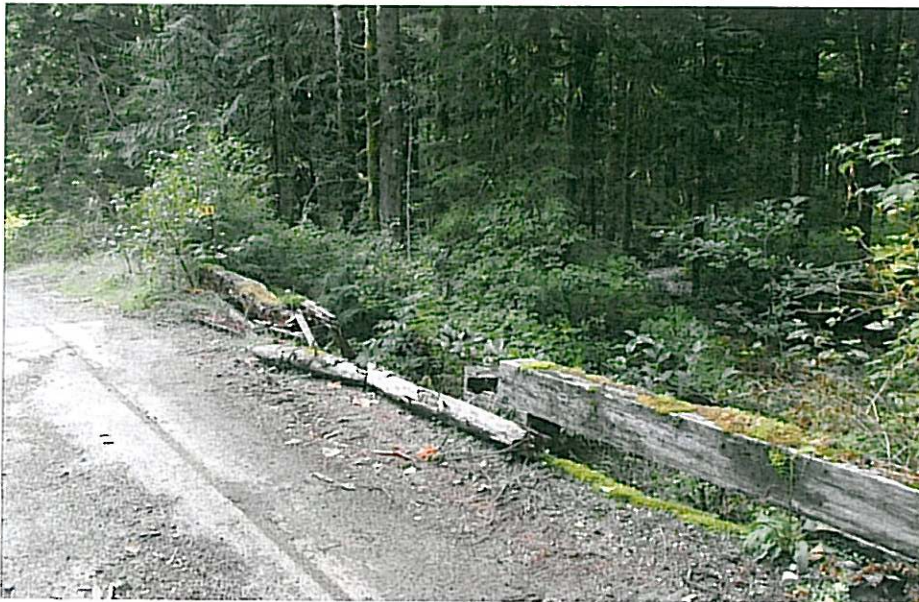
| Item | Present Condition (circle or fill-in) | Comments (a comment is mandatory if condition "Poor" is selected) |
|---|---|---|
| Fender Condition | E G F <b>P</b> None UR | Downstream right approach no post barriers have been hit and now lie in the ditch. |

CK-2353 Guard Downstream

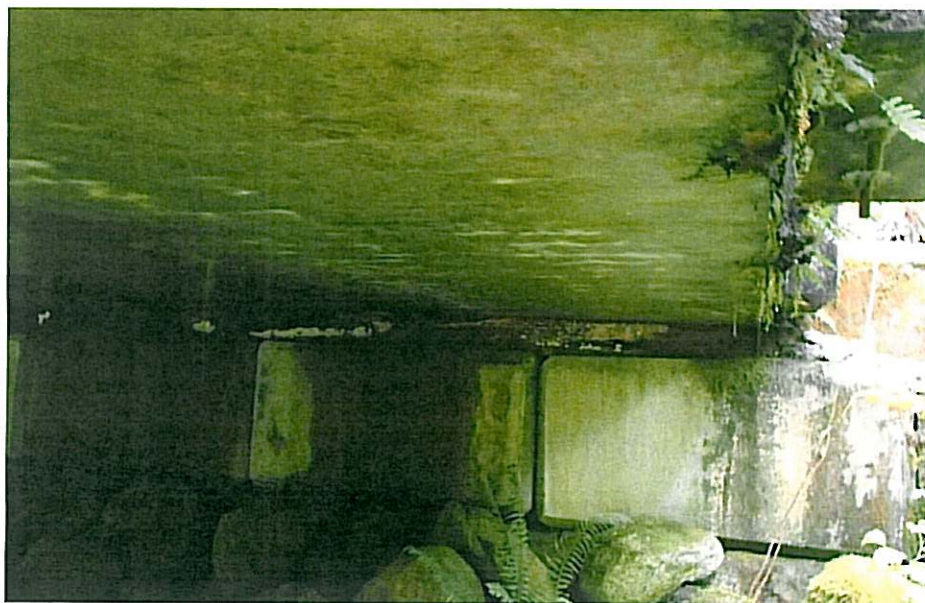
| Item | Present Condition (circle) | Comments (a comment is mandatory if condition "Poor" is selected) |
|---|---|---|
| Bearings | E G F <b>P</b> N/A UR | Rotten crushed |

CK-2353 Right Bearing

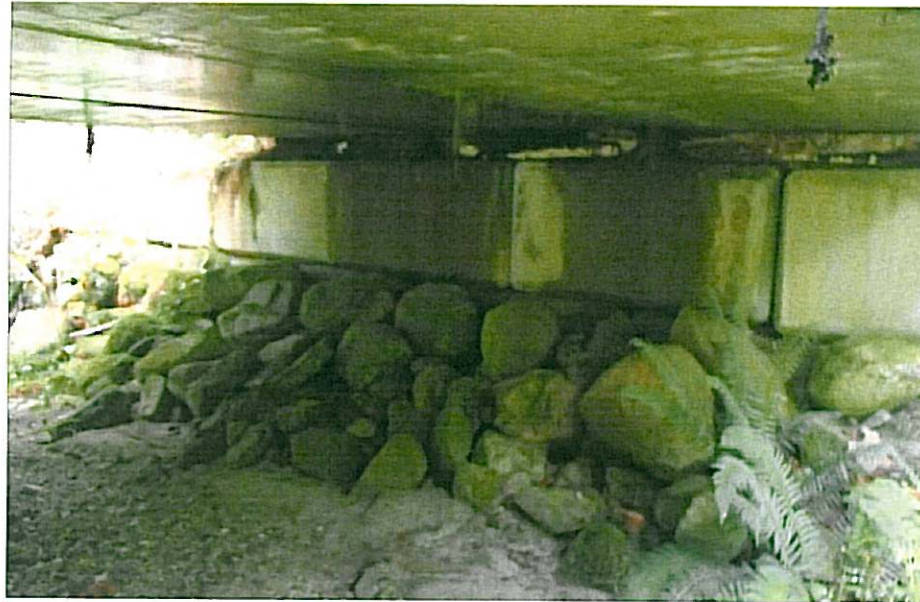
CK-2353 Right Abutment

| Item | Present Condition (circle) | Comments (a comment is mandatory if condition "Poor" is selected) |
|---|---|---|
| Caps or Sills | E G F <b>P</b> N/A UR | 8" x 8" timber, some fruiting bodies growing on them, crushed. |
