CK-2002

AMERICAN CREEK 4.6km

2014 Inspection

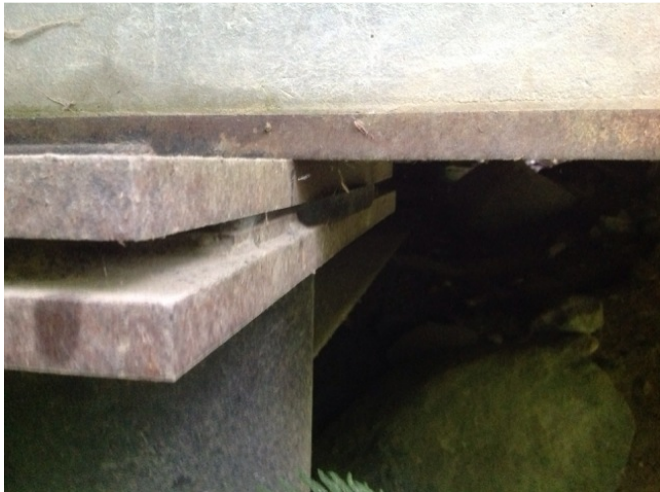
Bearings Fair slight bulging of pads

bulging rubber

1 bulging bearing pads

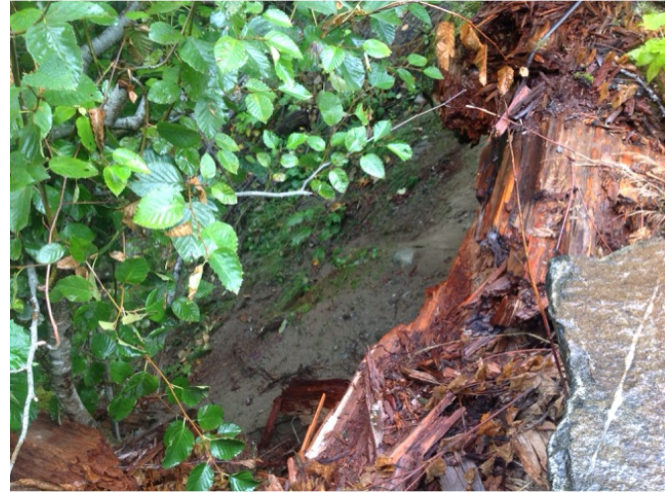
right we stream fill eroding

Post bridge ahead signs. Repair ravelling slope on downstream right approach. Monitor bearing pads. Present load rating of L60 or 54 tonnes to continue.

| Repair Item | Priority | Repair Description |
|---|---|---|
| 2 | Medium | replace/repair eroding fill downstream right approach |
