CK-2007

ANDERSON SEVEN 0.1km

2014 Inspection

| Structure Class | Temporary Bridge |

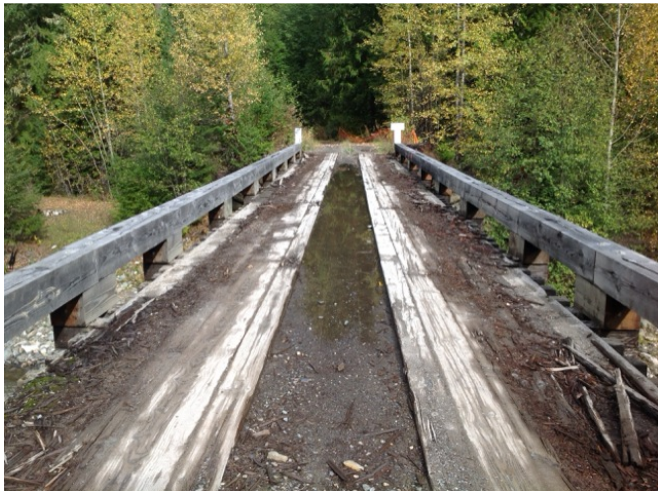
Running Planks Poor rotten

Nails Poor protruding

Overall Deck Condition Poor due to worn running planks

| Repair Item | Priority | Repair Description |
|---|---|---|
| 1 | Medium | replace wear planks with activity |

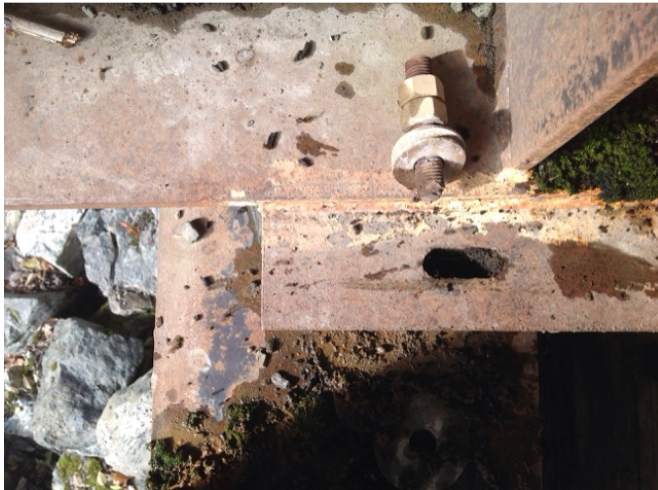
Bearings Fair fair to poor - bearing bolts on left bank all bent and all 4 bearing bolts on right bank (slotted) sheared off. Pier added in 2013 with what appears as fixed bearing holes as

Comments    pier added in 2013, with what appears as fixed bearings  
all 4 bearing bolts on right bank sheared completely off  
check previous inspections noting sheared bearing bolts

right bank upstream bearing bolts (both) sheared off

| 1 | bearing on right bank | Anually |

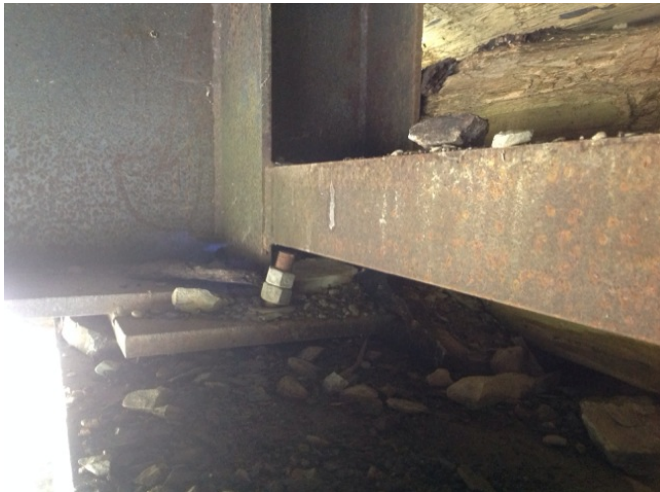
left bank upstream bearing bolts
