CK-2008

ANDERSON SEVEN 0.3km

2014 Inspection

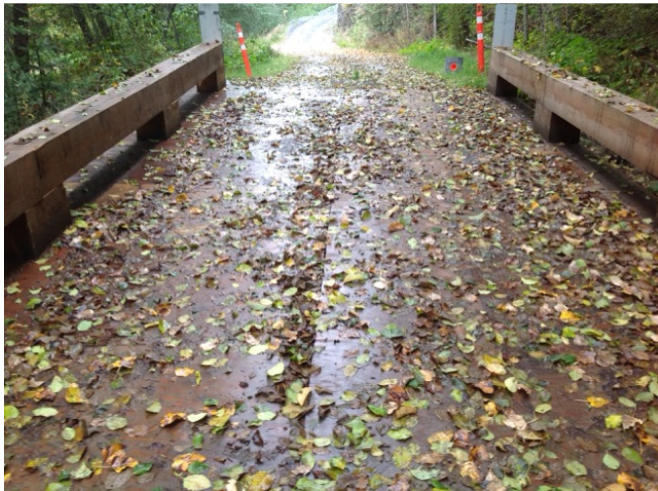
Overall Deck Condition Unrated can't see what is under plywood
