CK-2012

BLUE MTN TWO 0.8km

2014 Inspection

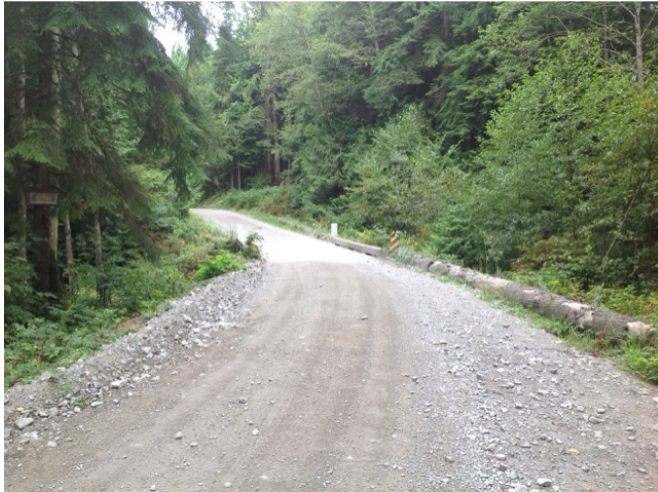
Approach from Left Bank when facing downstream

Bridge Ahead Signs  
Missing ☐ 0 ☐ 1 ☒ 2

| 1 | Medium | post bridge ahead signs |

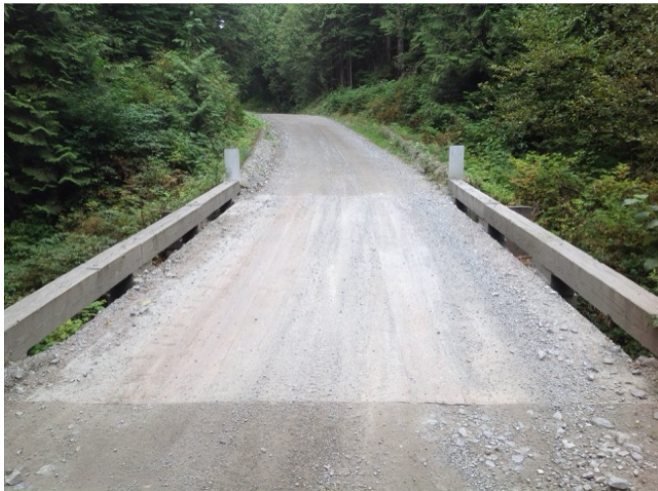
Overall Deck Condition Good

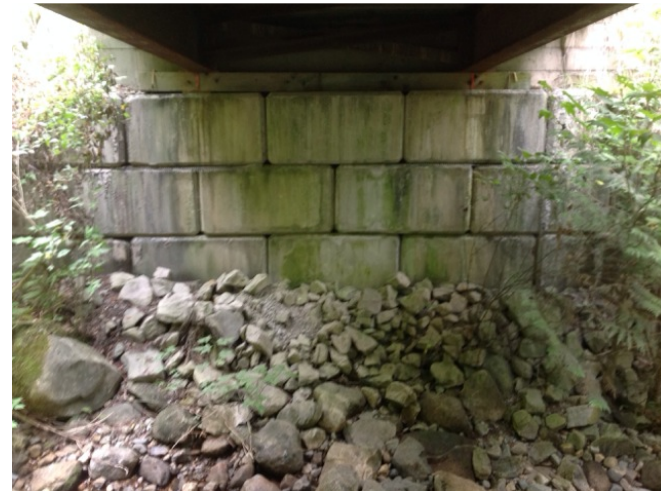
Left Bank Abutment when facing downstream

Concrete Fair lock blocks - 3x

Caps or Sills Fair 2 - 200mm x 200mm treated timbers bolted together and shimmed level

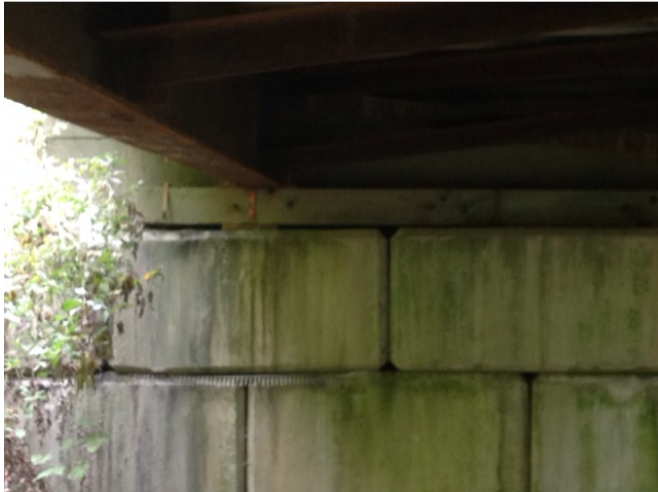
left upstream bearing shimmed level

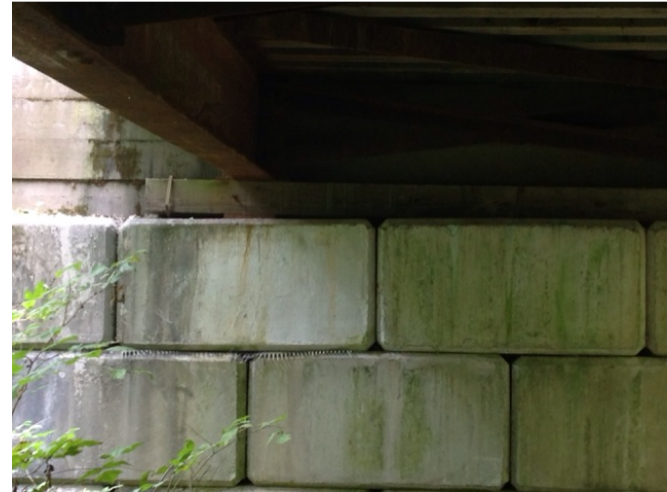
right downstream bearing shimmed

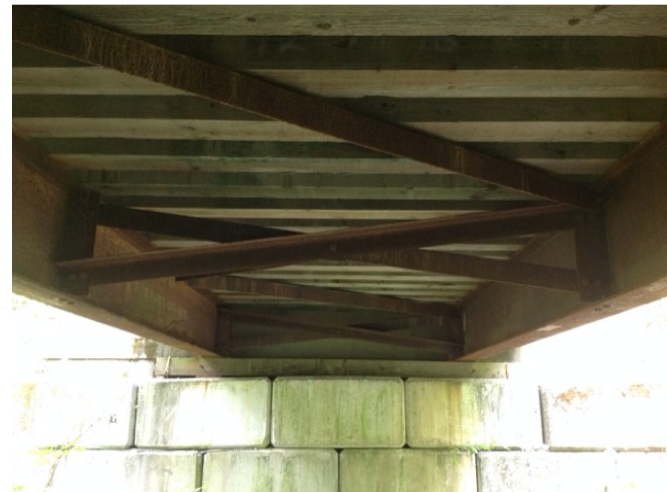
superstructure

Girders Fair 2 steel I beams - some corrosion
