CK-2014

CANTELON CREEK 8.2km

2014 Inspection

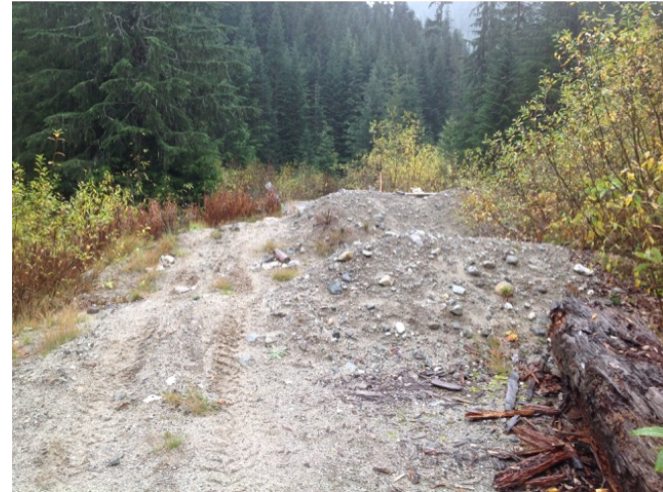
Approach from Left Bank when facing downstream

Fender Condition Poor Onsite but moved due to access blocking on left approach

Road Surface Poor access blocked to vehicle traffic

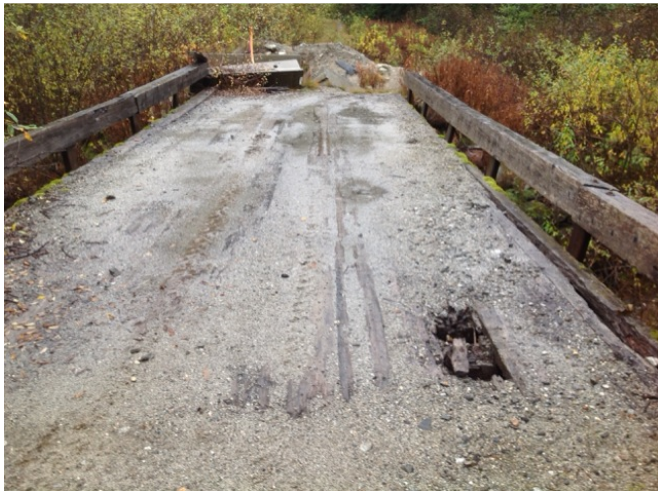
Running Planks Poor rotten

Ties Poor rotten

Nails Poor protruding

Deck to Girder Bolts Poor loose

Curb Rail/Blocks/Posts Poor rotten

Overall Deck Condition Poor rotten deck

Replace entire structure prior to industrial activity, 0 tonnes load rating. Please post.

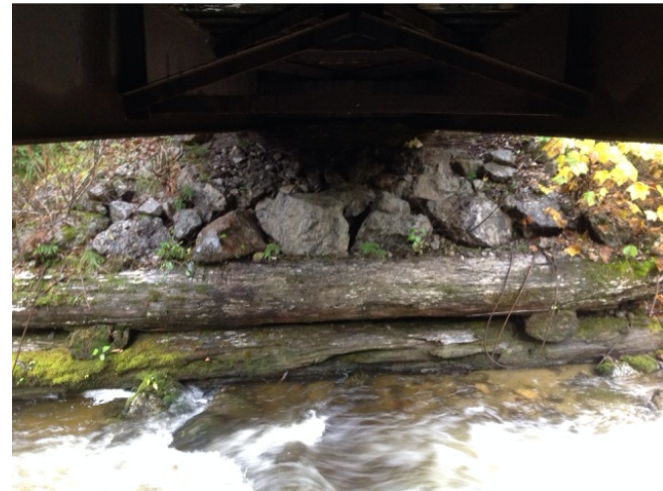
Right Bank Abutment when facing downstream

Comments scouring under right abutment fill retention crib

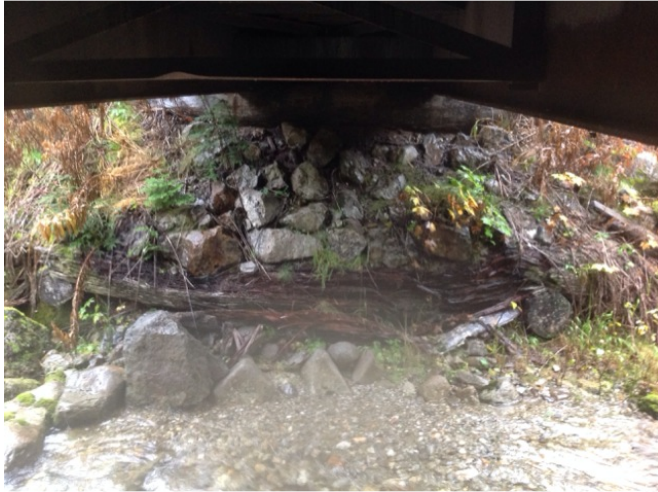
Left Bank Abutment when facing downstream

Riprap Poor left bank crib failing and riprap sloughing
