CK-2016

CANTELON CREEK 9.1km

2014 Inspection

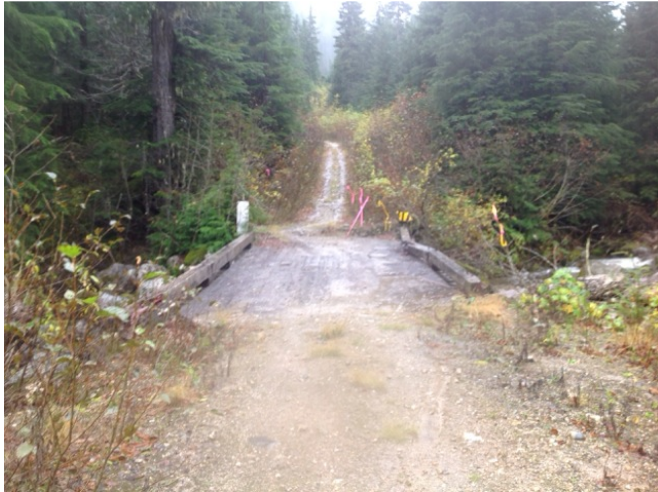
Approach from Left Bank when facing downstream

Fender Condition Poor none left approach

Road Surface Poor road grown over

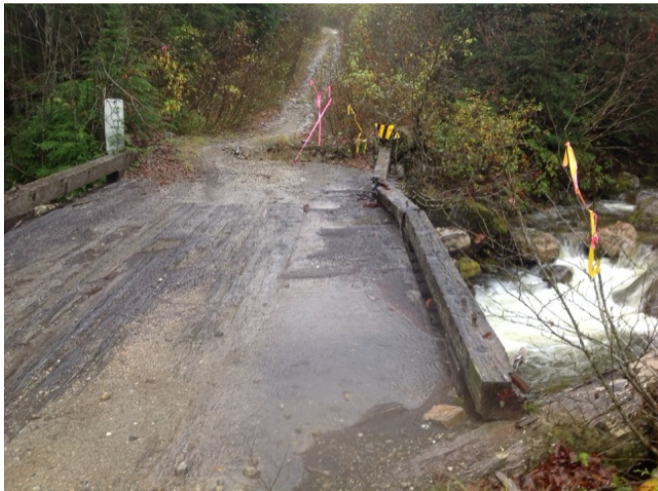
Running Planks Poor rotten

Ties Poor rotten

Nails Poor protruding

Deck to Girder Bolts Poor loose

Overall Deck Condition Poor rotten deck

Replace entire structure prior to industrial activity, 0 tonnes load rating. Please post.

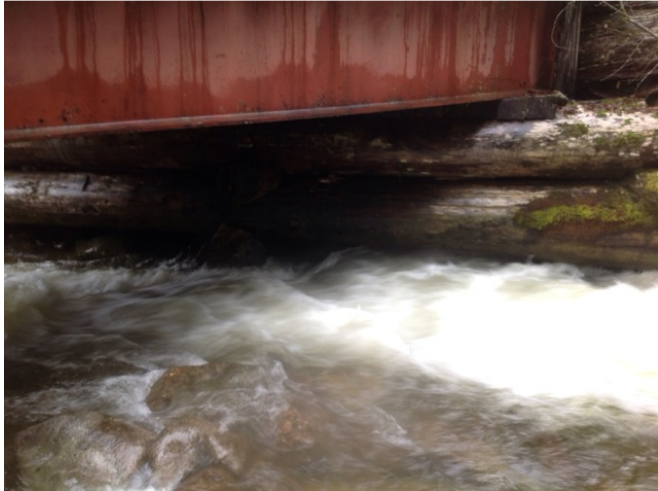
Right Bank Abutment when facing downstream

Log/Timber Cribs Poor undermined and rotting

Tie Backs Poor rotting

Caps or Sills Poor rotten timbers

Fill Poor failing

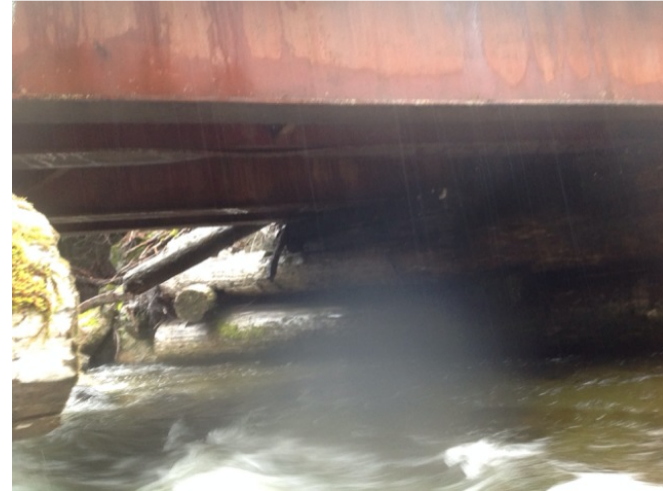
Girders Poor 4 girders, damaed

damaged giders
