CK-2019

CAYOOSE CREEK 0.1km

2014 Inspection

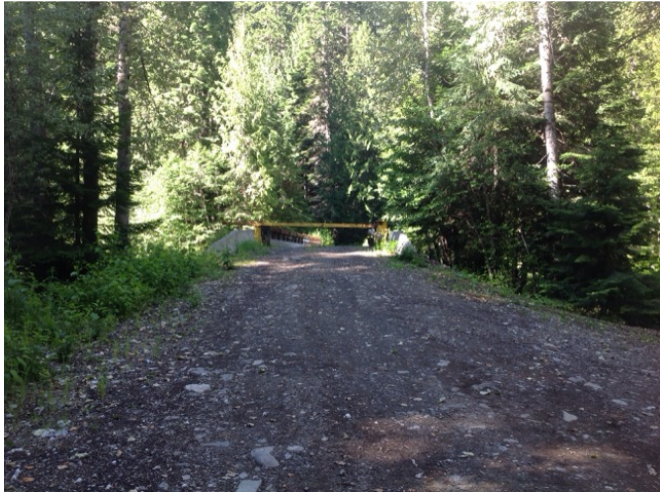
Approach from Right Bank when facing downstream

Brushing Required Y

Delineator Missing  
Left ☐ 0 ☐ 1 ☒ 2Delineator Missing  
Right ☐ 0 ☐ 1 ☒ 2

| Repair Item | Priority | Repair Description |
|---|---|---|
| 1 | Medium | brush with activity |
| 2 | Medium | replace missing delineators |

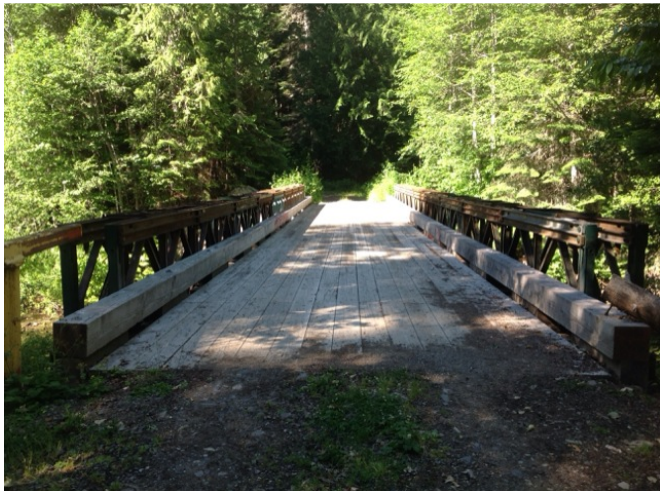
| Running Planks | Fair | 100x250 |
| Overall Deck Condition | Fair | |

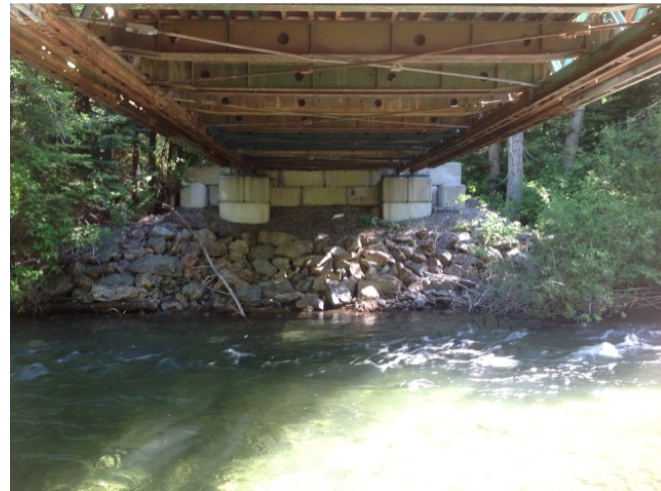
Right Bank Abutment when facing downstream

Concrete Good lock block columns 2x2

Ballast Wall Good lock blocks

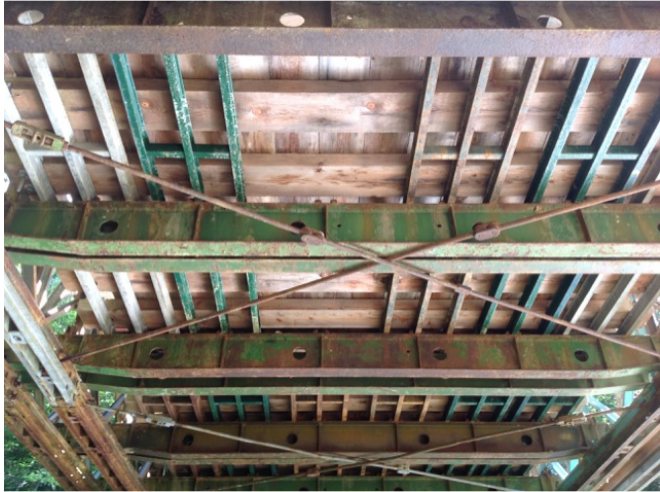
missing steel stingers

| 2 | deck - primarily when hauling as there are 2 missing steel stringers | Other |

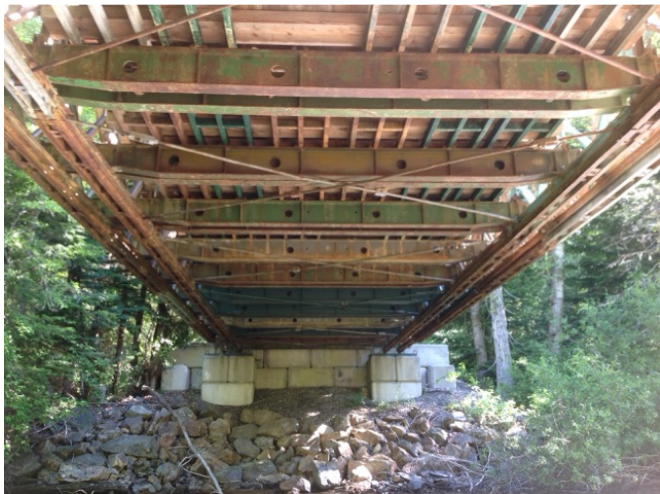
underneath deck

8 panel double single reinforced bailey - paint peeling and rusting

approx 50 missing cotter pins - no movement noticed on pins

| Repair Item | Priority | Repair Description |
|---|---|---|
| 3 | Medium | replace missing cotter pins prior to activity - approx 50 missing pins |

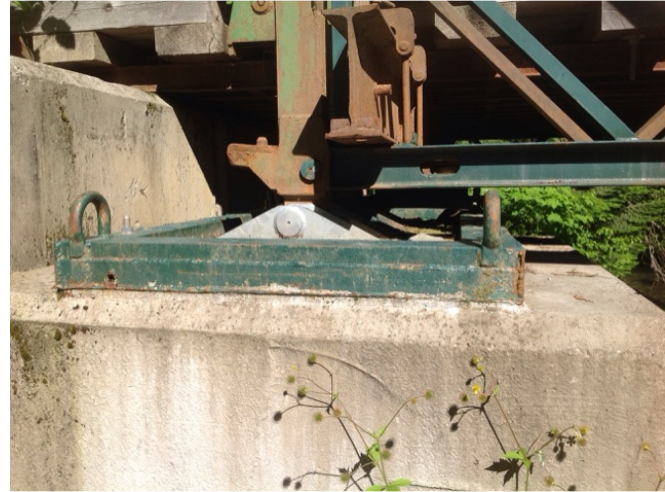
left bank bearing

Bearings Good
